FINAL REPORT
A-036/CENIPA/2022

OCCURRENCE:	ACCIDENT
AIRCRAFT:	PT-BOK
MODEL:	PA-28-140
DATE:	21MAR2022

This is the Final Report of the 21 March 2022 accident with the PA-28-140 aircraft, registration marks PT-BOK. The occurrence was typified “[SCF-PP] Engine failure or malfunction | With propeller.”

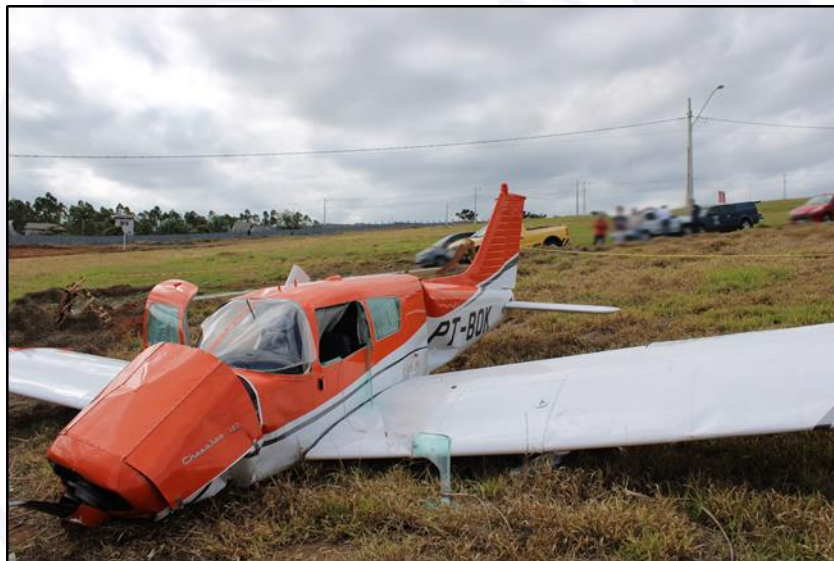
Figure 1 - Aircraft after coming to a complete stop.

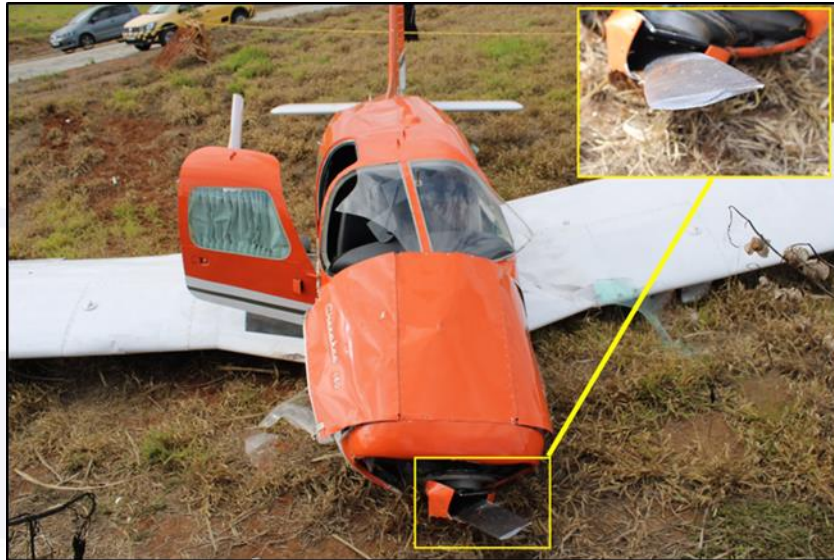
The aircraft sustained substantial damage to the entire landing gear, fuselage, wings, right-hand flap, engine, and windshield.

One of the propeller blades fractured and lost approximately 50% lengthwise. The other blade sustained damage due to impact.

Figure 2 - Close-up image of the damage sustained by the aircraft, and detail of the fractured propeller.

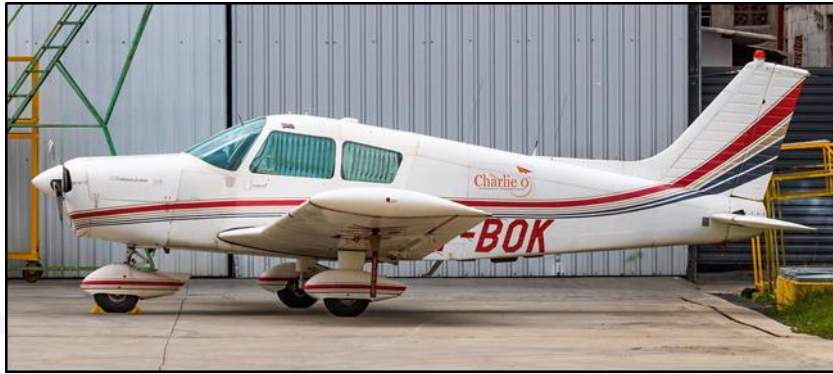
Figure 8 - Former livery of the PT-BOK.

The professional that painted the aircraft was not certified by the ANAC. According to the very painter, there was no one to supervise the painting service. Besides, no documentation was available to prove the assistance of a qualified professional during the execution of the service.

After the exchange of the propellers, between 03 January 2022 and 10 February 2022, one found that the aircraft underwent a painting service done by a professional not certified by the ANAC, and without the assistance of qualified staff to inspect the service being provided. In addition, in that general painting, according to reports, the aircraft was painted without removal of the SN K-26595 propeller.

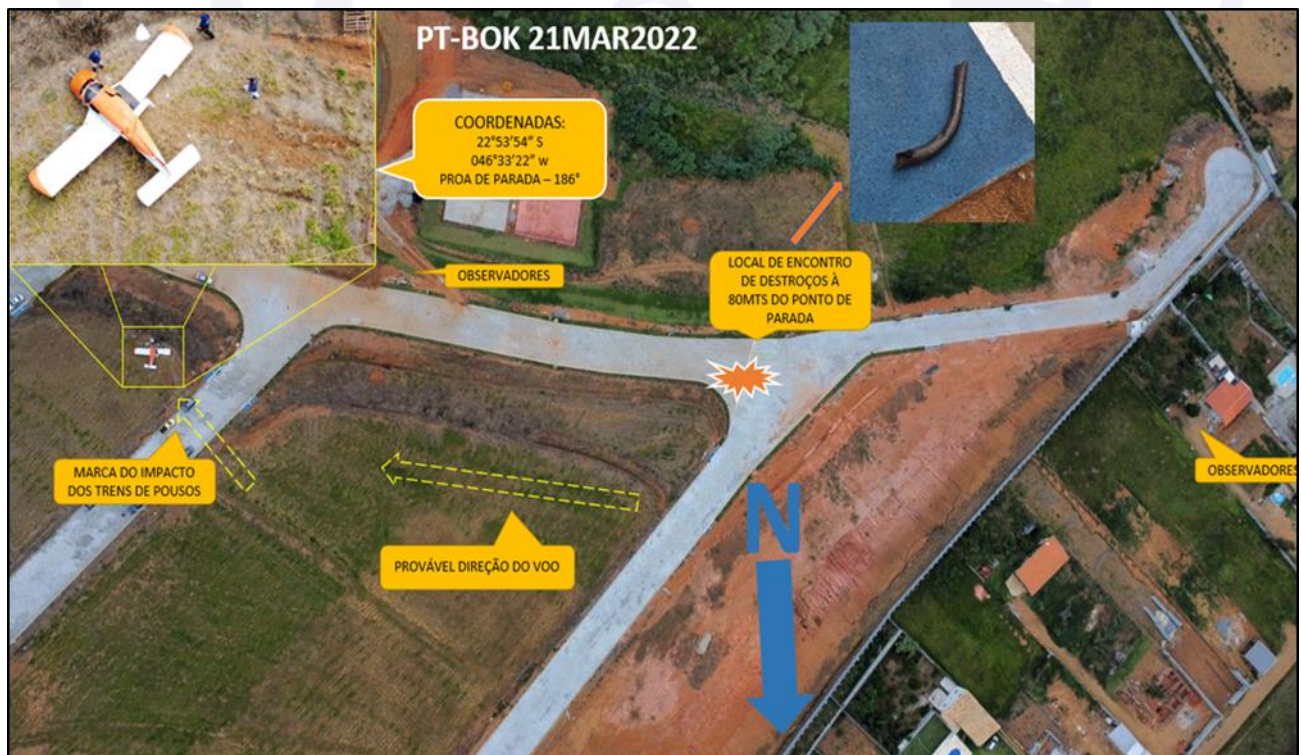
The distribution of the debris was concentrated, and the aircraft traveled approximately 20 m on the ground before coming to a stop.

Figure 11 - Sketch of the wreckage.

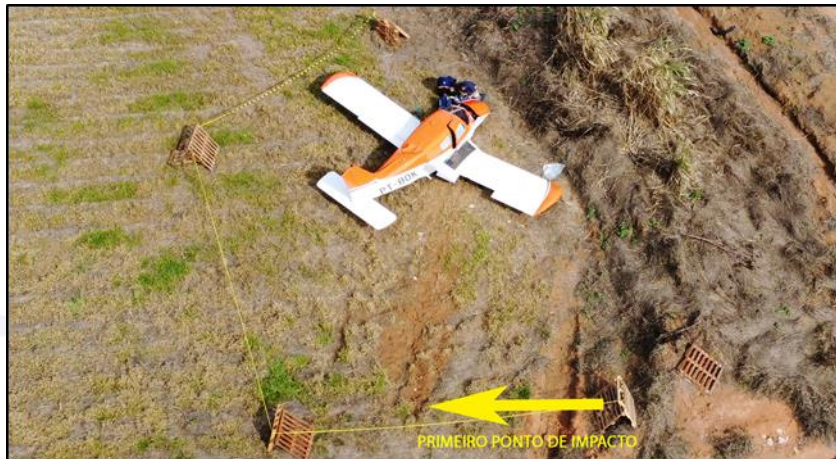
Figure 12 - Marks of the first impact, and final position of the aircraft.

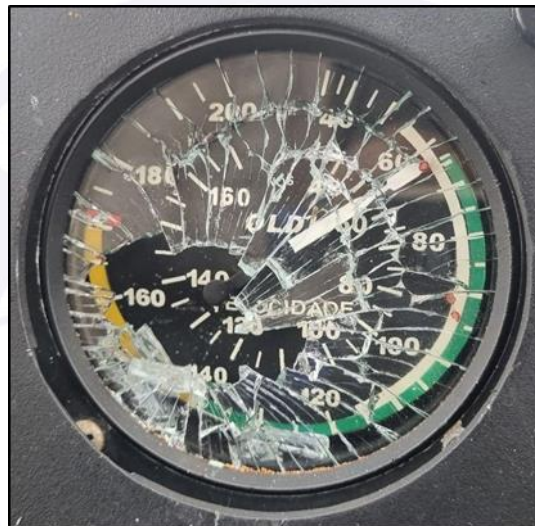
The speed recorded in the speedometer was approximately 62 kt (Figure 13).

Figure 13 - Indication of the speedometer found in the wreckage of the aircraft.

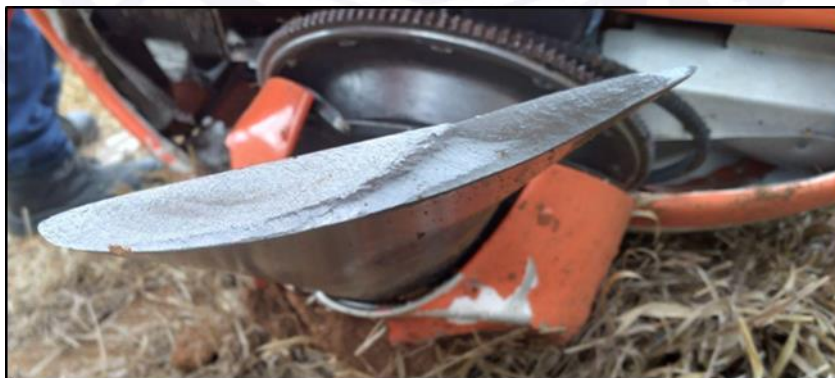
The propeller was painted black, and one of its blades had fractured (Figure 14).

Figure 14 - Fracture in one of the blades.

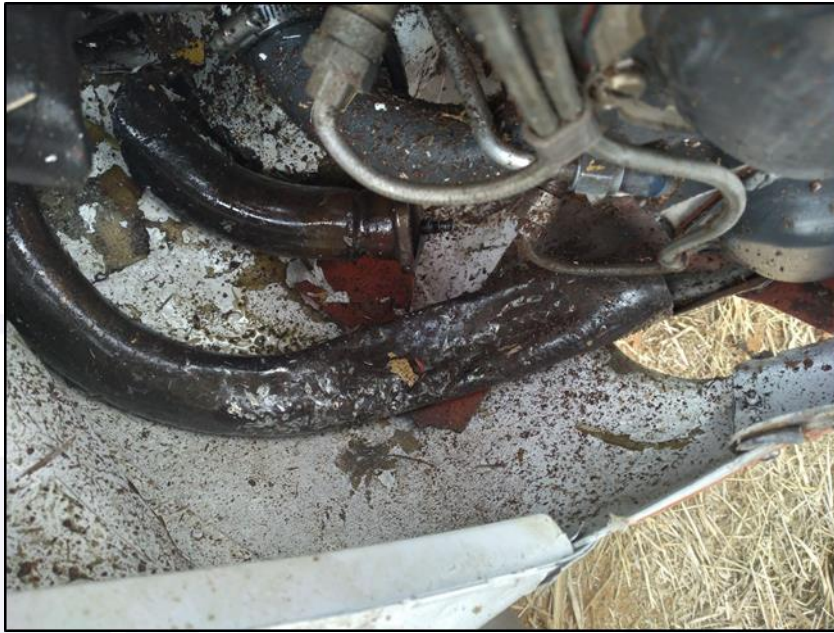
Inside the engine section, parts of the exhaust system were loose and fractured (Figure 15).

Figure 15 - Part of the exhaust pipes with signs of impact.

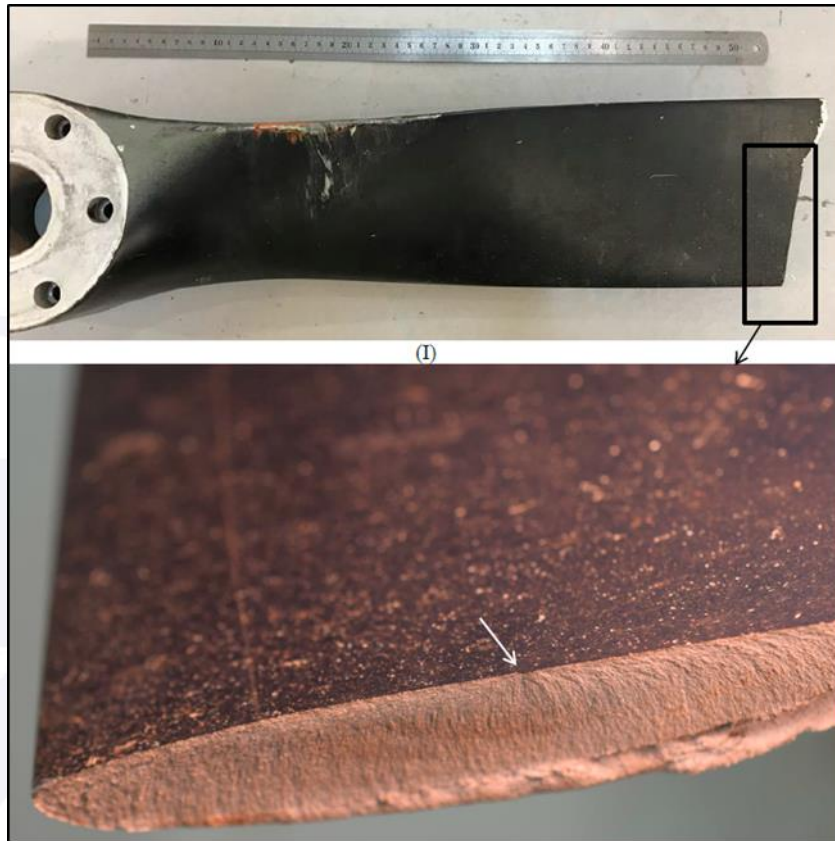
In visual examinations, one observed plastic deformations of the propeller blade caused by several small impacts (points where paint was lacking - Figure 16), in addition to typical fatigue characteristics (Figure 17).

Figure 16 - Top image: overview of the fractured propeller. Lower image: detail of the propeller close to the fracture (The arrow indicates the point of the fatigue onset).

In the analyses, it was also possible to observe that the soffit of the blade had several small points of impact, possibly resulting from FOD (Foreign Object Damage) on different occasions during the use of the propeller.

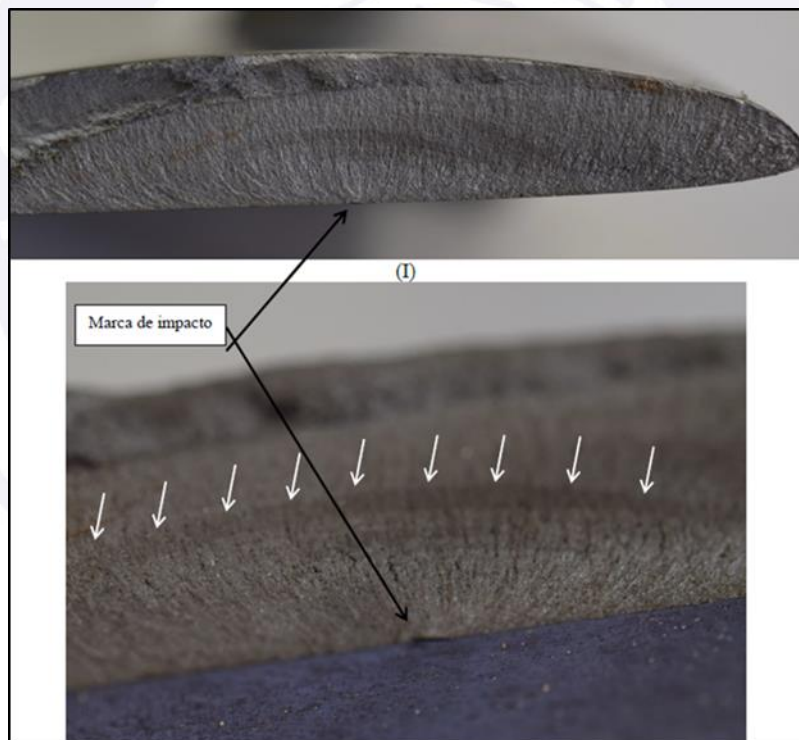
The analysis revealed that blade had a fracture surface with characteristics typical of fatigue. The onset of the material fatigue process was fostered by the presence of a dent, which actuated as a stress concentrator.

Figure 17 - Top image: precise point of the fatigue onset. Lower image, with further magnification: the white arrows indicate the advancement of fatigue from the expansion lines, aka *beach marks*.

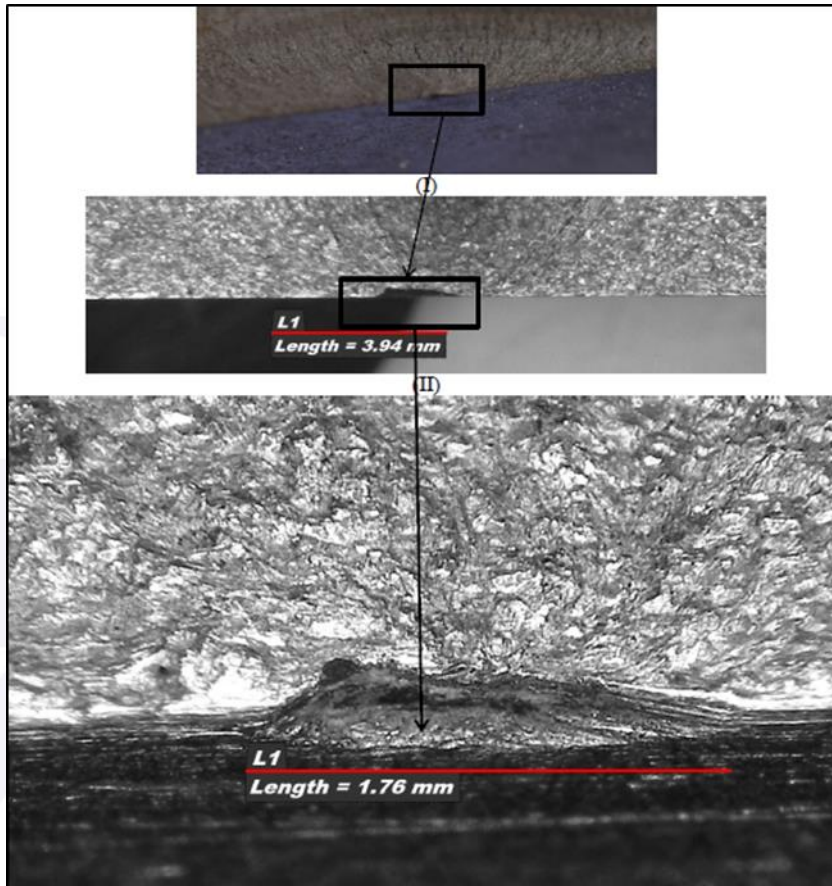
Stereoscopic examinations showed the presence of plastic deformation caused by particle impact in the region where fatigue began to propagate (Figure 18).

Figure 18 - Top image: detail of the spot where fatigue originated. Lower image: loss of material caused by impact (dent), acting as a stress concentrator that triggered the fatigue process.

Finally, the fractured propeller presented a fracture surface with typical characteristics of fatigue. The onset of fatigue process affecting the material was facilitated by the presence of a dent, which acted as a stress concentrator.

The information obtained from the analysis made it possible to conclude that the fracture occurred due to the formation of a dent, which actuated as a stress concentrator, leading to the collapse of the propeller, with an in-flight separation of approximately 50% of the affected blade along its length.
