**COMANDO DA AERONÁUTICA**  
**CENTRO DE INVESTIGAÇÃO E PREVENÇÃO DE**  
**ACIDENTES AERONÁUTICOS**

**FINAL REPORT**  
**A-122/CENIPA/2022**

<b>OCCURRENCE:</b>	<b>ACCIDENT</b>
<b>AIRCRAFT:</b>	<b>PT-DAB</b>
<b>MODEL:</b>	<b>182K</b>
<b>DATE:</b>	<b>29OUT2022</b>

This is the Final Report of the 29<sup>th</sup> October 2022 accident involving the 182K Cessna aircraft of registration marks PT-DAB. The accident received the typification of “[Fuel] fuel related.”

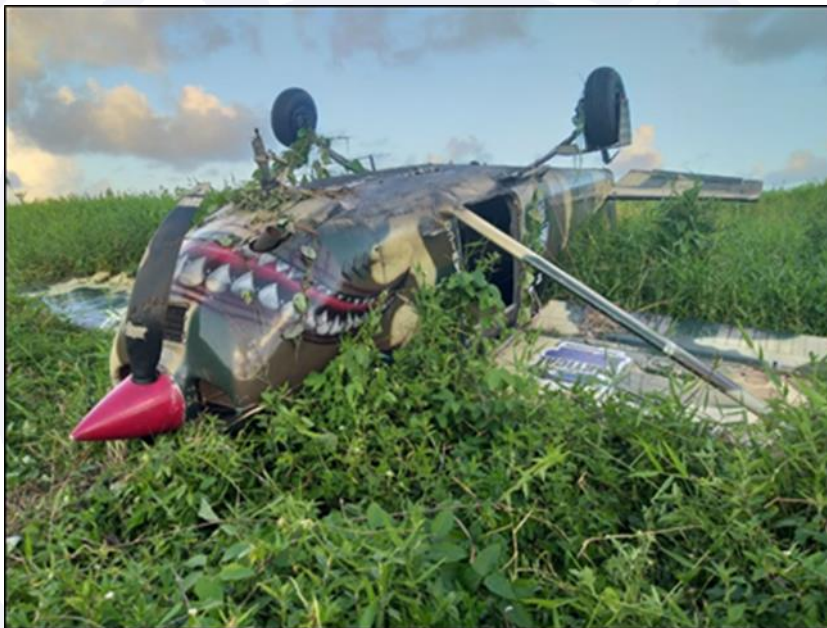
The aircraft landed at a distance of approximately 110 m to the right-hand side of the runway, close to the runway threshold 18, and came to rest in an upside down position, after traveling approximately 15 meters on the ground.

Figure 1 - View of the PT-DAB at the emergency landing site.

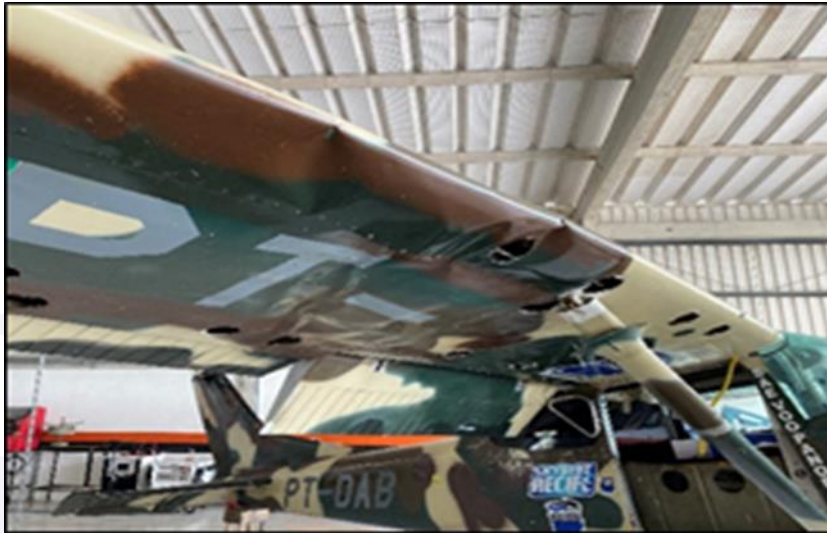
The aircraft sustained substantial damage to its engine, propeller assembly, auxiliary landing gear, vertical stabilizer, as well as to its right-hand wing (Figures 2 and 3).

Figure 2 - Damage to the right-hand wing.

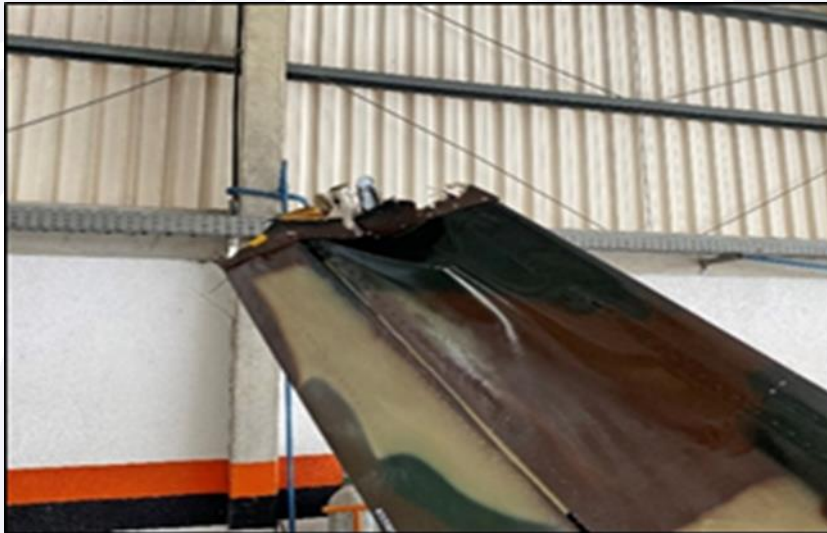
Figure 3 - Damage to the vertical stabilizer.

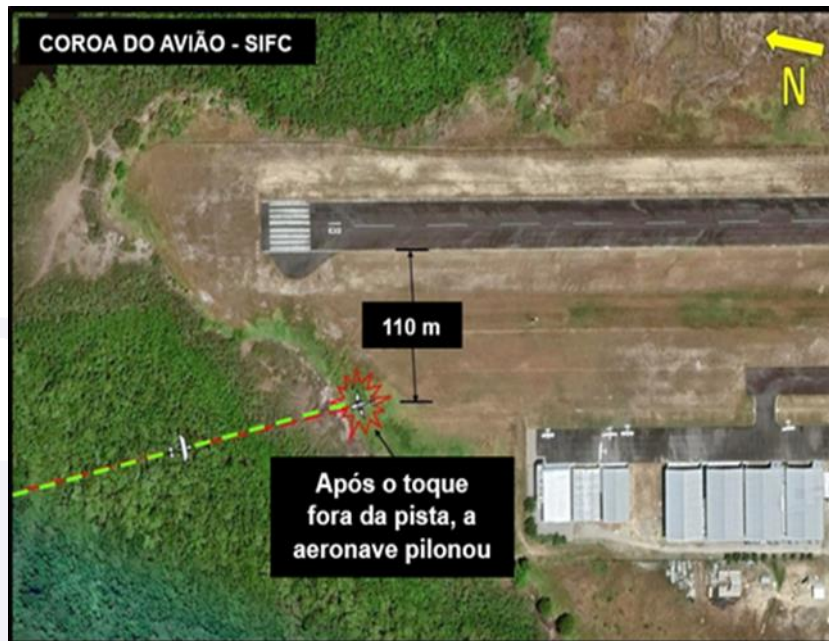
After performing a 360°-approach, starting at 2,000 ft. overhead the runway threshold 18 of SIFC, the pilot made a forced landing outside the runway in an area located to the right of the runway alignment (Figure 4).

Figure 4 – Croquis of the accident.

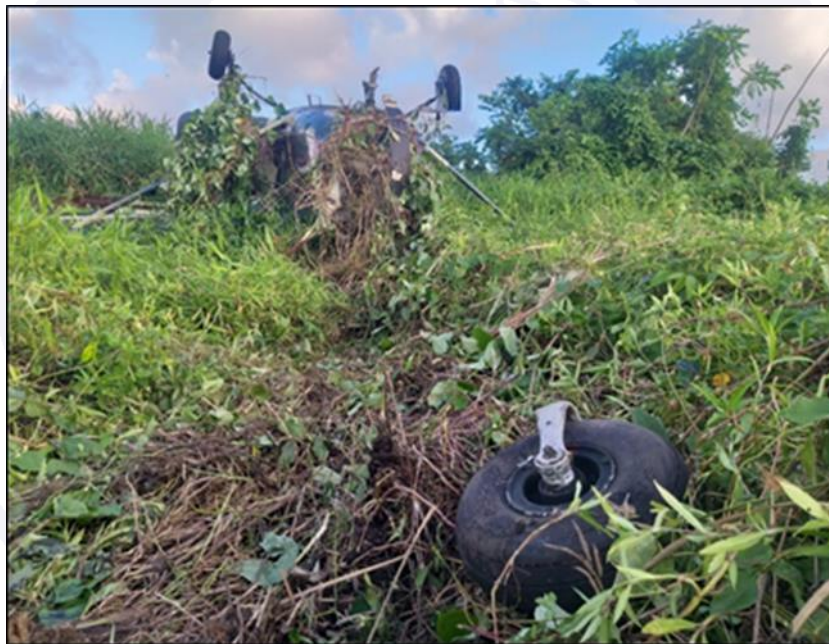
After traveling approximately 15 m on the terrain, the aircraft came to a complete stop in an area located approximately 110 m away from the right-hand side of the runway, after overturning in the process. With the impact, the auxiliary landing gear separated from the aircraft, but the rest of the debris remained concentrated (Figure 5).

Figure 5 - Auxiliary landing gear separated from the aircraft.

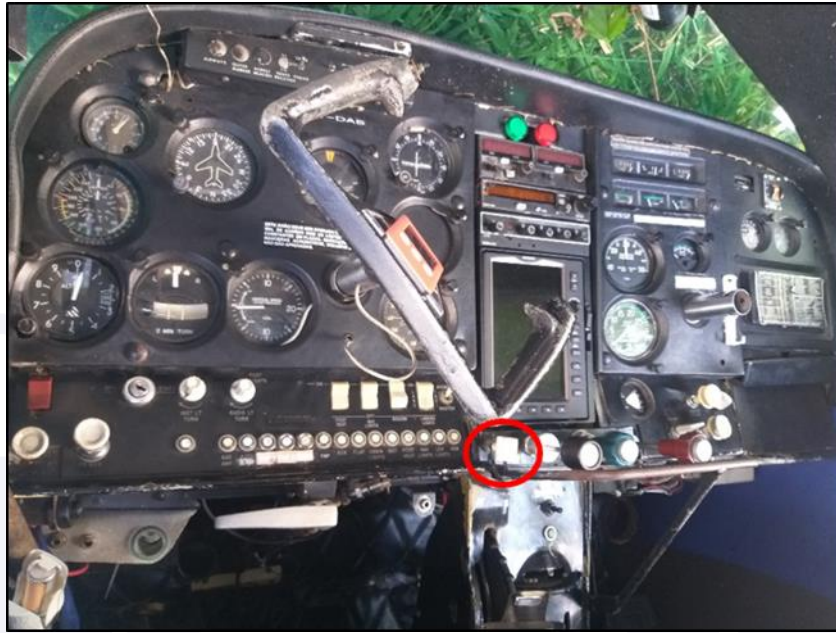
At the scene of the accident, the Carburettor Heat lever was in the off position (Figure 6).

Figure 6 - Detail of the Carburettor Heat lever in the off position.

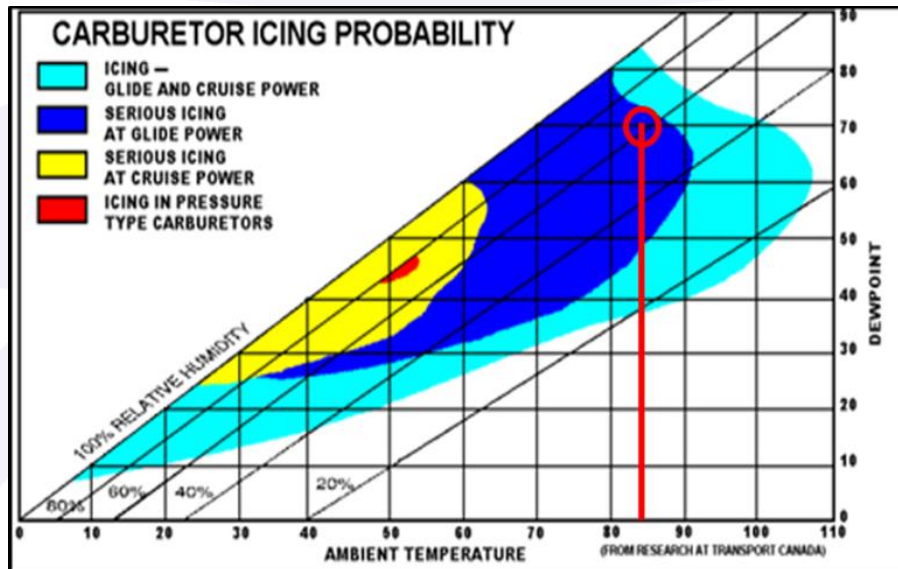
In fact, based on the graph on potential carburetor icing with reduced power (*glide power*), one observed that the aircraft was operating in the danger zone, precisely, in the so-called *Serious Icing (glide power)* (Figure 12).

Figure 12 - Probability of occurrence of icing in the carburetor, taking as reference the temperature and relative humidity in SBRF.

Taking into account the meteorological variables then present (temperature and relative humidity), which are compatible with the formation of severe ice in the carburetor, the engine with reduced power, the failure to activate the carburetor-heating lever, and with no discrepancies found in the engine and its accessories, the Investigation Committee inferred that the engine failure may have been related to a restriction in fuel supply due to ice formation in the carburetor.
