**FINAL REPORT**  
**A-025/CENIPA/2022**

<b>OCCURRENCE:</b>	<b>ACCIDENT</b>
<b>AIRCRAFT:</b>	<b>PT-DKK</b>
<b>MODEL:</b>	<b>M20F</b>
<b>DATE:</b>	<b>23FEV2022</b>

This is the Final Report of the 23<sup>rd</sup> February 2022 accident with the model M20F aircraft, registration marks PT-DKK. The accident was typified as “[SCF-PP] Engine failure or malfunction”.

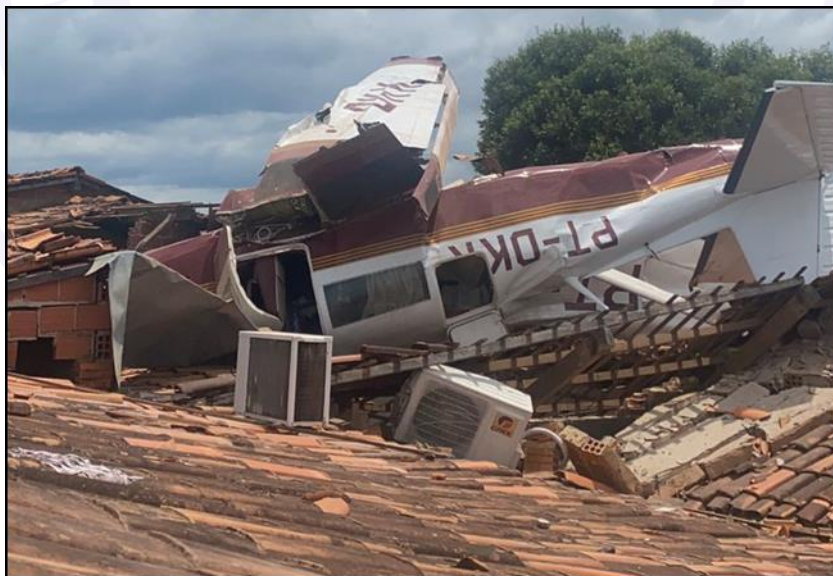
The aircraft sustained substantial damage to its entire structure after colliding with residences.

Figure 1 – Picture taken of the aircraft at the crash-site.

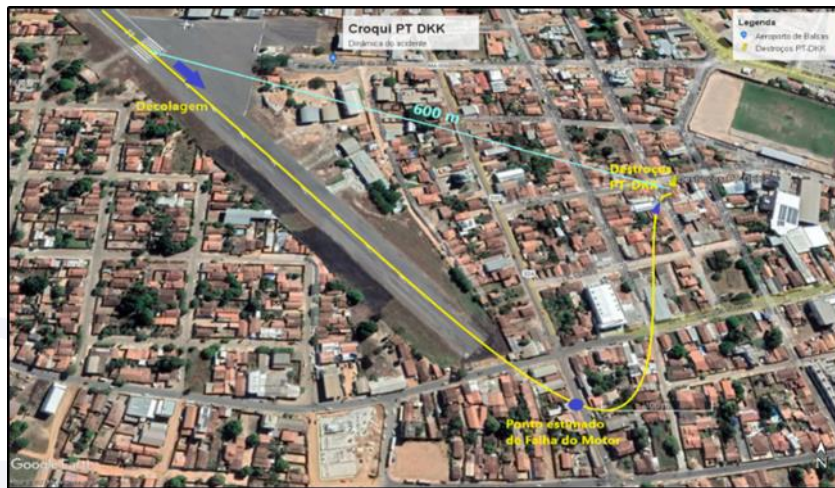
The wreckage was located at a distance of 600 m from the threshold 33 of SNBS, on the rooftops of contiguous residences. The area in the extended direction of takeoff had a large number of houses, as well as other buildings.

Figure 2 - Croquis showing the distance between threshold 33 and the wreckage.  
Source: adapted from Google Earth.

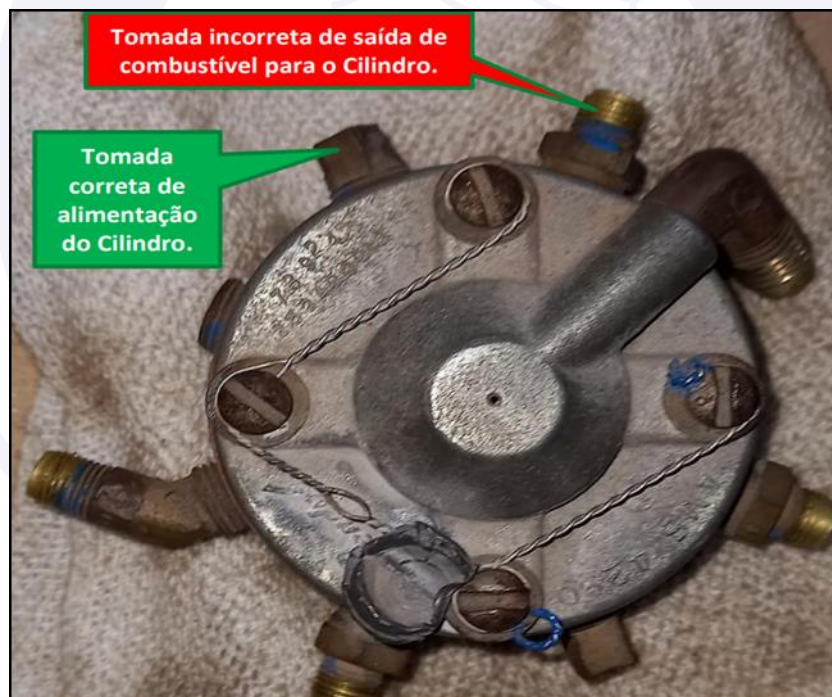
During the analysis of the fuel distributor, one verified that the nipple of the fuel-line outlet nipple for one of the cylinders had been installed incorrectly: instead of being installed in the cylinder feed line, it was attached to the fuel-pressure indication port.

With regard to this fact, it is important to note that the internal dimensions and calibrations of each fuel-distributor outlet orifice were different, resulting in distinct flow rates.

Figure 4 - Outlet nipple of the fuel flow to the cylinder incorrectly installed in the pressure indication line.

One should note that, for the port of pressure measurement, the distributor had a physical restriction that reduced the amount of fuel output. Therefore, one of the cylinders was receiving a fuel flow rate below the one expected.

In relation to the incorrect connections observed in the fuel distributor, it is worth noting that they generated a flow-rate that was lower than the amount recommended by the manufacturer for one of the cylinders, resulting in alterations of the engine's performance.

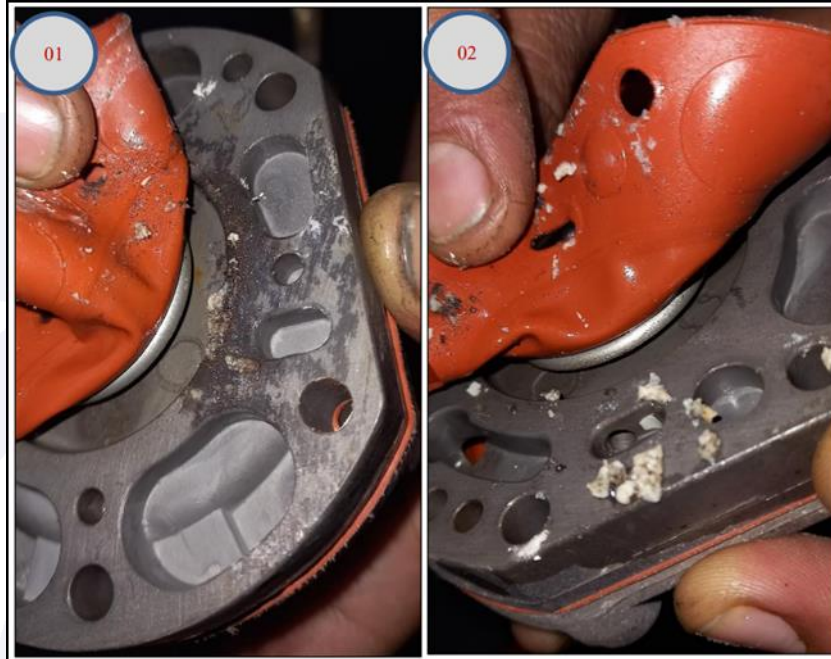
Subsequently, the servo fuel injector underwent a functional test as per the maintenance manual, with testing of the low-, medium-, and high-pressure fuel flows. For all the three pressure regimes, one observed insufficient fuel flow, indicating malfunction of the component.

The servo injector was disassembled for inspection of its internal parts. During the inspection, one observed contamination of the component with water and solidified residues in the internal chamber, showing obstruction of the calibrated orifices, which caused restriction of the fuel flow to the distributor and fuel injection nozzles.

Figure 5 - Contamination of the fuel servo injector.

During the analysis of the servo fuel-injector, one found that there was insufficient flow for the low, intermediate, or high-pressure regimes, resulting in malfunction of the component due to internal obstruction.

For this reason, a hypothesis was raised that the lack of adequate preservation of the aircraft and its engine may have contributed to the degradation of several components, especially the servo injector, contributing to the contamination of this item, and leading to its eventual obstruction.

- h) the meteorological conditions were consistent with the flight;
- i) the fuel servo injector presented obstruction, due to contamination by water and solid waste in its interior;
