FINAL REPORT
A-099/CENIPA/2023

OCCURRENCE:	ACCIDENT
AIRCRAFT:	PT-DLO
MODEL:	A36
DATE:	11JUN2023

This is the Final Report of the 11 June 2023 accident with the model A36 aircraft, registration marks PT-DLO. The accident was typified as “[SCF-PP] Engine failure or malfunction”.

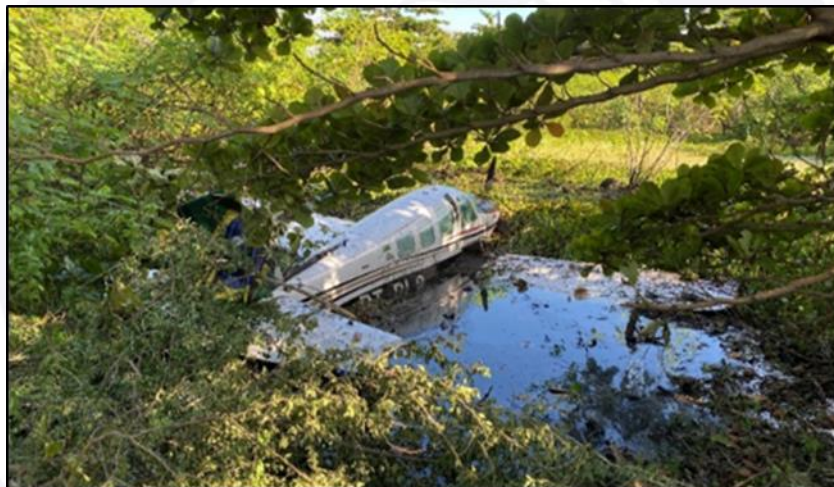
Figure 1 - View of PT-DLO airplane at the forced landing site.

In addition to ruptured fuel system lines, the aircraft sustained substantial damage to its right-hand wing root and to the vertical stabilizer. There was also slight damage to the fuselage, including the soffit, as well as to the left-hand wing, horizontal stabilizer, elevator, and electrical system.

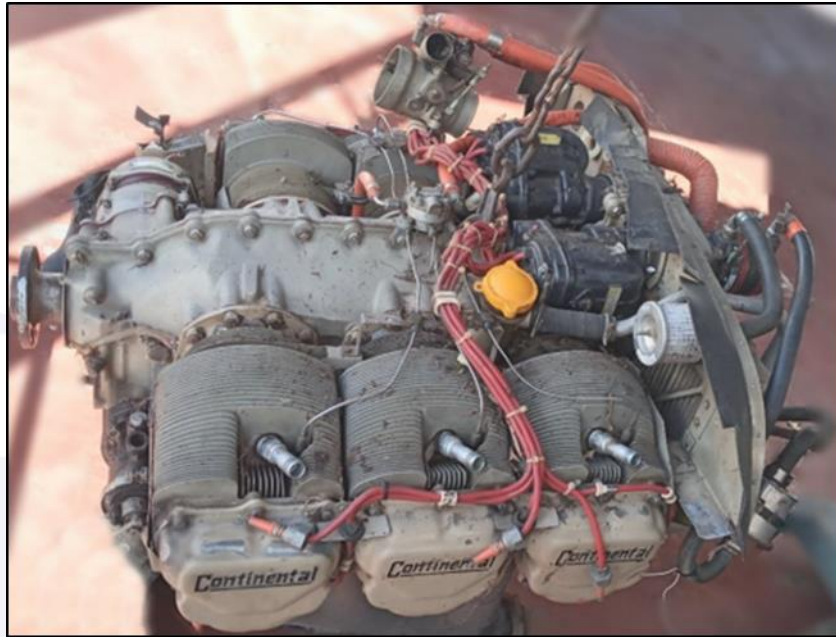
Figure 4 - Top view of the engine.

The engine had restrictions to rotation due to the breakage of the alternator, which occurred at the impact with the ground. In spite of the accident, the internal parts of the engine showed no apparent physical damage.

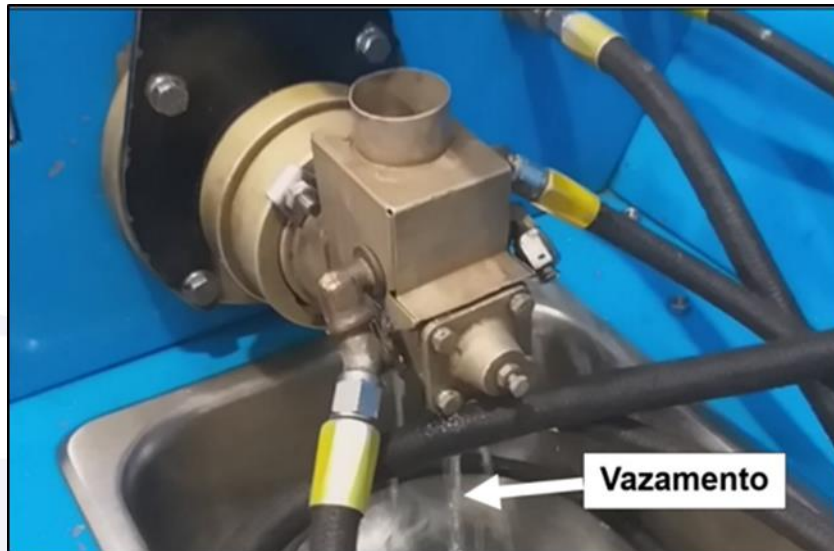
During the test, the pump exhibited a fuel leak through the drain (Figure 5). This evidence was then associated with the impossibility of the item reaching the acceptable pressure and fuel flow parameters listed in the test form of the item's overhaul manual (*Overhaul and Parts Catalog for Fuel Injection Systems-X30593A*).

Figure 5 - Leak in the mechanical fuel pump.

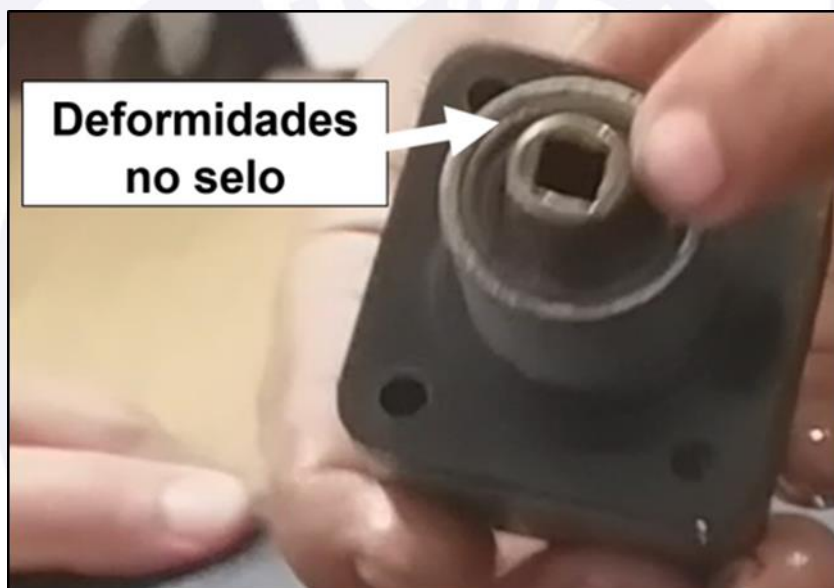
During the disassembly, a deformity was found in the retaining seal of the eccentric housing (*seal adapter* PN - 646198), which caused pressure to leak with the consequent reduction of the fuel flow pressure (Figure 6).

Figure 6 - Retaining seal showing deformities.

During the bench inspection of the components that presented the functional failure (namely the mechanical pump and the fuel controller), one identified that there was wear on the seal shaft of the mechanical fuel pump and deformations in the internal sealing O-ring of the fuel controller' shaft.

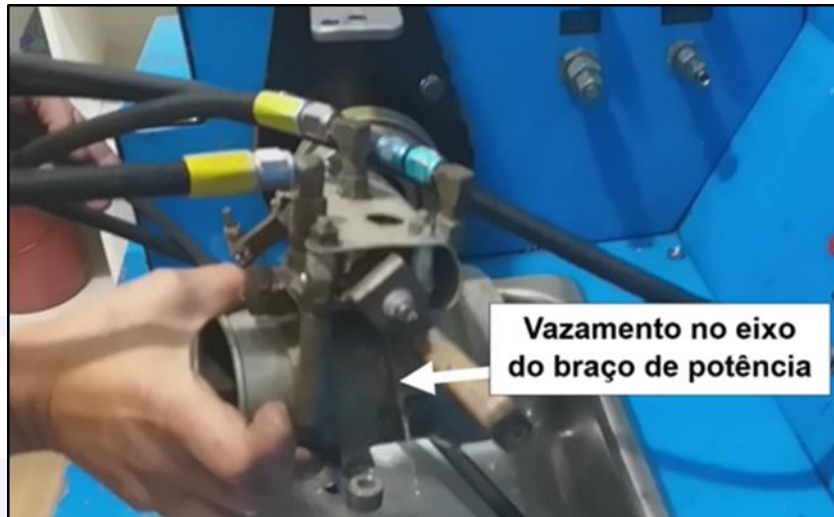
The PN 629904-2 / SN G118303A fuel controller exhibited a leak on the power and mixture arm shaft (Figure 7) and, therefore, it was not possible to reach the parameters established in the test form contained in the X30593A Manual.

Figure 7 - Leak in the fuel controller power-arm shaft.

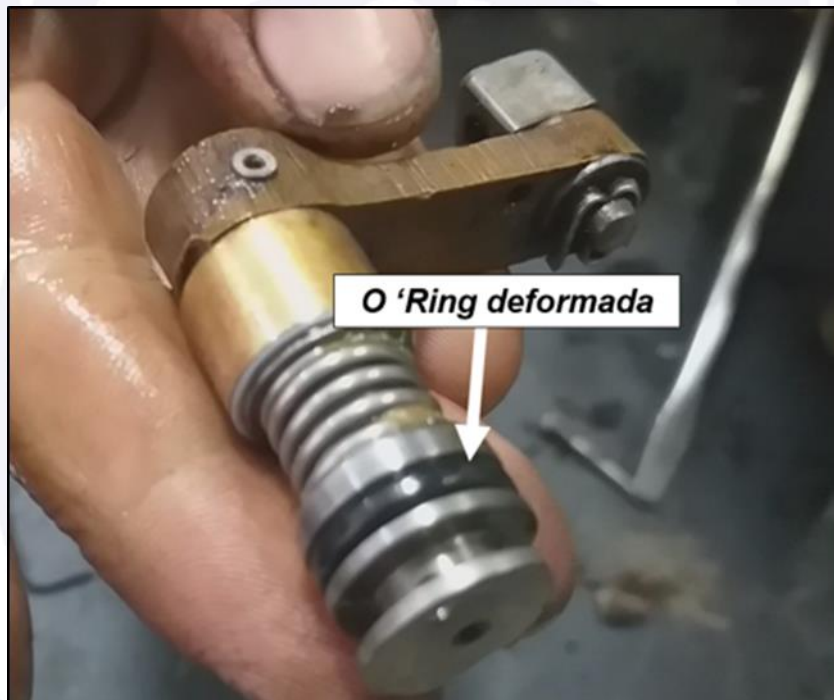
After the disassembly, deformations were detected in the internal sealing O-ring of the power-arm shaft PN 630979 (Figure 8).

Figure 8 - Aspect of the power-arm shaft O-ring.
