FINAL REPORT
A - 129/CENIPA/2021

OCCURRENCE:	ACCIDENT
AIRCRAFT:	PT-DQU
MODEL:	PA-31
DATE:	19NOV2021

This is the Final Report of the 19NOV2021 accident with the PA-31 aircraft model, registration PT-DQU. The accident was classified as “[FUEL] Fuel and [RE] – Runway Excursion I Fuel Starvation”.

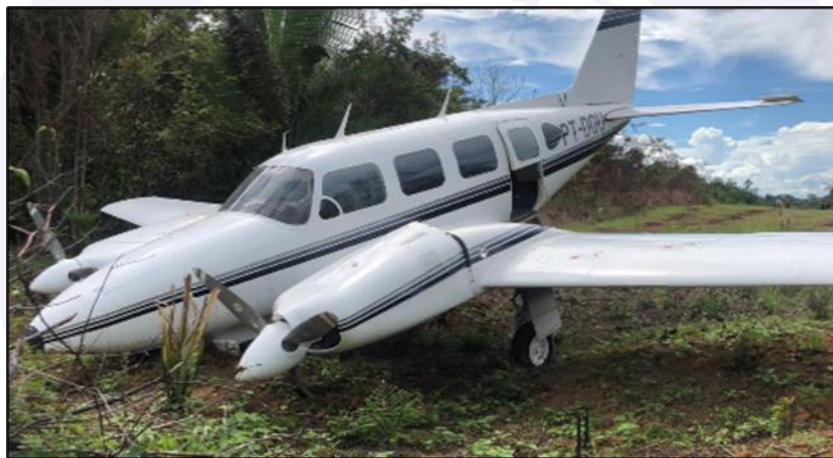
Figure 1 - View of the PT-DQU at the emergency landing site.

The aircraft had substantial damage. There was breakage of the auxiliary landing gear and damage to the fuselage, propeller assemblies, and engines.

The landing was performed at threshold 11. However, during the run after landing, the auxiliary landing gear broke. The aircraft covered the entire available distance and overshot the aft limit, stopping in a planting area about 10 m after threshold 29 and had substantial damage.

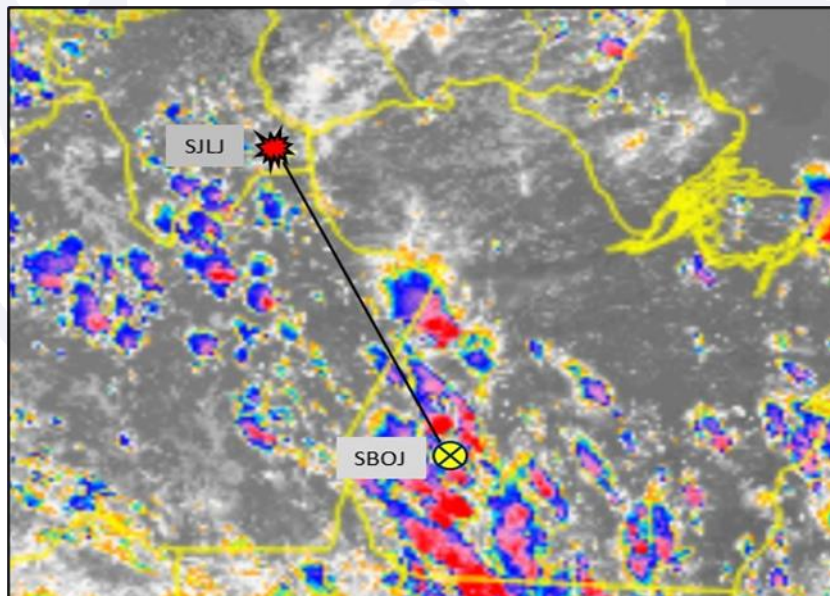
Figure 2 - Enhanced Satellite Image at 1850 (UTC). Source: Adapted REDEMET.

The image above corroborates the information provided by the operator that the crew encountered adverse weather conditions en route.

According to the Enhanced Satellite Image extracted from the REDEMET, it was observed that, at the time the flight occurred, there were significant weather formations on the probable route of PT-DQU.

Probably, due to the weather conditions found en route, detours were executed to maintain the VMC flight. This may have impacted the duration of the planned leg, causing an increase in flight time, with direct impact on the airplane's range.

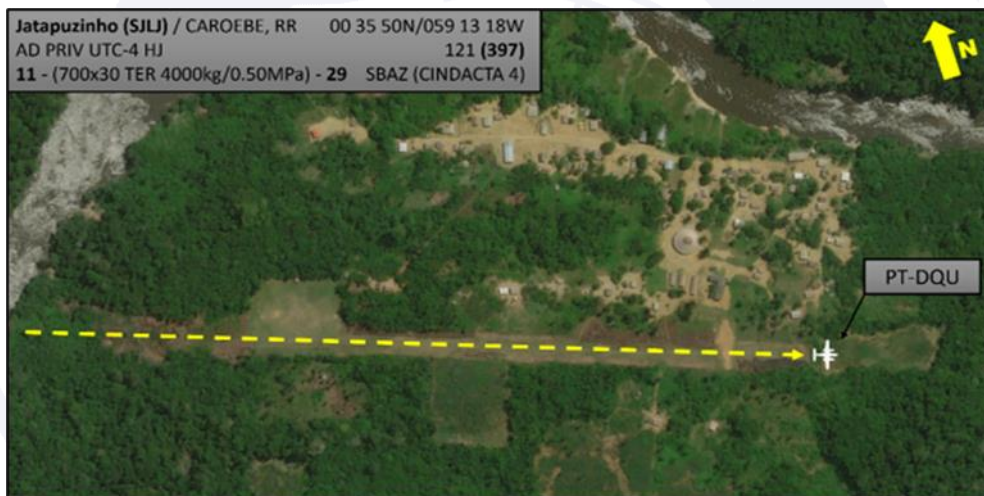
Figure 3 - Sketch of the landing at SJLJ Aerodrome. Source: Adapted from Google Maps.

According to third party information, the runway had 400 meters available for landing and take-off, although records indicate that it had the dimensions of 700 x 30 meters. This fact may have contributed to the PT-DQU exceeding its longitudinal limit.
