FINAL REPORT
A-012/CENIPA/2021

OCCURRENCE:	ACCIDENT
AIRCRAFT:	PT-FIB
MODEL:	150M
DATE:	27JAN2021

This is the Final Report of the 27 January 2021 accident with the Cessna 150M aircraft, registration marks PT-FIB. The accident received the typification of “[FUEL] Fuel related”.

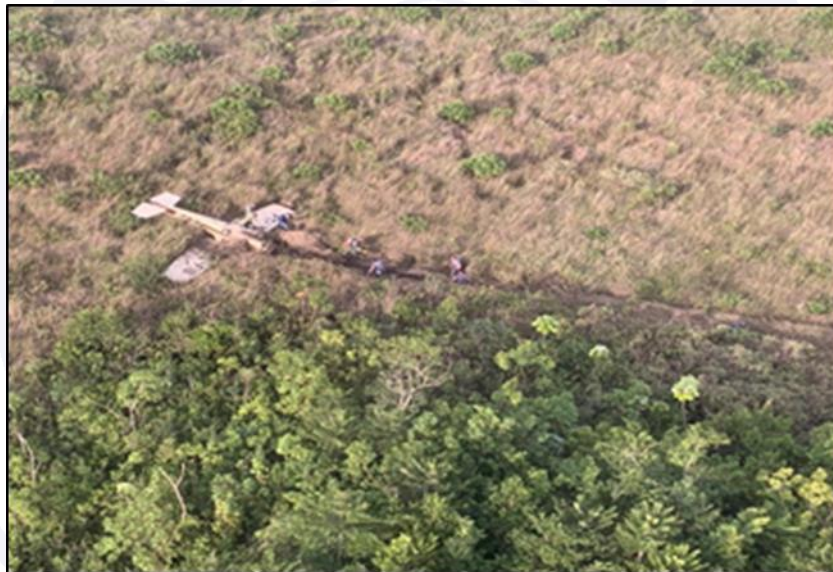
Figure 1 - View of the PT-FIB at the accident site.

The aircraft sustained substantial damage. There was damage to the nose landing gear, wing extrados, empennage, and fuselage.

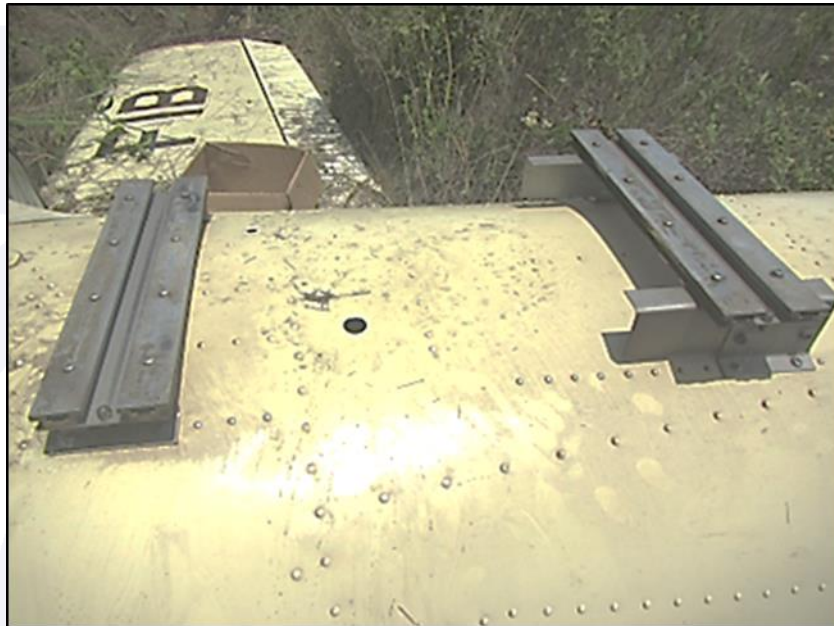
The aircraft had two metal structures fixed to the soffit of the fuselage that served as support for fitting a device contained in a metal box, found inside the airplane at the initial investigation (Figures 2 and 3).

Figure 2 - Metallic structure fixed to the fuselage's underside.

According to information, the purpose of the said external structures was to support equipment used for aerial surveys/filming.

No records related to such modification were found in the aircraft documentation. When consulted, the OM that performed the last *IAM* affirmed that they were unaware of the aforementioned installation.

The investigation commission did not receive any documentation concerning a process by means of which the civil aviation authority could have been notified or consulted on the implementation of the said modification.

With regard to the aircraft's airworthiness conditions, the fact that no records of the installation of a structure under the fuselage were found in the pertinent documentation, and that no process related to this modification was presented to the investigators, showing that the civil aviation authority had been notified or consulted about the intended implementation, as well as the operator's statement of being unaware of the determination not to operate the mixing lever revealed inadequate supervision by the Aeroclub management, with regard to the control of the documentation and to the technical conditions of the equipment.

Finally, assuming that the installation of the device found on the aircraft during the initial investigation constituted a minor modification in the design of the 150M model, one found that the requirements established in section 21.95 of the RBAC-21 were not met, something suggestive of low compliance of flight safety principles, capable of compromising the safety of operations.

Work alongside the Aeroclub of *Barretos*, in order to ensure that its managerial oversight mechanisms demonstrate proper control over the airworthiness conditions of the aircraft operated, particularly in what refers to the effective management of the documentation and the technical conditions of the equipment used in air operations.

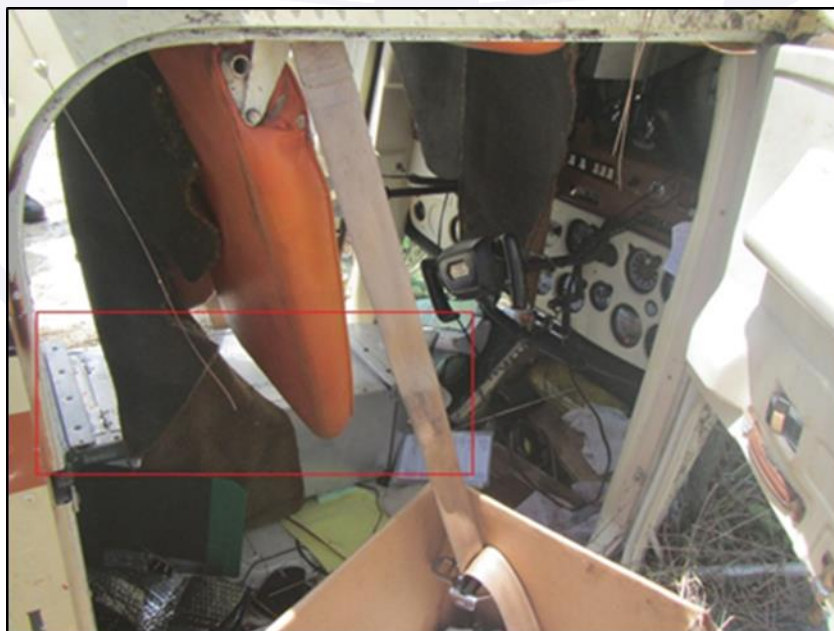
Figure 3 - Metal box that was fixed to the existing structure on the fuselage soffit.

The absence of records regarding the installation of a structure under the PT-FIB fuselage in its documentation, the lack of presentation of any process related to this modification to the investigators, where the civil aviation authority was notified or consulted about its implementation, along with the operator's statement of being unaware of the directive not to operate the mixing lever, exposed inadequate supervision by the aeroclub's management staff concerning the control of documentation and technical conditions of the equipment.

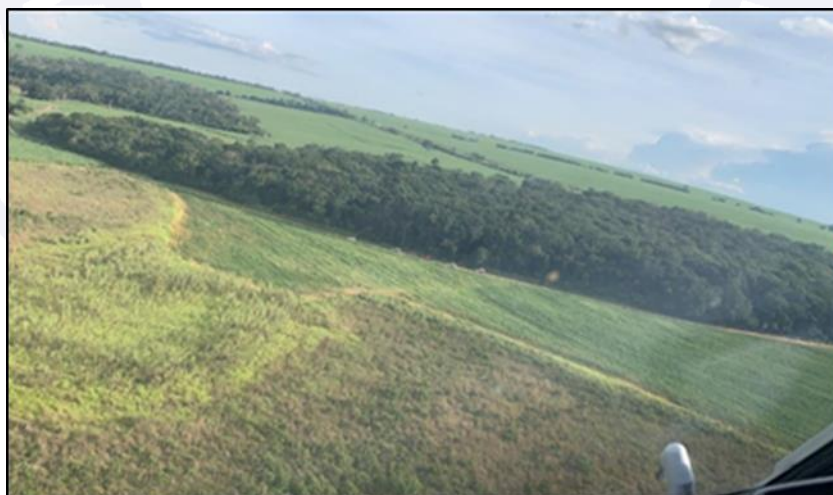
Figure 10 - View of meteorological conditions on the day of the occurrence.

The conditions were favorable for VFR flights, with visibility above 10 km, few clouds at 4,000 ft, and temperatures varying between 31°C and 32°C.

Considering that the information gathered on the weather conditions in SBRP and at the site of the forced landing showed no significant meteorological phenomena in the region where the flight was being conducted, one concluded that the meteorological aspect did not play a role in the accident in question.

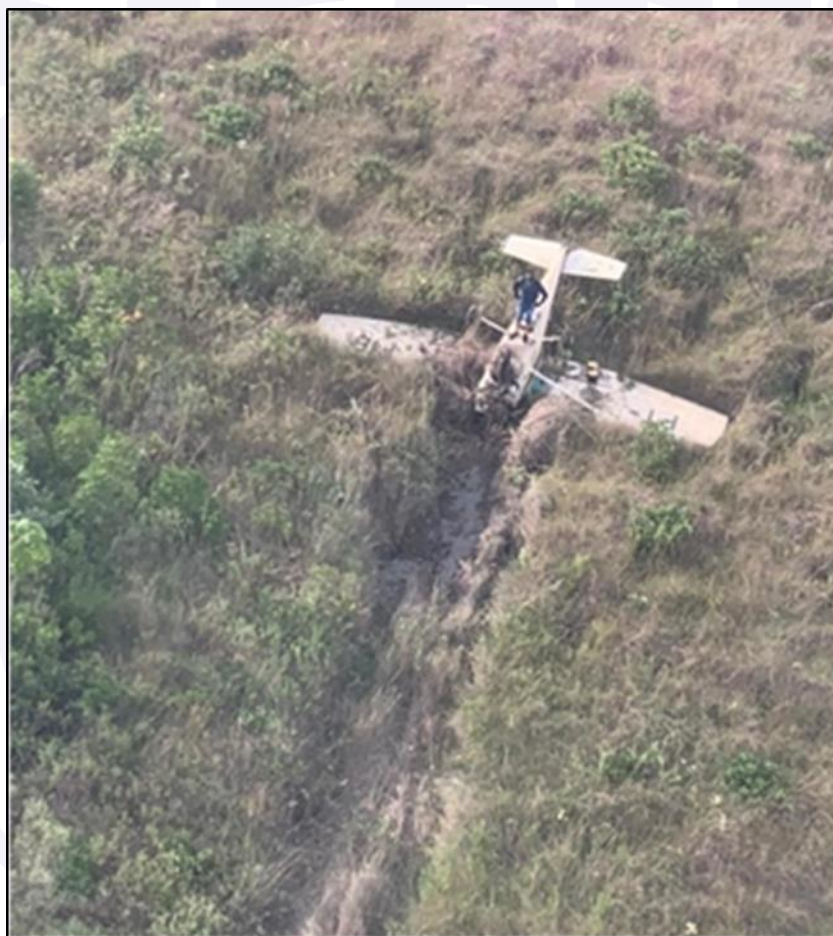
The first contact with the ground was with the main landing gear. After traveling approximately 50 meters, the aircraft pivoted due to undulations in the terrain. The distribution of the debris was concentrated (Figure 11).

Figure 11 - Final position of the aircraft.

The landing gear assembly remained attached to the aircraft, but the nose gear sustained substantial damage. The flaps were in the retracted position.

Military personnel who rescued the pilot reported not having smelled any fuel during the rescue. There were also no signs that gasoline had drained from the tanks, such as dryness in the vegetation around the aircraft or other signs of fuel contact with the water surrounding the plane.

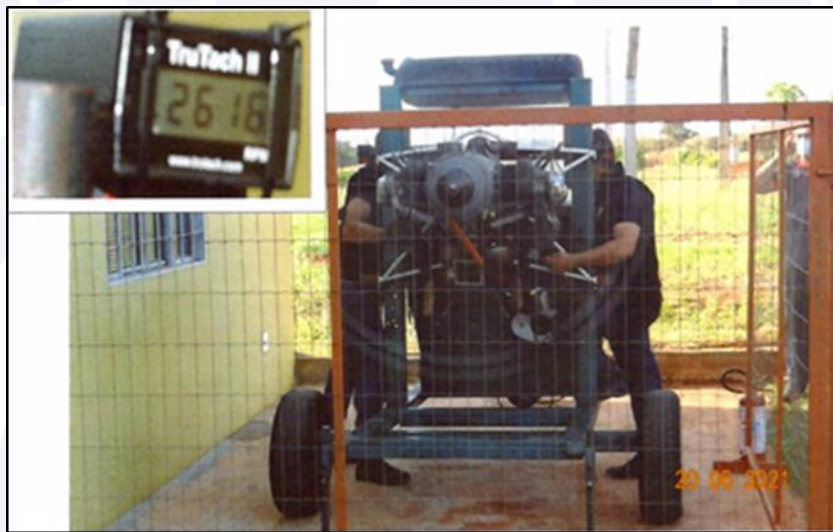
Then, the engine was accelerated to maximum power, and reached 2,616 RPM, remaining at this speed for 6 minutes to simulate takeoff conditions. The maximum rotation prescribed in the aircraft manual was 2,750 RPM, however, the angle of the windlass blade used for the test was greater than that of the propeller installed on the aircraft and limited the rotation to the value achieved. Therefore, one considered that the observed difference did not constitute a discrepancy (Figure 12).

Figure 12 - Engine running at 2,616 RPM during the functional test.

Thus, after 13 minutes of functional testing, no abnormalities that might result in loss of performance during the flight were observed in the operation of the engine.

Similarly, considering that, after 13 minutes of functional testing, no abnormalities that could result in loss of performance during the flight were observed in the operation of the engine, one concluded that the engine shutdown was not due to a failure of its internal components or external systems (fuel, ignition, and lubrication).
