**COMANDO DA AERONÁUTICA**  
**CENTRO DE INVESTIGAÇÃO E PREVENÇÃO DE**  
**ACIDENTES AERONÁUTICOS**

**FINAL REPORT**  
**A-043/CENIPA/2023**

<b>OCCURRENCE:</b>	<b>ACCIDENT</b>
<b>AIRCRAFT:</b>	<b>PT-FLK</b>
<b>MODEL:</b>	<b>R182</b>
<b>DATE:</b>	<b>11MAR2023</b>

This Final Report pertains to the March 11, 2023, accident involving the Cessna R182 airplane of registration marks PT-FLK. The occurrence was typified as "[MED] Medical Conditions" and "[RE] Runway Excursion."

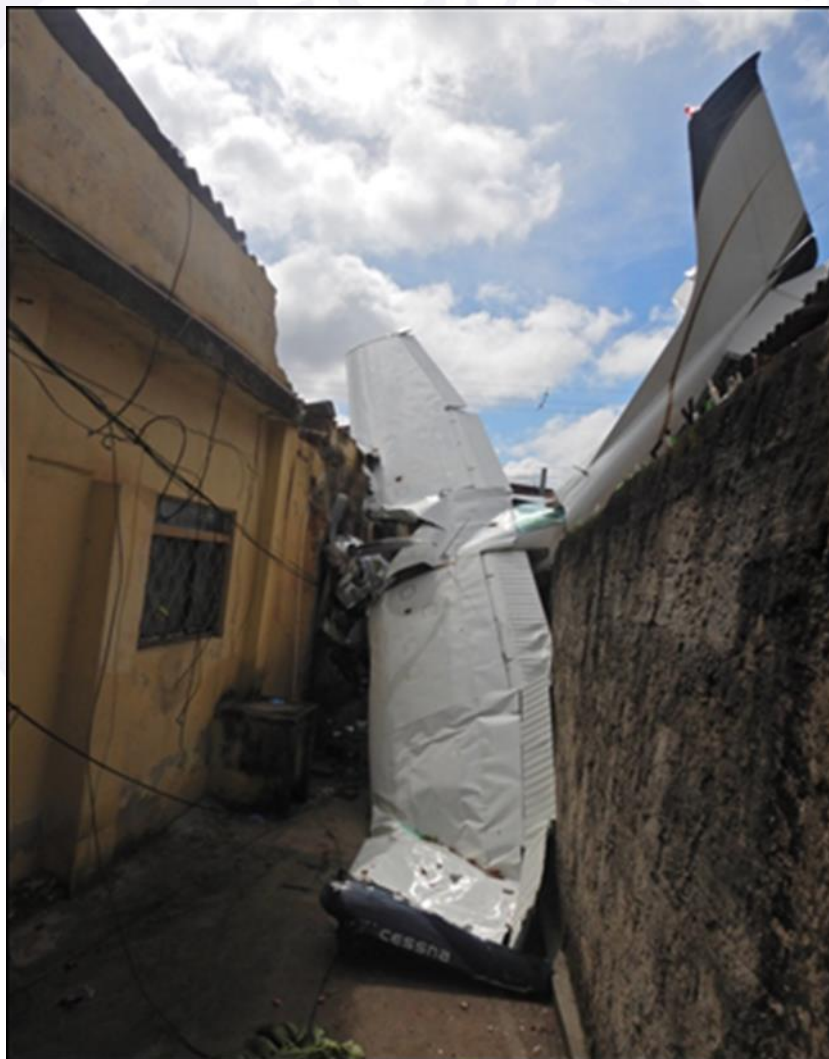
During landing, the aircraft overran the departure end of the runway and impacted two residential structures located beyond the runway overrun area.

Figure 1 – Final position of the aircraft after the runway excursion.

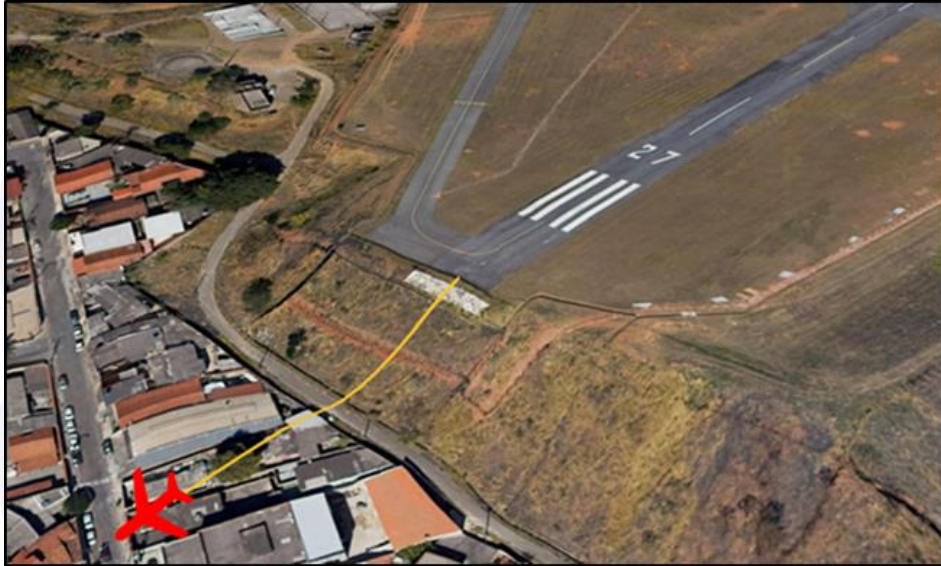
Evidence indicated that the aircraft made ground contact at a distance of 180 meters short of the departure end of the runway and came to a final stop approximately 74 meters after overrunning it, in a residential area outside the limits of the aerodrome. There were no marks on the ground between the departure end and the wreckage site, suggesting that the aircraft covered this distance in flight (Figure 3).

Figure 3 – Sketch of the flight path after the runway excursion.

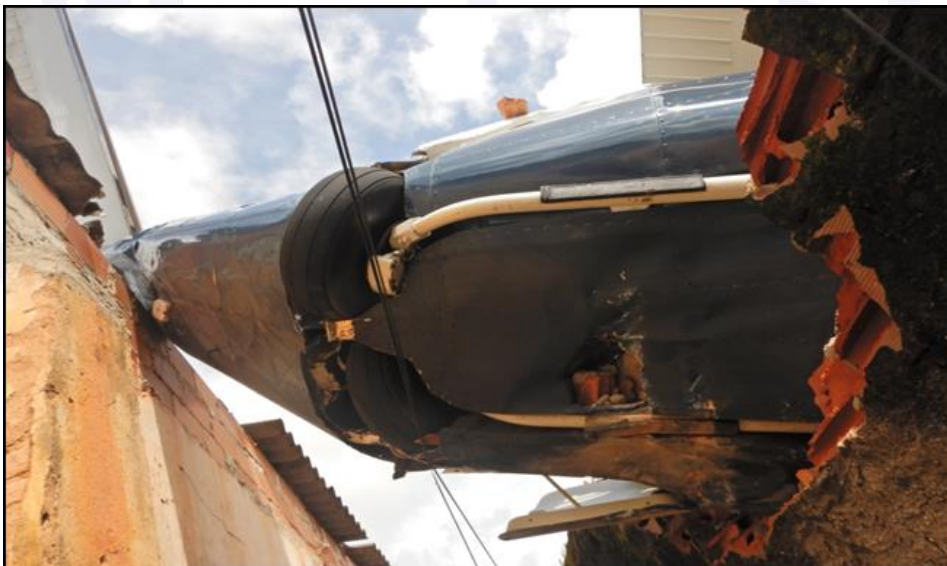
Analysis of the wreckage revealed that the landing gear was retracted, as shown in Figure 4.

Figure 4 – The airplane with retracted landing gear at the crash site.

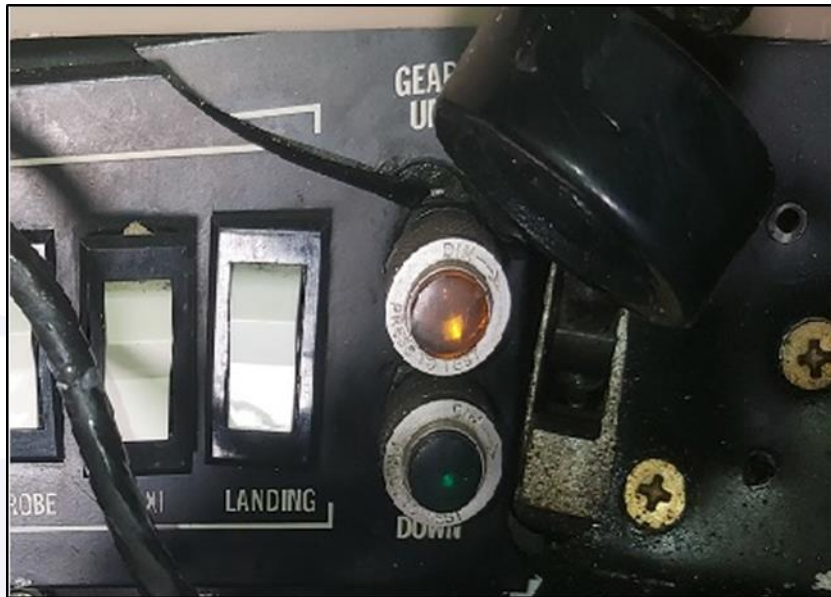
Additionally, the landing gear control lever was found in the “UP” position, as shown in Figure 5.

Figure 5 – Landing gear control lever in the UP position.

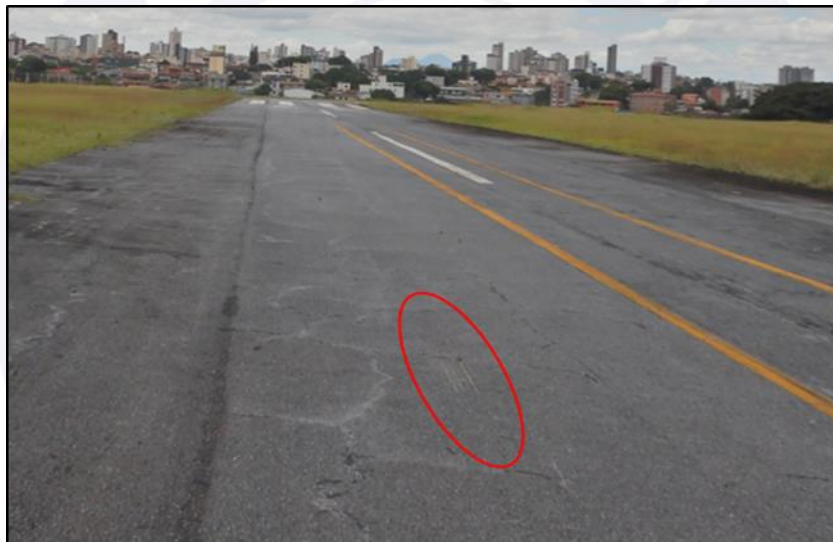
The footage indicated that the aircraft touched down with the landing gear retracted at a distance of 180 meters short of the runway's end, a fact confirmed by tire marks left on the tarmac (Figure 6).

Figure 6 – Touchdown point of the aircraft, 180 meters short of the runway's end.

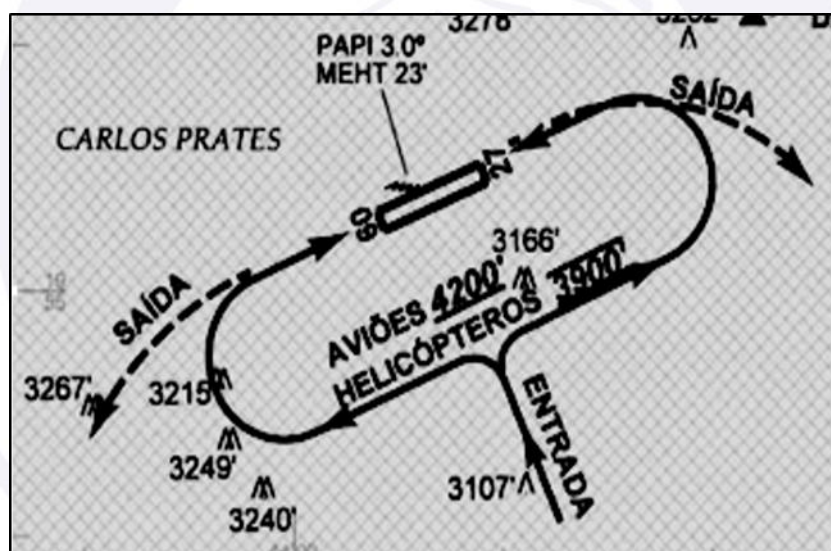
Figure 8 – Traffic Circuit for SBPR as defined in the VAC chart.

The analysis of the operational factors revealed that the PIC did not follow the prescribed traffic pattern entry as outlined in the SBPR's Visual Approach Chart (VAC). Instead, he opted for a direct approach at a moment that mechanical failures or any other type of emergency either did not exist or went unreported.
