FINAL REPORT
A-087/CENIPA/2018

OCCURRENCE:	ACCIDENT
AIRCRAFT:	PT-HKY
MODEL:	206B
DATE:	09MAI2018

This is the Final Report of the 09 May 2018 accident with the 206B aircraft, registration marks PT-HKY. The occurrence received the typification of “[FUEL] Fuel related”.

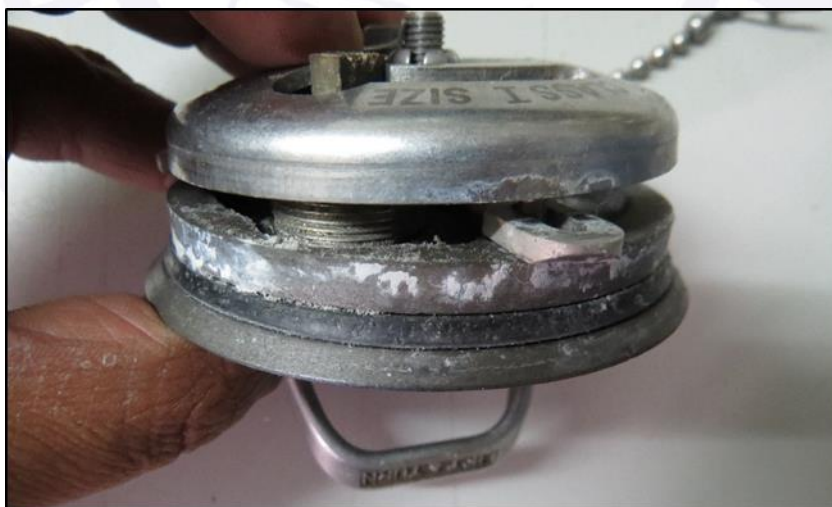
Figure 2 - Condition of the cap sealing-gasket.

After the tests, one removed the fuel filler cap, in order to check the integrity of the fuel filler cap -sealing gasket. In this way, it was possible to perform a visual inspection of the sealing gasket (O-ring), in which damage was observed that could have contributed to the ineffectiveness of the seal against the leakage of fluids. An ineffective fuel filler cap could also provide a path for water to enter the fuel tank and contaminate the fuel.

Due to seawater having entered the fuel tank, it was not possible to determine whether the fuel was contaminated prior to takeoff. However, one identified that the fuel filler cap allowed water to enter the tank.

A visual inspection of the sealing gasket (O-ring) of the fuel filler cap was carried out and damage was observed that may have contributed to the ineffectiveness of the seal against the passage of fluids.

Thus, one inferred that, despite being reported as completed, the task may have been performed inappropriately, in view of the conditions of the sealing gasket. Additionally, it is possible that there was a lack of effective monitoring of the maintenance service delivered.

Work with *Helimar Helicopters Ltda.* (COM No. 8003-02/ANAC), so that the referred maintenance organization demonstrates that its managerial oversight mechanisms guarantee the quality of the services performed on the aircraft the OM maintains, particularly in the case of 206B aircraft.

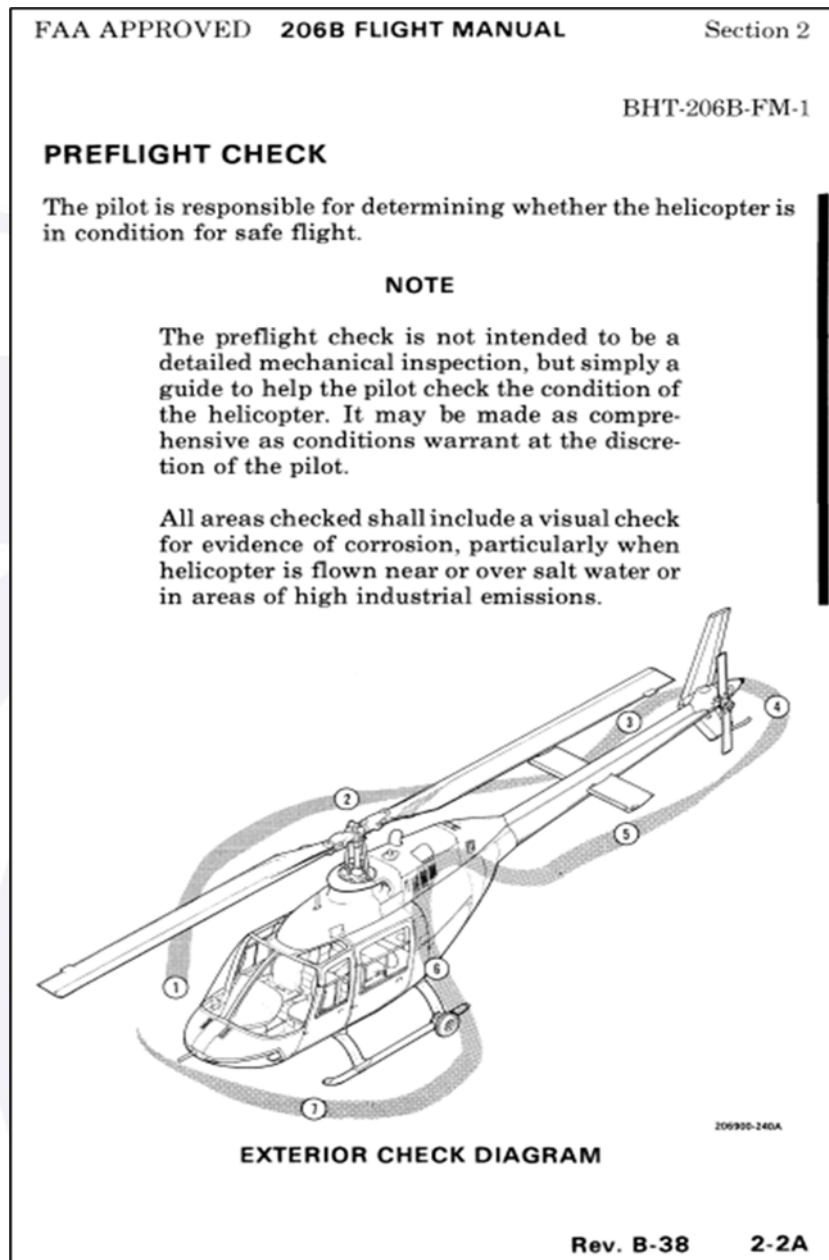
Figure 4 - Pre-flight of the aircraft as provided for in the Flight Manual.

The Preflight Check had prescriptions for several other procedures, including fuel draining before the first flight of the day. One did not find any evidence regarding the conduction of that procedure.

The analysis of the images of the security cameras revealed that the PIC did not perform the pre-flight inspection prescribed in the aircraft's manual. The inspection included drainage of the fuel. Had such action been taken, any contingent water allowed to enter the tank through the fuel neck would have been removed.

The PIC did not perform the prescribed pre-flight inspection, in which the fuel had to be drained, thus revealing a complacent attitude characterized by non-compliance with procedures established in the aircraft's manual, which may have resulted in his taking off with fuel in the tank contaminated with water.

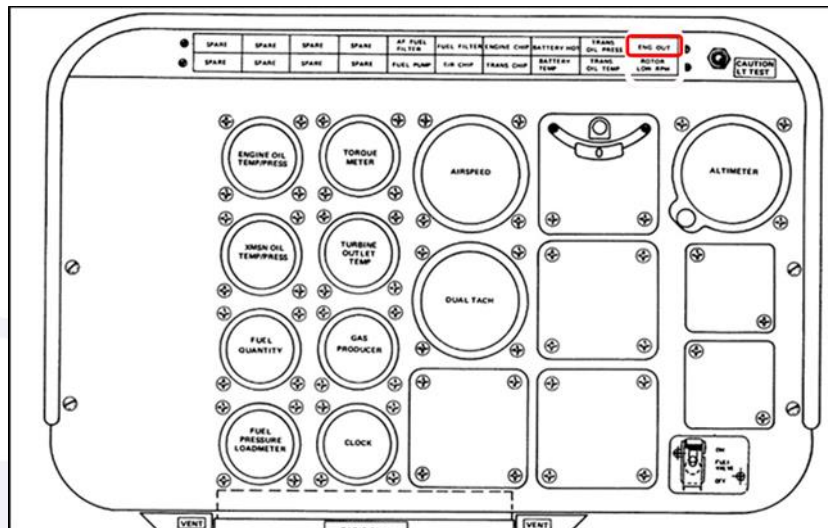
Figure 5 - Location of the ENG OUT alarm on the aircraft panel.

According to the passengers, a red light illuminated during the flight in the upper right-hand corner of the pilot's panel. They reported that the noise of the helicopter's engine diminished significantly, but the rotor blades remained rotating until the collision with the water. In addition, the passengers reported that the PIC told them that he had a failure.

The illuminated light in question may have been the ENG OUT light on the alarm panel. Such light would come on whenever the engine power (N1) dropped below 55%.

According to the passengers, a red light came on in the upper right corner of the pilot's panel, and the noise of the helicopter's engine diminished significantly. The referred warning light may have been the ENG OUT light, indicating engine power (N1) below 55%.
