**COMANDO DA AERONÁUTICA**  
**CENTRO DE INVESTIGAÇÃO E PREVENÇÃO DE**  
**ACIDENTES AERONÁUTICOS**

**FINAL REPORT**  
**A - 091/CENIPA/2013**

<b>OCCURRENCE:</b>	<b>ACCIDENT</b>
<b>AIRCRAFT:</b>	<b>PT-HML</b>
<b>MODEL:</b>	<b>HB-350B</b>
<b>DATE:</b>	<b>08MAY2013</b>

This is the Final Report of the 08MAY2013 accident with the HB-350B aircraft model, registration PT-HML. The accident was classified as “[LOC-I] Loss of Control in Flight”.

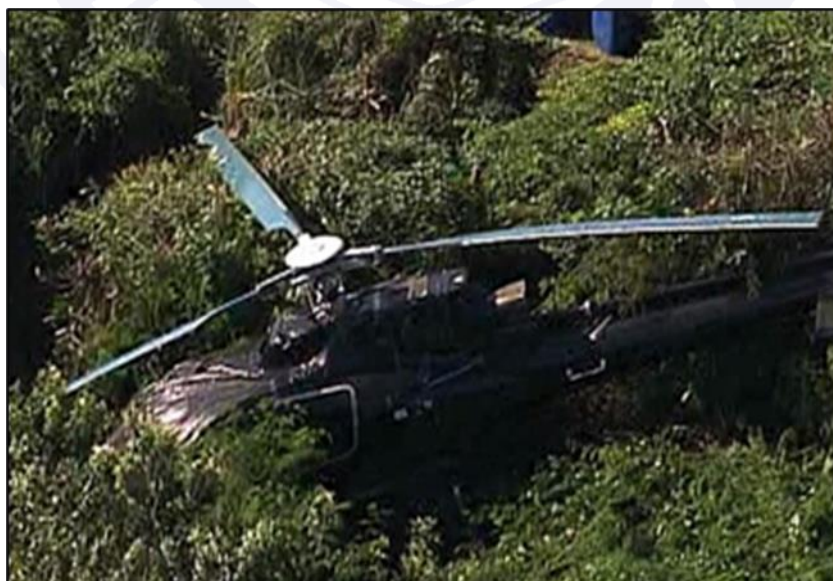
The aircraft had substantial damage to the main rotor, tail cone, tail rotor, perforations in the lower fairings, and wrinkling of the tail cone (Figures 1 and 2).

Figure 1 - General view of the aircraft after impact.

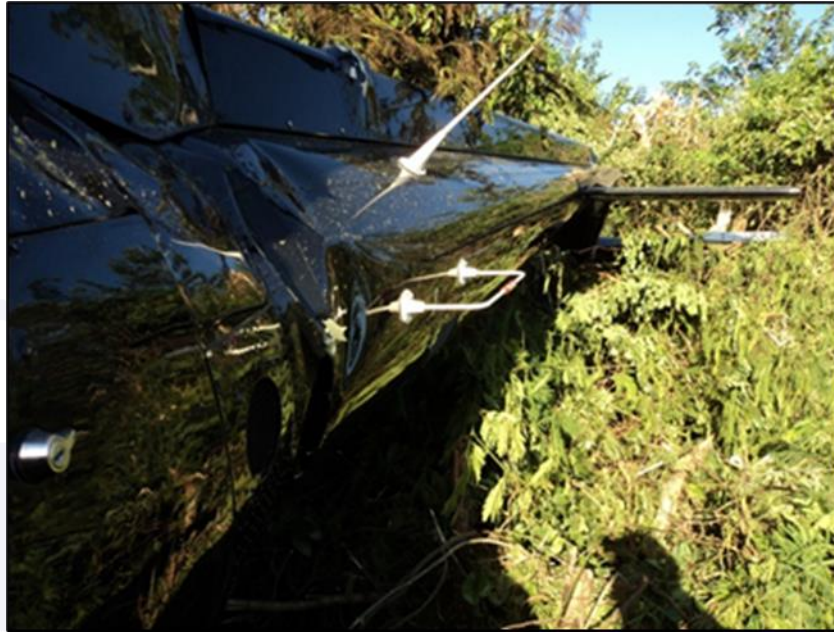
Figure 2 - View of the wrinkled tail cone.

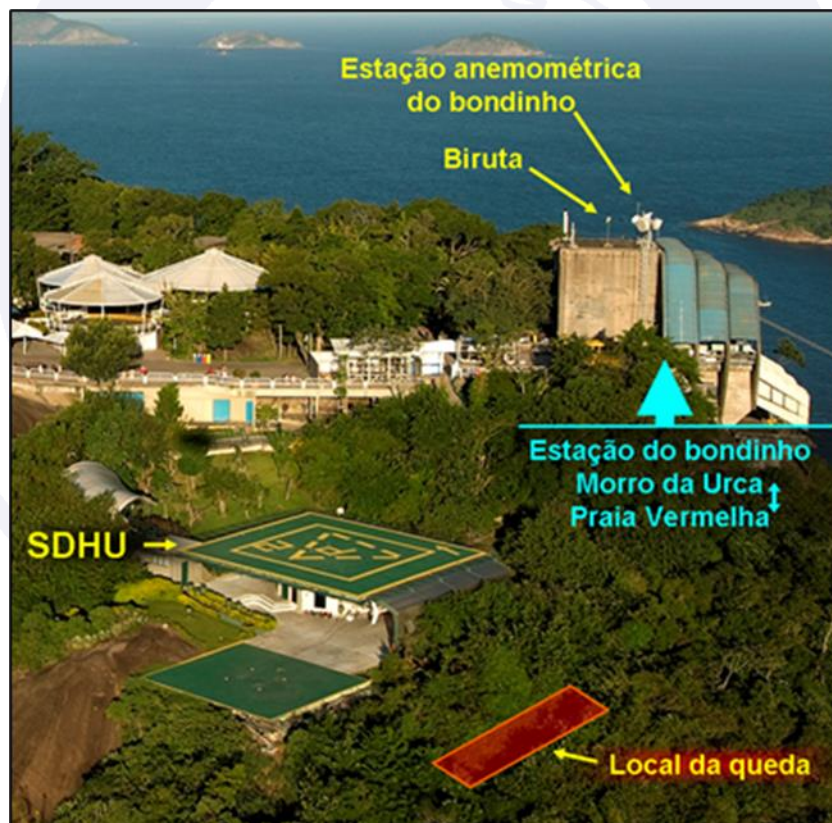
However, its location was sheltered from winds coming from the South, due to a set of antennas close to the anemometric station of the cable car (Figure 3).

Figure 3 - View of the helipad and the location of the occurrence.

However, a wind from the South may have been influenced by the antennas installed in the vicinity of the windsock, interfering with the precise information of direction and intensity to the pilot.

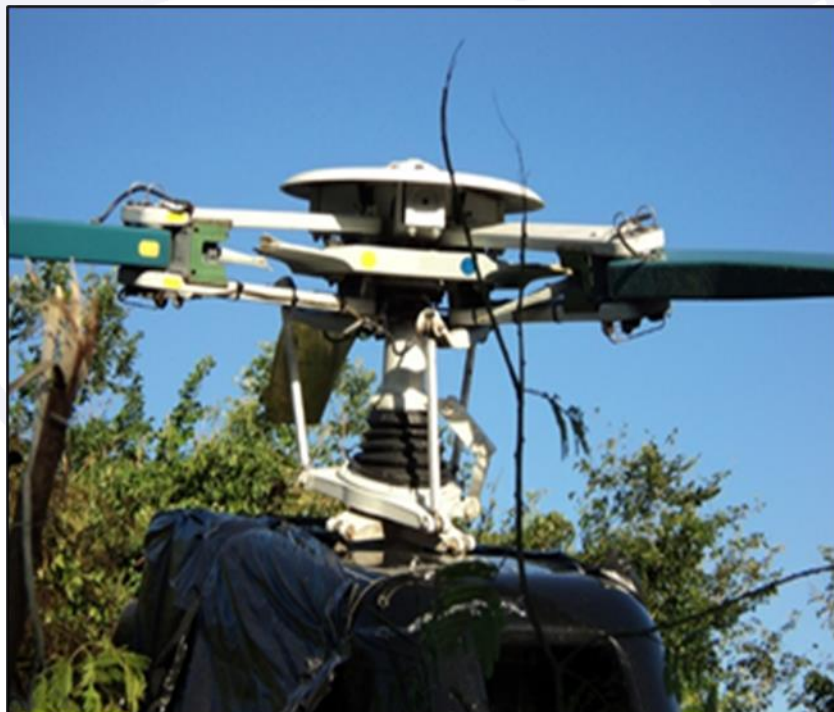
The damage observed to the main rotor and the trailing edges of the blades was typical of an engine developing power and applying collective at the moment of impact.

The shock against the ground was cushioned by the vegetation (Figures 4 and 5).

Figure 4 - Damage to the main rotor head.

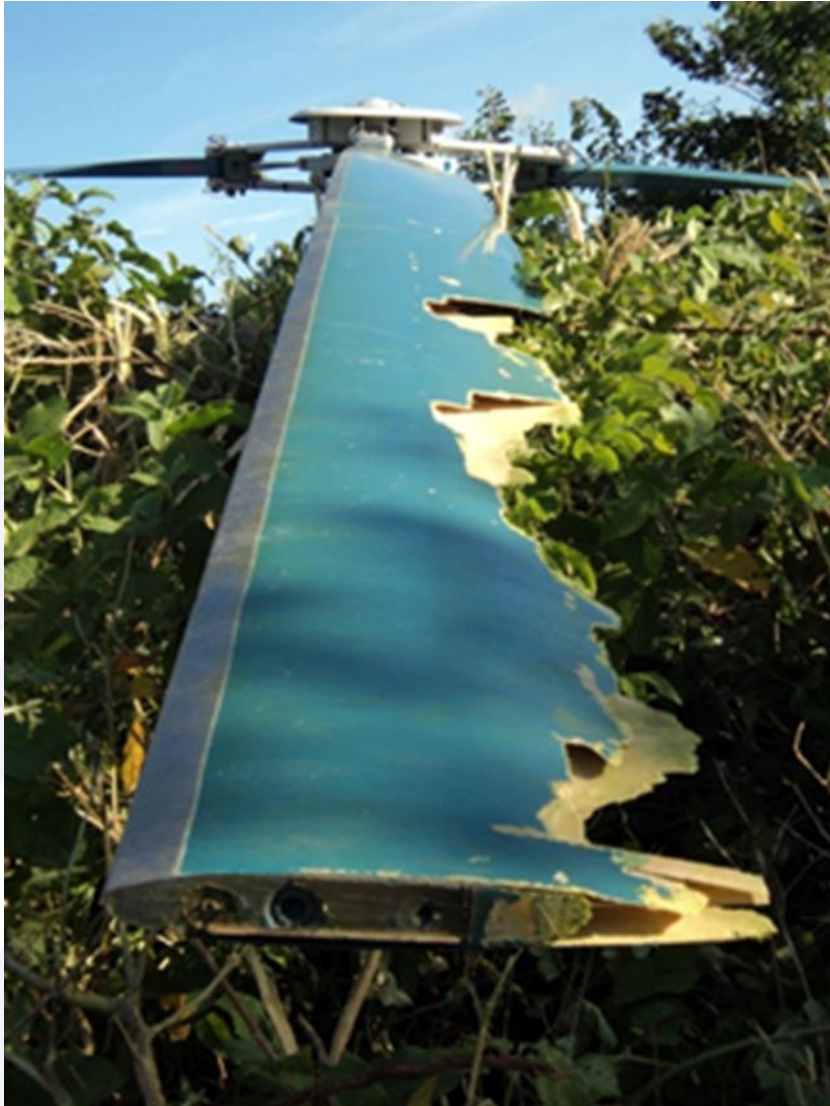
Figure 5 - Main rotor blade broken at the trailing edge.

This hypothesis is supported by the damage to the trailing edge of the main rotor blades and by the final trajectory to the left taken by the aircraft until the impact on the forest area, to the left of the helipad.

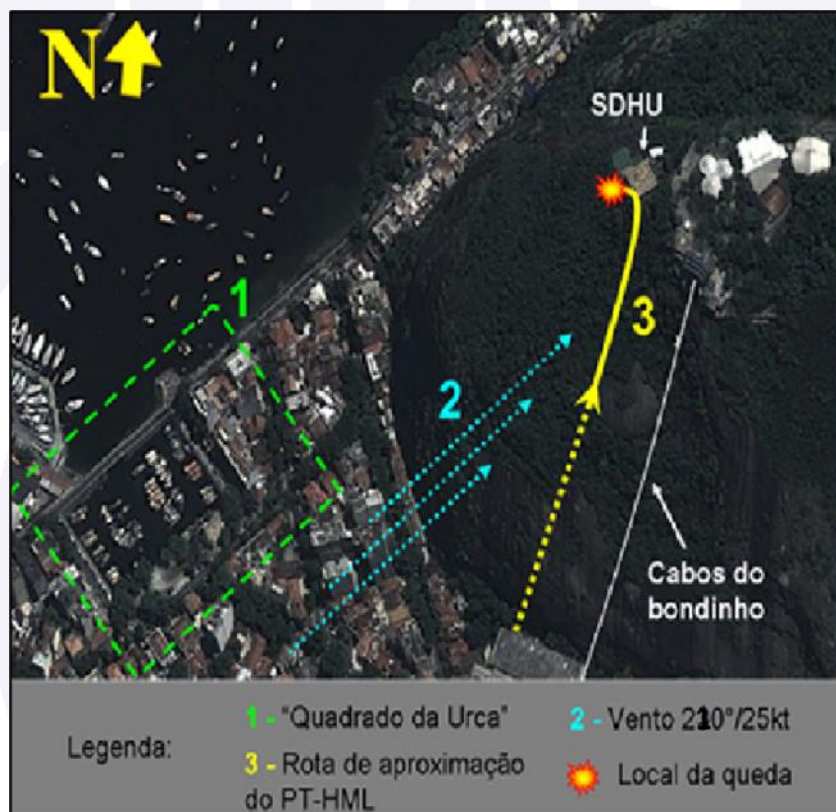
Figure 6, below, shows the trajectory performed by the aircraft on approach to land on the helipad, with a strong tailwind throughout the maneuver. A strong tailwind can be one of the trigger conditions for the vortex stall.

Figure 6 - Aircraft trajectory until impact.

It is noteworthy that a strong tailwind is one of the conditions that can initiate the vortex stall phenomenon.
