COMANDO DA AERONÁUTICA
CENTRO DE INVESTIGAÇÃO E PREVENÇÃO DE
ACIDENTES AERONÁUTICOS

FINAL REPORT
A - 146/CENIPA/2016

OCCURRENCE:	ACCIDENT
AIRCRAFT:	PT-HYE
MODEL:	HB-350B
DATE:	08NOV2016

This is the Final Report of the 08NOV2016 accident with the HB-350B aircraft model, registration PT-HYE. The accident was classified as “[SCF-PP] Engine Failure or Malfunction – With Rotor”.

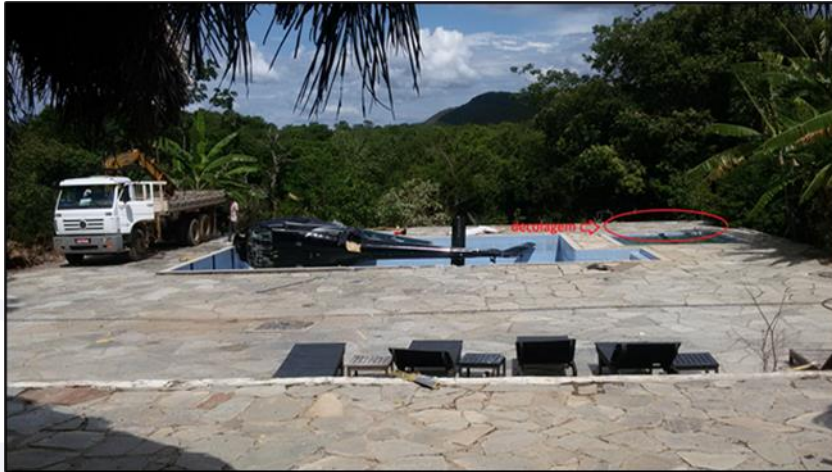
The impact occurred on the swimming pool of an Inn, with no evidence of previous impact. The distribution of the wreckage was of the concentrated type (Figure 1).

Figure 1 - Aircraft crash site.

After the impact, the aircraft remained on for a short time. The resistance imposed by the water in the swimming pool and its structure contributed to the abrupt stop of the engine assembly.

The place where the aircraft took off was very restricted and with several obstacles, some buildings and vegetation in the surroundings.

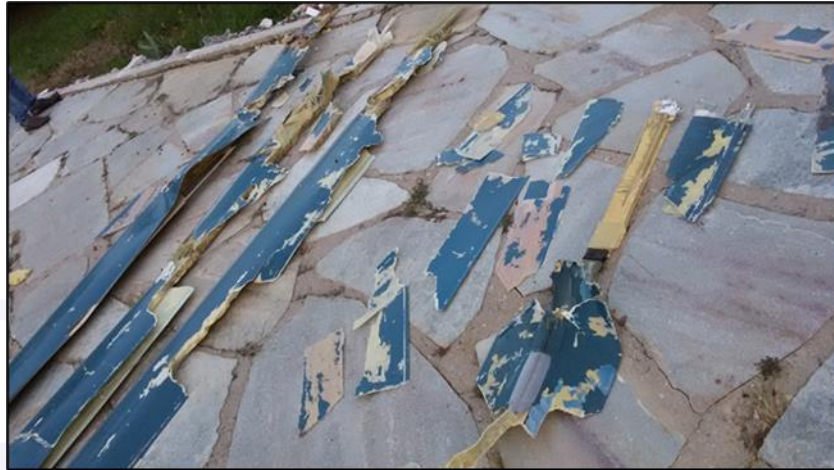
It was found that the blades of the main rotor showed signs of impact. The damage observed was characteristic of impact with power (torque and NR), as shown in Figure 2.

Figure 2 - Set of blades of the main rotor.

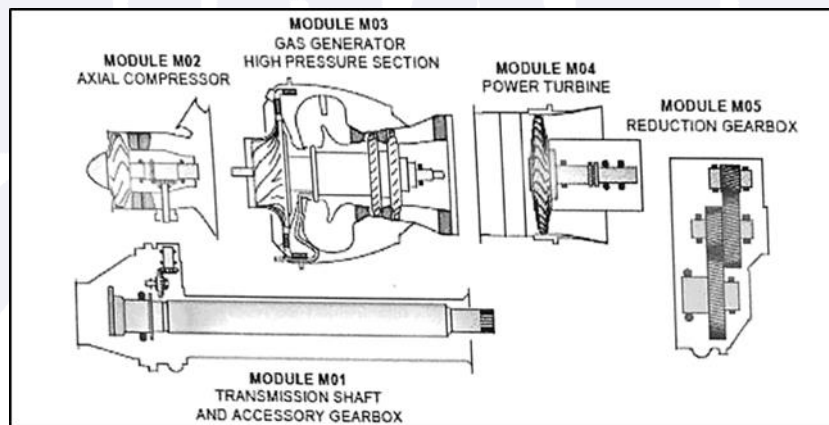
Figure 5 - Division of the aircraft engine modules.
Source: Aircraft Flight Manual (AFM).

An inspection of the lubrication system did not indicate the presence of filings in the magnetic plugs. The engine permeability test revealed that the parameters were within the maximum limit established by the manufacturer. A boroscopic inspection on the M03 module (Figure 5) did not reveal any discrepancies.

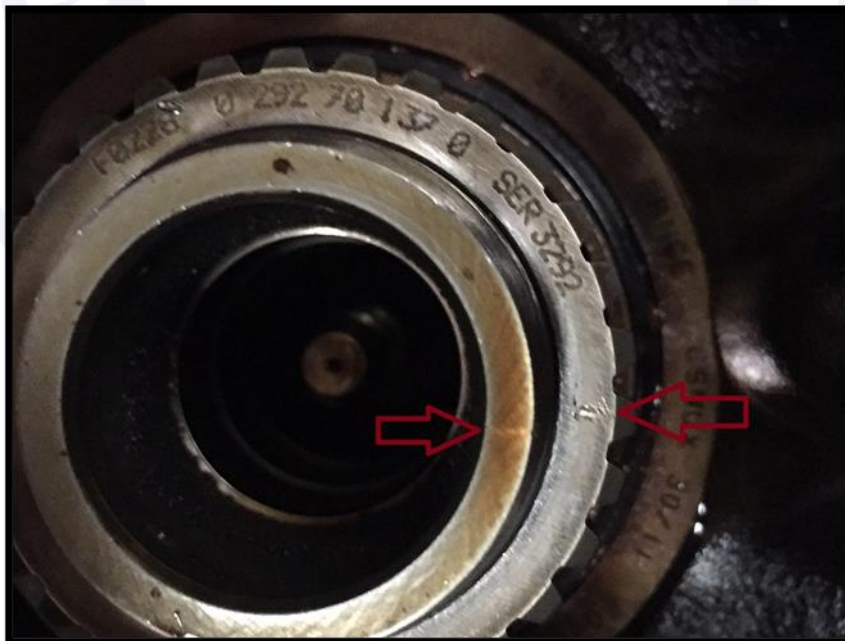
The M05 module (Figure 5) was removed from the engine to check the alignment of the marks on the input pinion and its nut. After the removal, a misalignment of approximately 1mm was observed between these components (Figure 6).

Figure 6 - Displacement of the nut from the engine's M05 module.

After consulting the engine manufacturer, it informed that, for the nut to move, the torque would necessarily have to be, at least, twice the nominal torque applied in its final

assembly. Therefore, this condition was an indication that the engine developed power at the moment of impact.

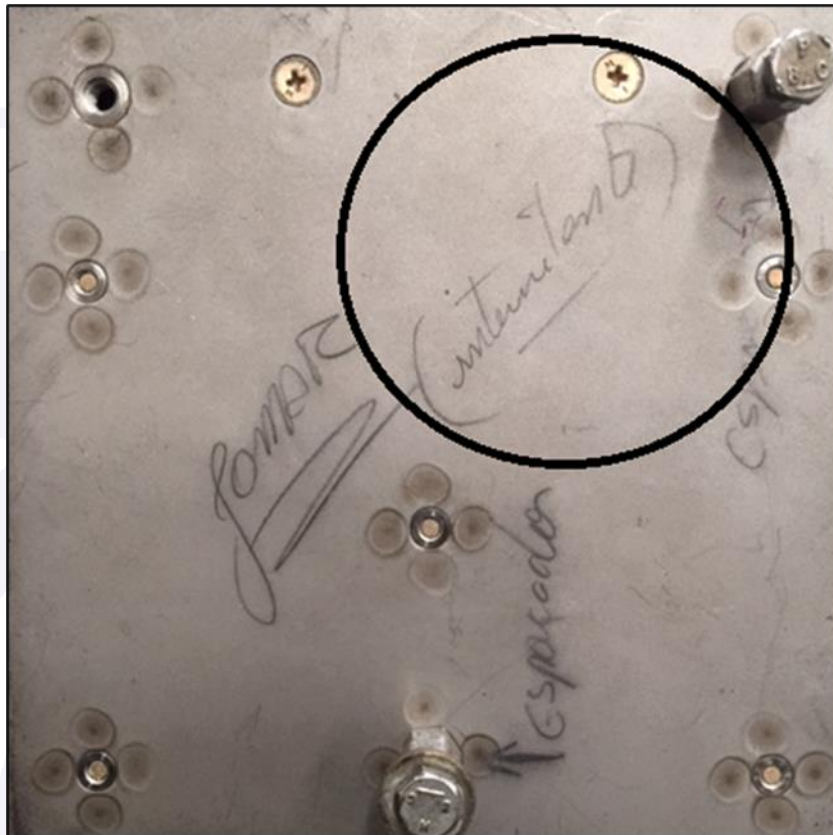
The tachymeter box, removed from the aircraft, had its seal and safety label violated, as well as an annotation in its structure with the inscription “intermittent” (Figure 7).

Figure 7 - Tachymeter box with the inscription “intermittent”.

The tachymeter box has the function of piloting the bleed valve and in doing so it allows the engine to operate correctly (without stall).

The pilot of the aircraft reported that, after the identification of a previous failure, the aforementioned equipment had been sent by the operator for maintenance at the company NAVTEC.

A consultation on the ANAC’s website revealed, however, that there was no certification issued by the Brazilian civil aviation authority for the company NAVTEC to act as a Maintenance Organization (OM).

Tests were performed on the tachymeter box and on the bleed valve, in a test bench, which were installed on an auxiliary engine. However, the results found were not able to reproduce the failure conditions reported by the pilot in the flight of the occurrence.

In view of the information collected, in view of the reports of previous failures of the tachymeter box, associated with the lack of records that would guarantee the traceability and adequacy of any maintenance interventions, the hypothesis of the occurrence of a momentary failure of the tachymeter box was considered, which it may have resulted in a temporary loss of the engine power and a variation of the helicopter's main rotor rotation.
