FINAL REPORT
A - 047/CENIPA/2018

OCCURRENCE:	ACCIDENT
AIRCRAFT:	PT-HYV
MODEL:	AS-350BA
DATE:	15MAR2018

This is the Final Report of the 15MAR2018 accident with the AS 350 BA aircraft model, registration PT-HYV. The accident was classified as “[LALT] Low Altitude Operations”.

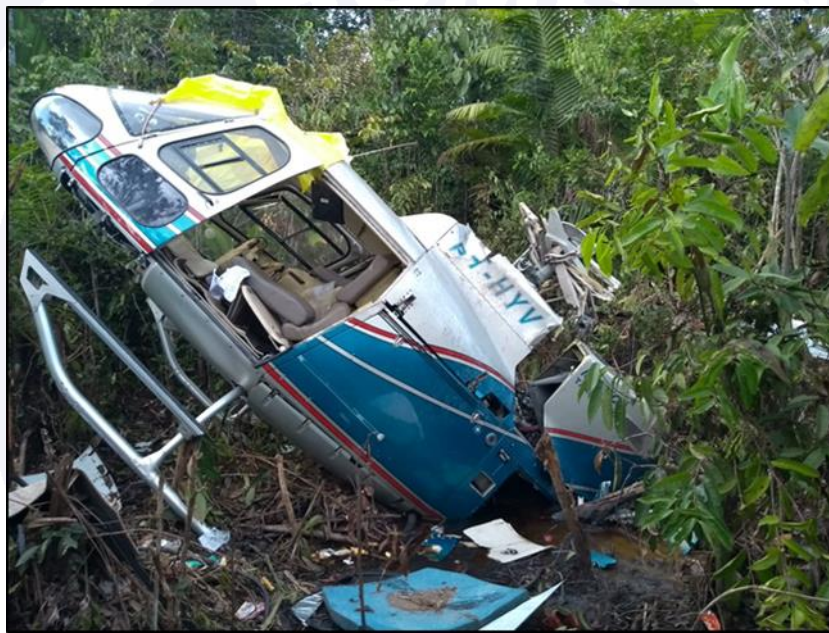
Figure 1 - View of the PT-HYV after the accident.

The aircraft had substantial damage to the engine, main rotor, tail rotor, structure, cockpit, passenger cabin, tail cone, windshield, landing ski, stabilizers, engine fairings, transmission and rotor drive shaft tailed.

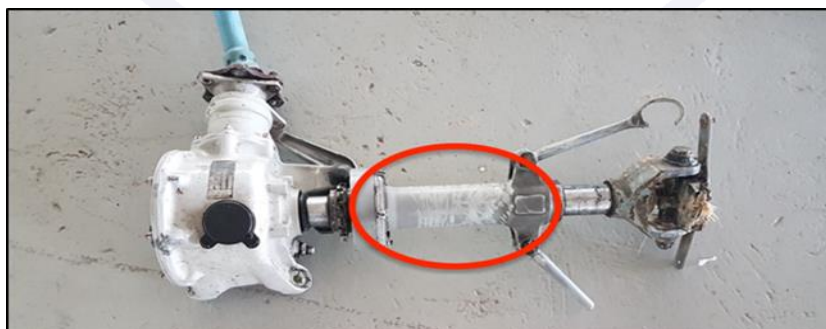
In an attempt to get out of that condition, the aircraft was commanded to the right. In this maneuver, however, the tail rotor reached the wiring, being this component broken and damaged (Figure 6).

Figure 6 - Marks of the collision of the rotating plateau of the tail rotor against the cables of the transmission line.

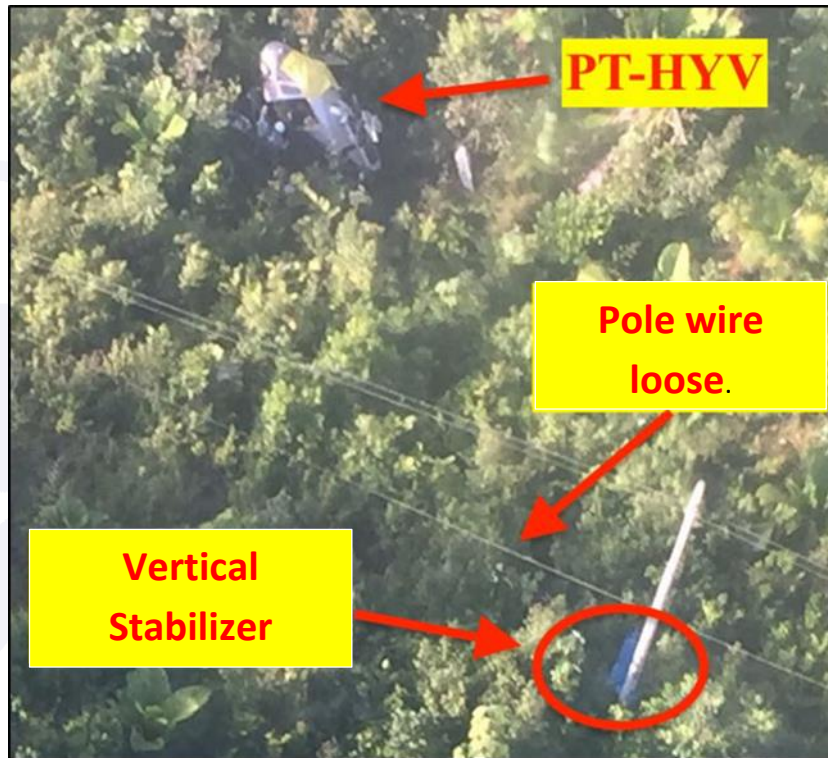
With the loss of the anti-torque effect provided by the tail rotor, the aircraft's nose was turned to the left. During this turn, the right part of the aircraft's tail cone collided with the pole and detached from the helicopter (Figures 7 and 8).

Figure 7 - Aerial view of the aircraft at the accident site, with emphasis on the pole and the vertical stabilizer.

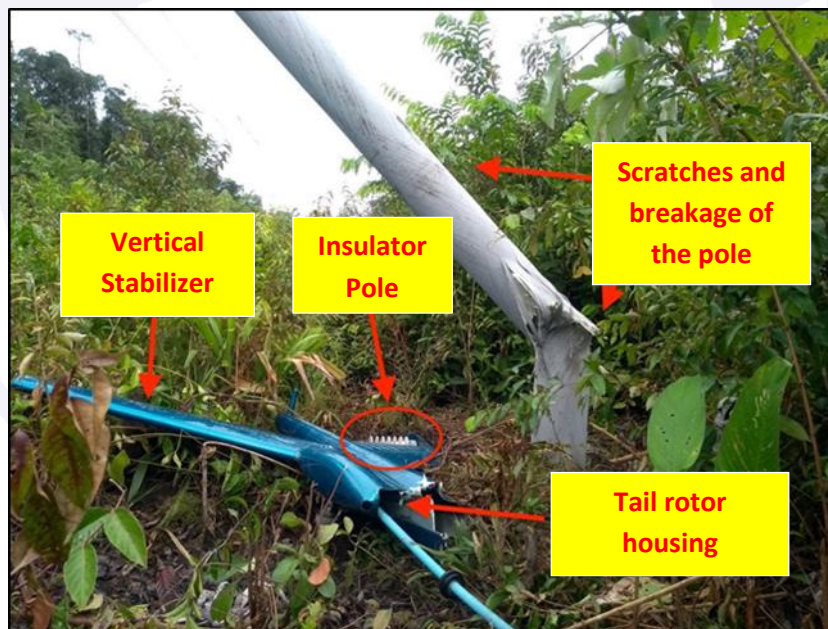
Figure 8 - Vertical stabilizer of the aircraft next to the pole broken by the impact.

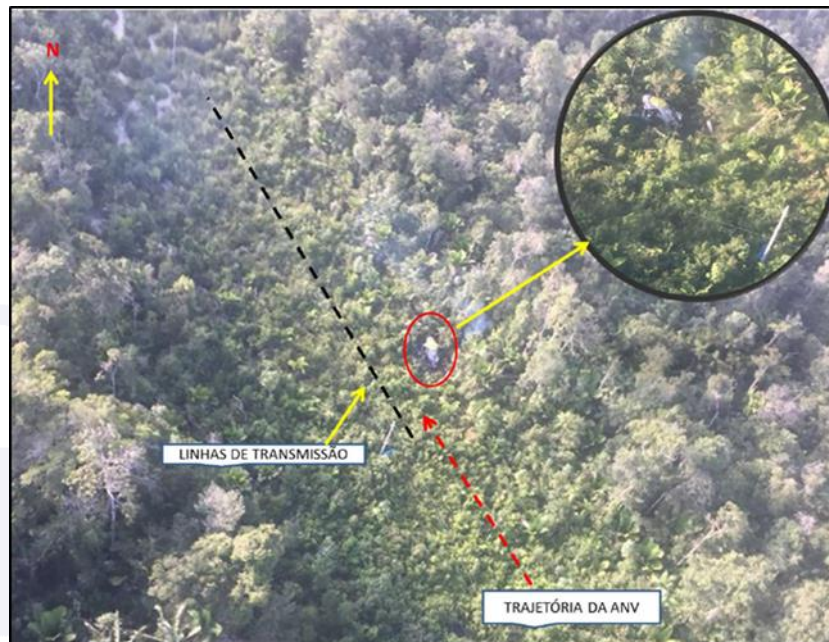
Then, the aircraft continued turning its nose to the left, losing height until it collided with uneven and swampy terrain, remaining in a 30° pitch up attitude (Figure 9).

Figure 9 - Aerial view of the accident site, with emphasis on the PT-HYV.

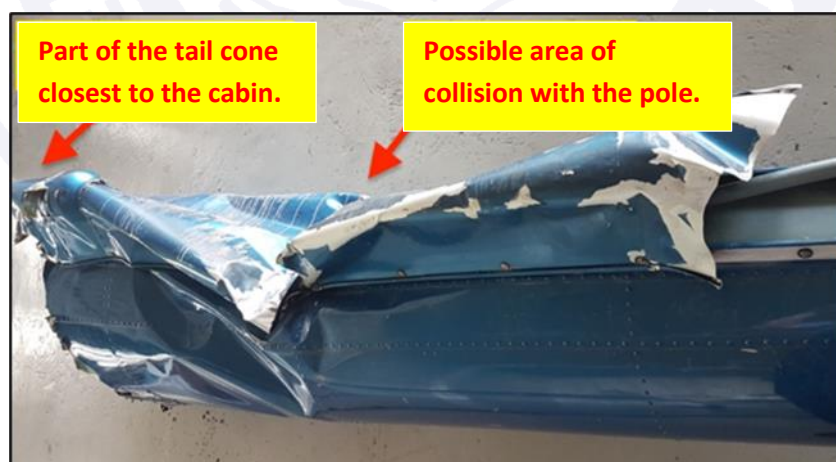
Figure 14 – PT-HYV Tail cone.

During this turn, the right part of the aircraft's tail cone collided with the pole, breaking it and detaching itself from the aircraft.

It was analyzed that the reports on the unfolding of the accident coincided with the evidence of the friction marks found on the rotating plateau of the tail rotor with the wiring (Figure 6) and also with the impact mark on the right side of the tail cone (Figure 14).

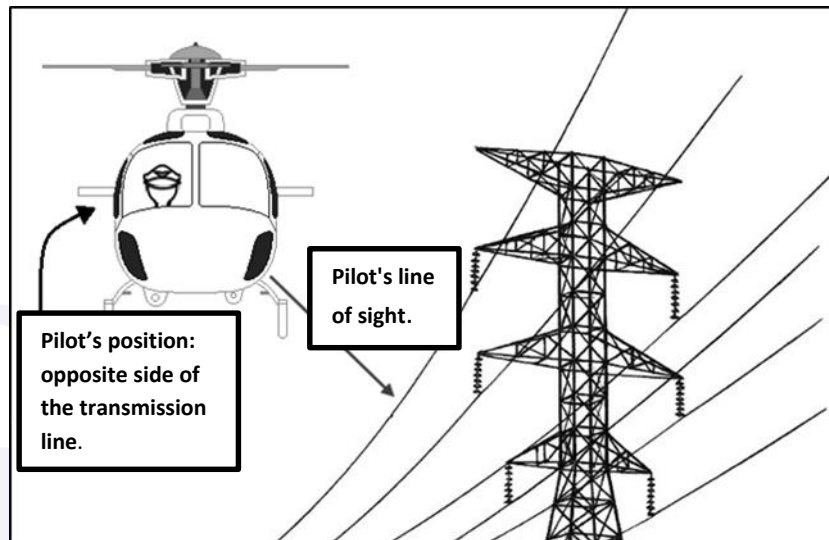
In addition, as reported, the approach was performed 3 meters above the line, with the wiring being on the left and below the aircraft and the pilot occupying the right seat, which would presumably make it difficult to visualize the wiring (Figure 15).

Figure 15 - Representative diagram, out of scale, of the aircraft's position in relation to the transmission line cables.

Because the visualization of the wiring is impaired, it is possible that the attempt to establish and maintain the distance of 3 meters, with tail wind component, was carried out imprecisely, leading to an involuntary approach of the aircraft against the wires.
