COMANDO DA AERONÁUTICA
CENTRO DE INVESTIGAÇÃO E PREVENÇÃO DE
ACIDENTES AERONÁUTICOS

FINAL REPORT
A-032/CENIPA/2018

OCCURRENCE:	ACIDENTE
AIRCRAFT:	PT-HYW
MODEL:	AS350B2
DATE:	22FEV2018

This is the Final Report of the 22Feb2018 accident with the AS350B2 aircraft, registration PT-HYW. The accident was typified as “[SCF-NP] System/component failure or malfunction and [LOC-I] Loss of control in flight”.

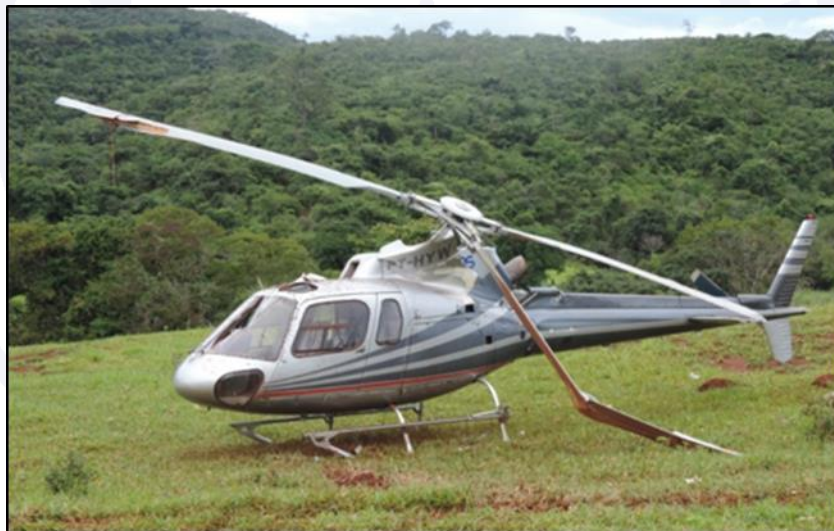
At the end of the approach, as the helicopter was about to land, the pilot lost control of the aircraft, and the main rotor blades struck the ground. Subsequently, the helicopter skids touched the ground, and the aircraft stopped

Figure 1 - View of the PT-HYM at the crash-site.

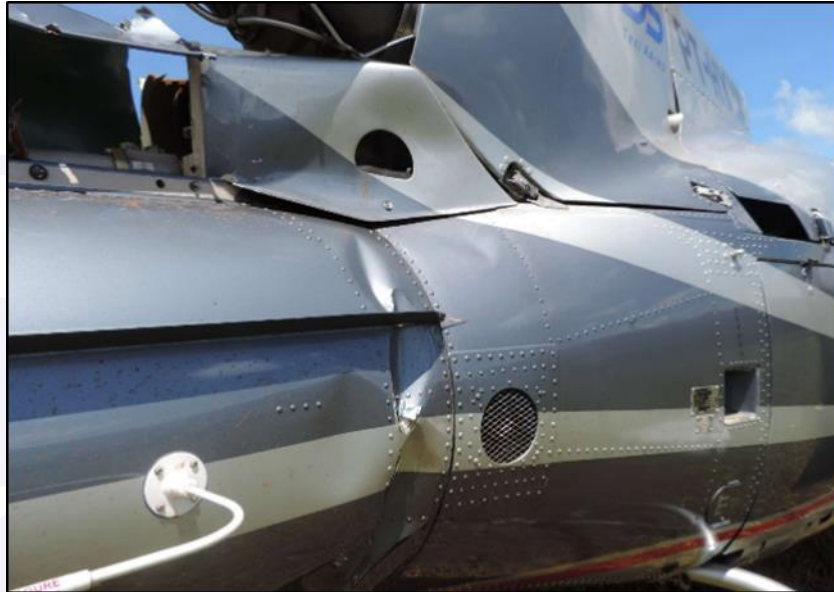
One of the main-rotor mast support-rods was broken, the tail boom had a fracture, and there was breakage of the main and tail rotor blades, left skid and left windshield (Figure 2).

Figure 2 - Damage to the PT-HYW tail boom.

With the second impact, the control rod of the right-hand servo of the main rotor, the left-hand skid and left-hand windshield got broken, the tail boom was damaged, and the short shaft of the tail rotor transmission was fractured, causing a tear in the protective fairing of the component.

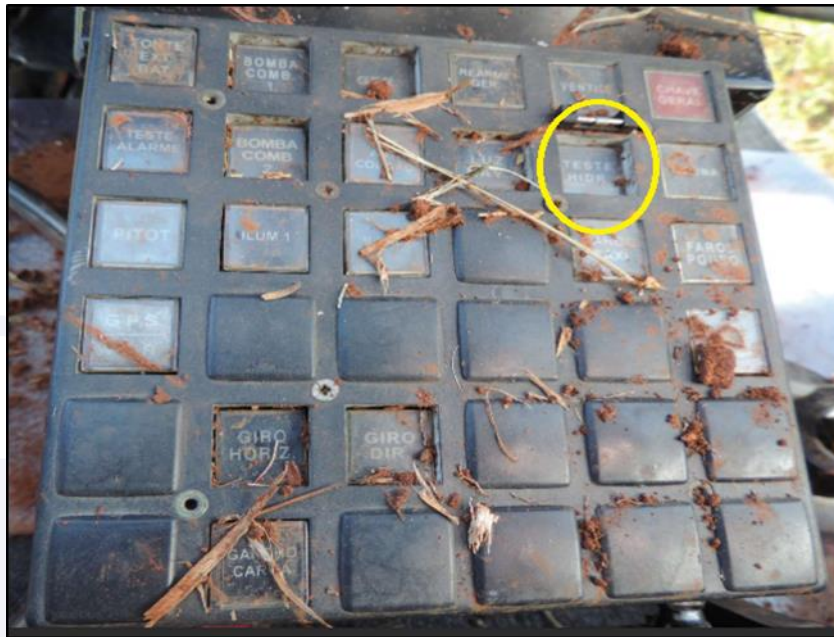
The "HYD TEST" pushbutton was in the depressed position (Figure 7).

Figure 7 - View of the depressed hydraulic-test (TESTE HIDR) pushbutton.

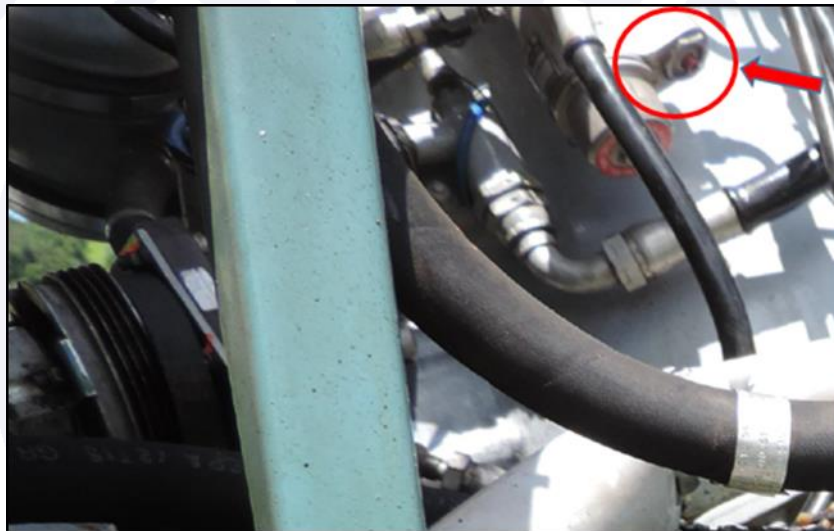
At the initial action of the investigation, upon checking the PT-HYW hydraulic filter clogging indicator, the investigators observed that the pin was apparent (Figure 8).

Figure 8 – Hydraulic-fluid filter clogging indicator (with apparent pin).

The contamination of the hydraulic fluid probably initiated on account of malfunction of the pump, which also showed wear in its internal moving parts.

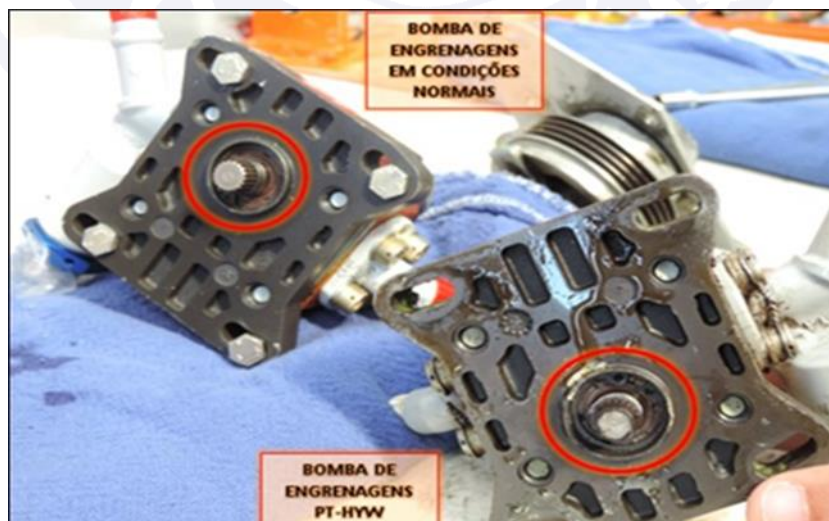
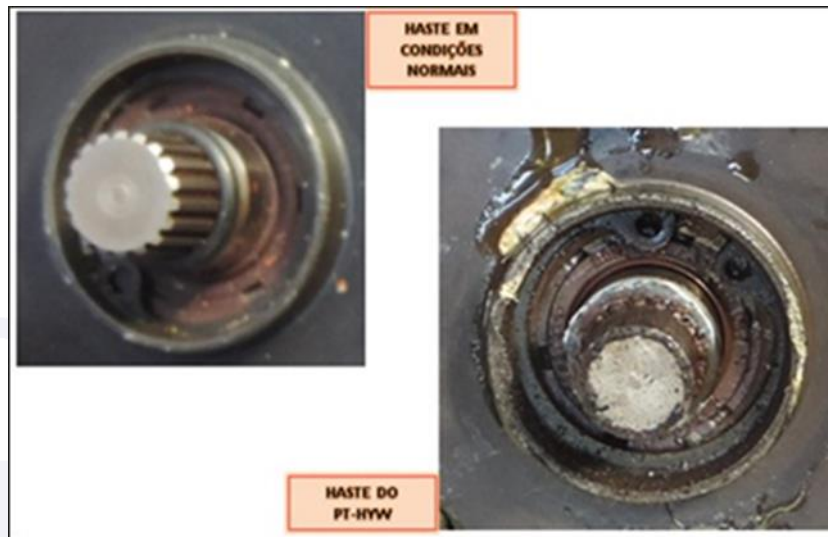
The hydraulic pump shaft (P/N A5026780), which received the torque and transferred it to the pump's internal gears, showed wear on the notches (splines), as was verified from the comparison between the pump that equipped the PT-HYW and the pump in normal operating condition (Figures 12 and 13).

Figure 12 - Hydraulic Gear-Pumps and respective shafts.

Figure 13 - Detail of the Gear Pump shafts.

The P/N A5026780 hydraulic pump notches (splines), which received the torque of motion transference from the pulley to the hydraulic pump were completely worn.

Therefore, one cannot rule out the possibility that the wear on the notches (splines) of the hydraulic pump rod may have resulted from at least one of the following: misalignment of the connecting shaft, bearing malfunction, looseness in pump attachment, a tension value different from the one prescribed for the connecting pulley, or poor lubrication. The mentioned problems may be the result of an inappropriate previous maintenance procedure, either due to inadequate services performed on the aircraft or due to misinterpretation of the relevant documents.

In any case, the wear of the notches (splines) compromised the operation of the hydraulic pump, interrupting the supply of hydraulic fluid to the system, making the pressure drop below 30 bars, leading to illumination of the "HYD" light, and activation of the horn.

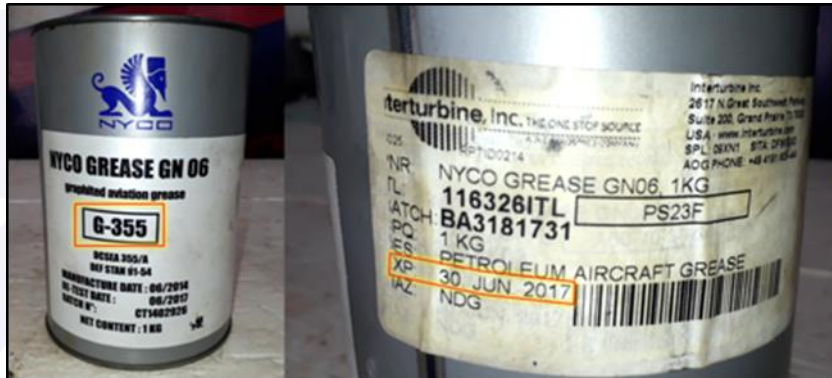
The grease validity date of the grease was 30Jun2017, i.e. about 8 months after the expiry date (Figure 18).

Figure 18 - Evidence of use of expired product

Despite the fact that, in a visit of the Maintenance Organization facilities, cans of grease with expired validity were found to have been used recently, it was not possible to relate such non-compliance with inadequate lubrication of the component.

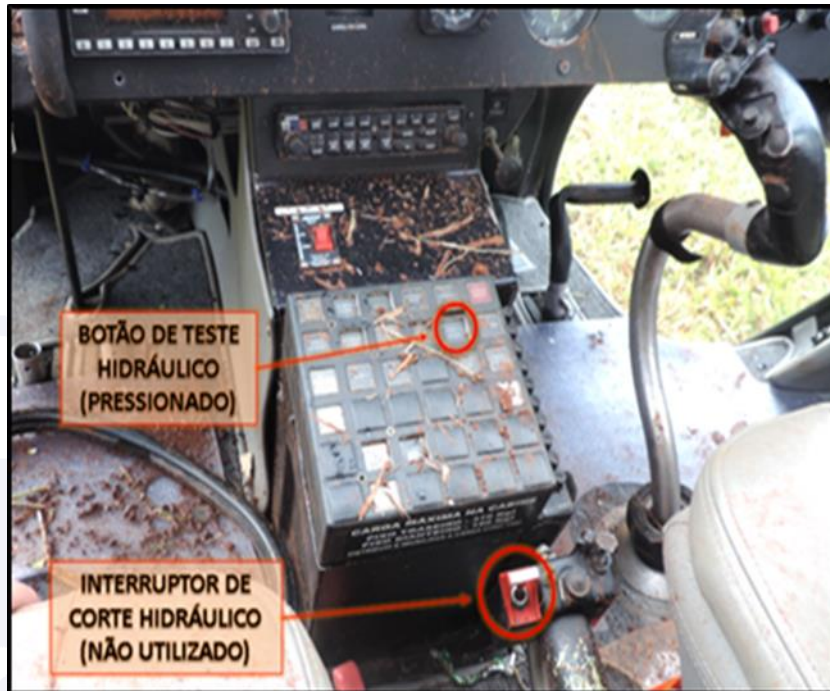
The PIC informed that, upon noticing that the HYDR light illuminated, he cut off the hydraulic system by means of the hydraulic-test pushbutton of the central console button-panel, instead of using the HYD switch of the collective handle, as can be seen in Figure 24, in a photo taken moments after the occurrence.

Figure 24 - Final position of the center-console button-panel, and the PT-HYW hydraulic cut-off switch.
