FINAL REPORT
A - 037/CENIPA/2018

OCCURRENCE:	ACCIDENT
AIRCRAFT:	PT-IEL
MODEL:	V35B
DATE:	27FEB2018

This is the Final Report of the 27FEB2018 accident with the V35B aircraft model, registration PT-IEL. The accident was classified as “[UIMC] Unintentional IMC and [LOC-I] Loss of Control in Flight”.

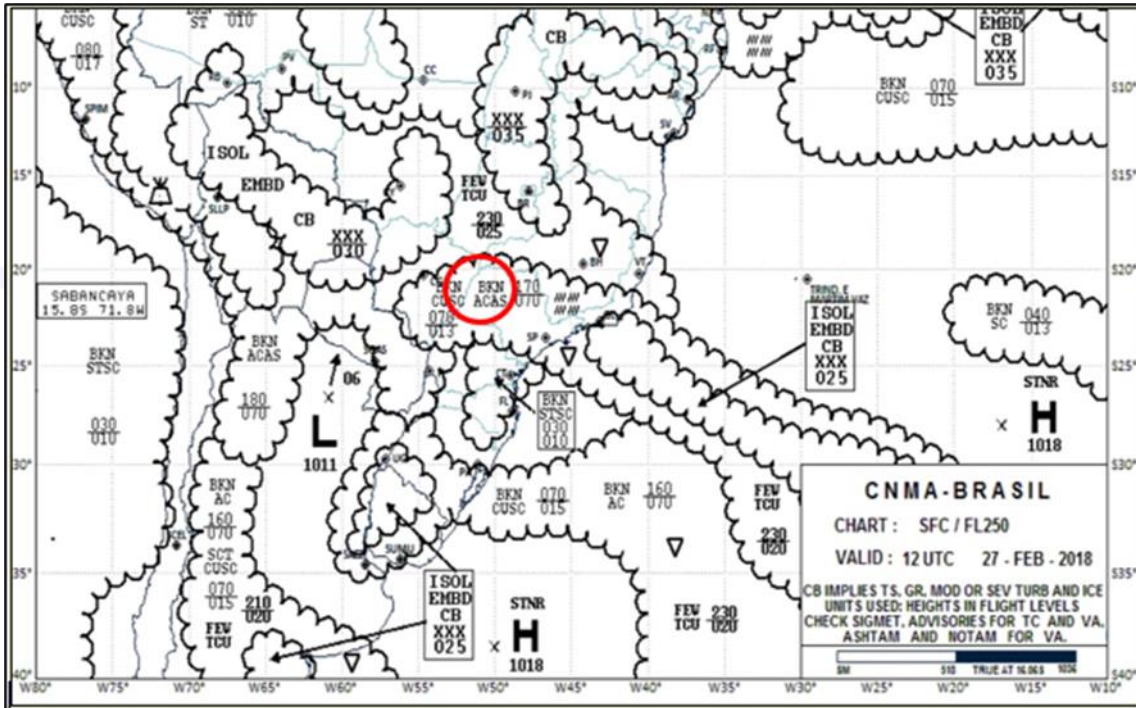
Figure 1 - SIGWX chart from the surface to FL250. Accident area highlighted in red.

The SIGWX chart generated at 2036 (UTC), valid until 1200 (UTC) on 27FEB2018, illustrated the presence of Cumulus (CU) and Stratocumulus (SC) clouds based at 1,300 ft and top to 7,000 ft, with coverage of 5 to 7 oktas (BKN) and possibility of rain showers in the region where the first half of the flight would occur (Figure 1).

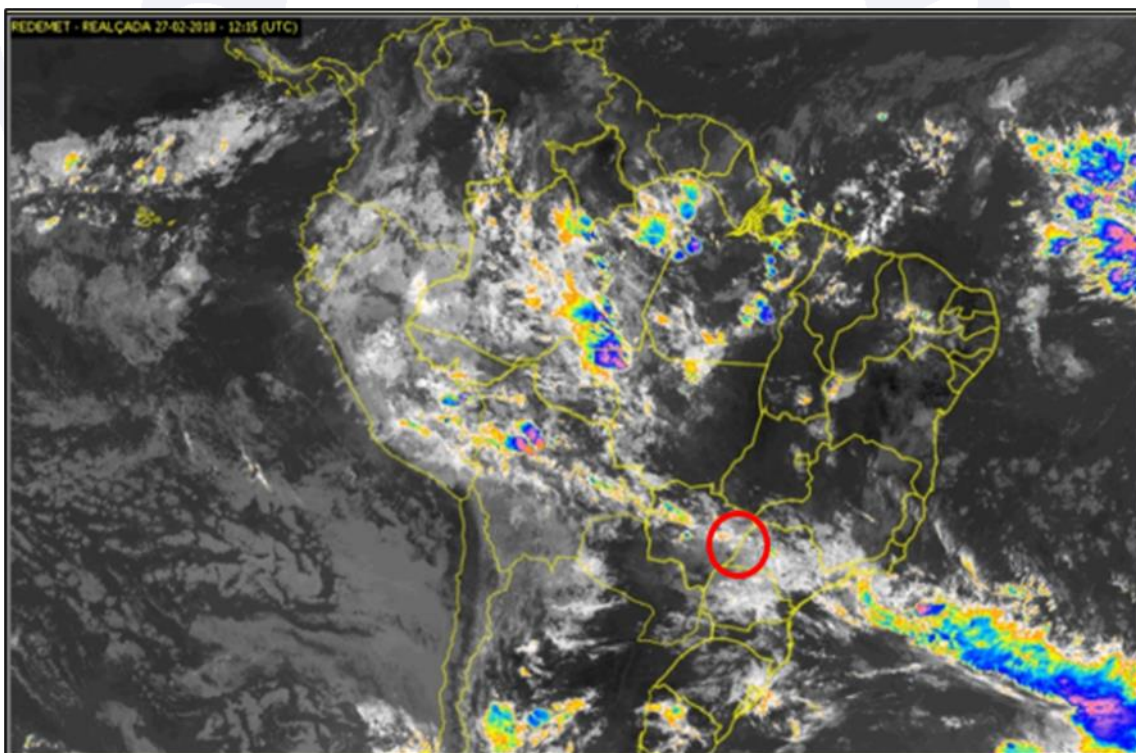
Figure 2 - Satellite image (enhanced) at 1215 (UTC). Origin and destination areas highlighted in red.

The satellite image, generated at 1215 (UTC), illustrated the synoptic situation of the region with the existence of a meteorological system and a humidity corridor in a Northwest-Southeast direction, with the presence of some clouds of the Towering Cumulus (TCU) type.

In the region of the accident, there was cloudiness at low and medium levels (Figures 2 and 3).

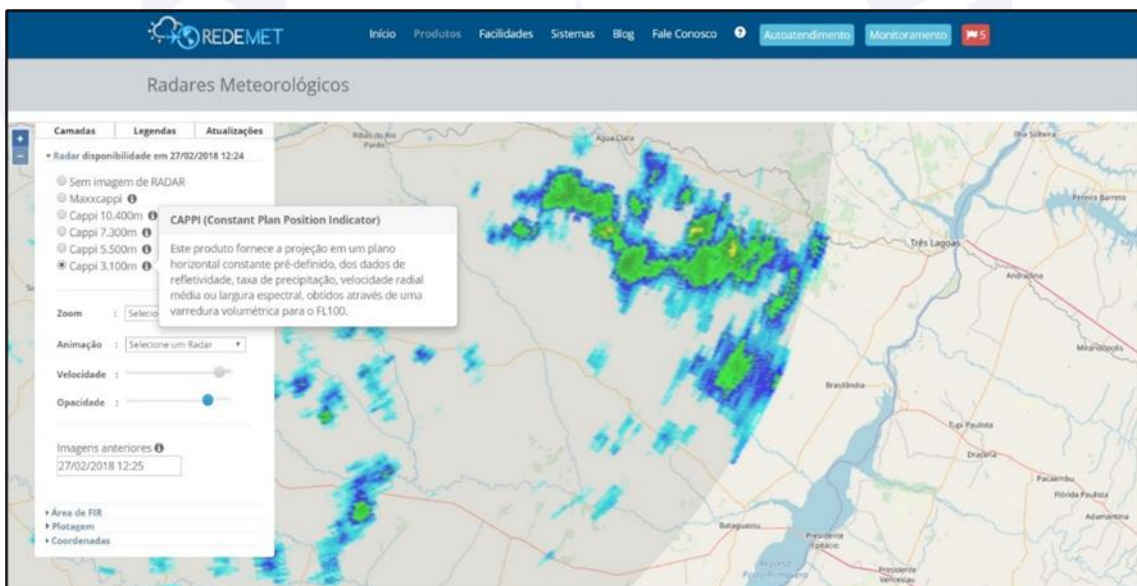
Figure 4 - Jaraguari meteorological RADAR (CAPPi 3.100m), at 1224 UTC.

The image generated by the Jaraguari meteorological RADAR, at 1224 (UTC), with the horizontal projection of the precipitation information obtained for the FL100, presented a rainy region between the cities of Água Clara, Três Lagoas and Brasilândia (Figure 4).

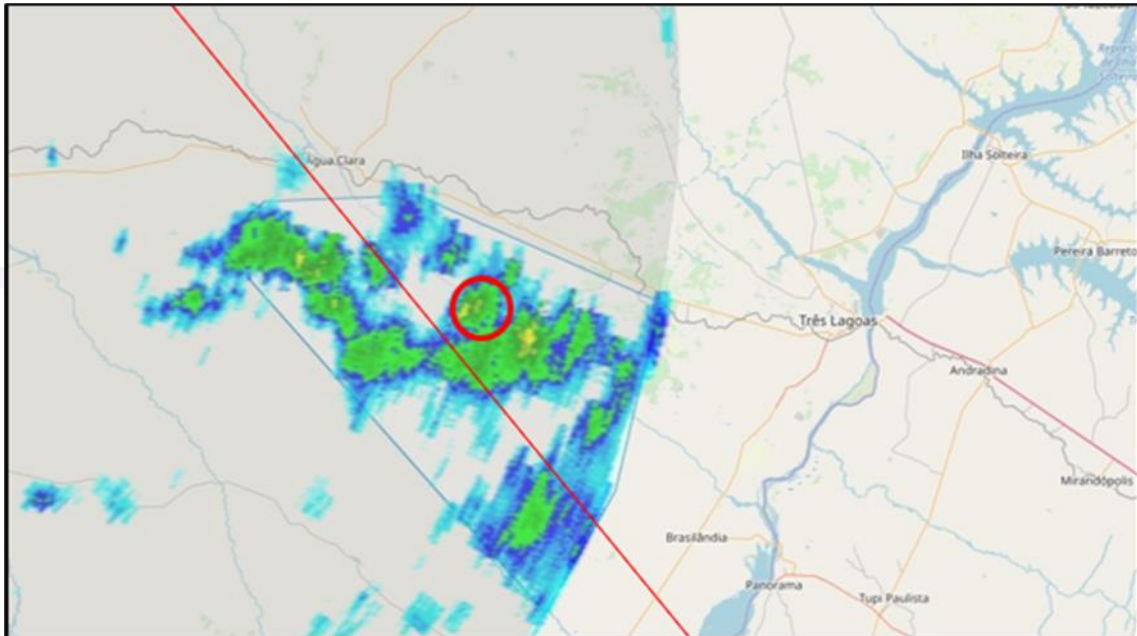
Figure 5 - Precipitation region. Red dash and circle indicate the route and region of the crash, respectively.

The region limits defined a polygon (Figure 5) for comparison purposes with the aircraft route in field 1.18 of this report.

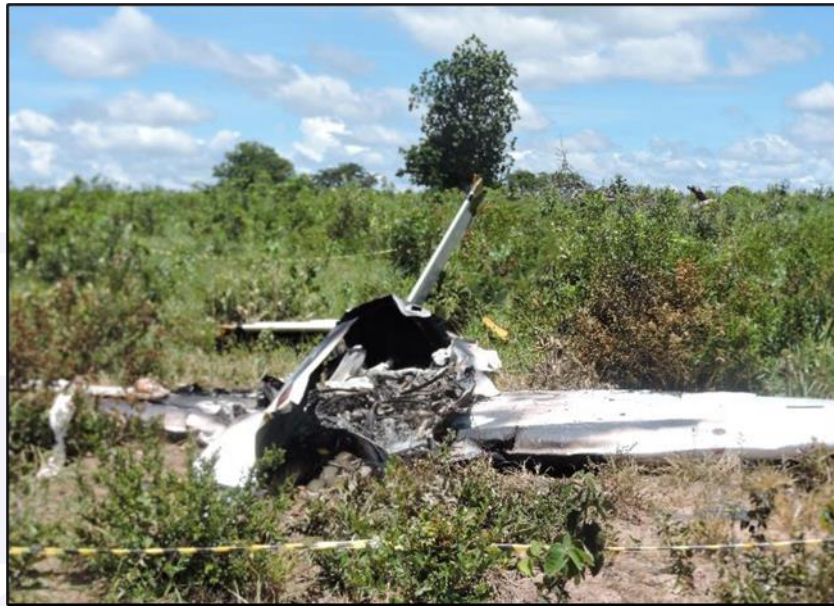
Figure 6 - Layout of the aircraft wreckage.

There was a single point of impact, and this one occurred in a pitch down attitude (approximately 10 degrees) and with practically no inclination. The aircraft's nose was buried in the soft ground. The wing tip tanks have separated from the wings. Some light objects, which were being transported, were projected out of the aircraft, to the right side, stopping near the tip of the right wing.

Such impact characteristics indicated the possibility of sinking in a flat spin (Figure 6).

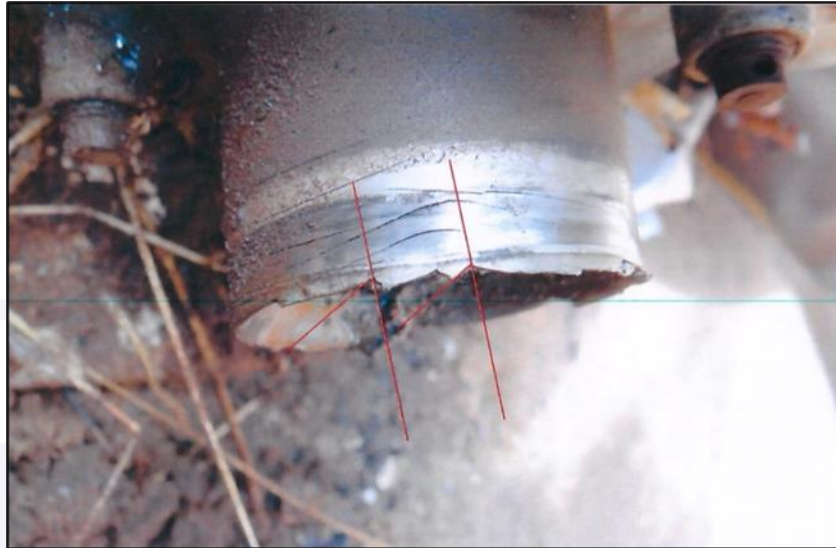
Figure 7 - Crankshaft rupture cracks.

Regarding the powertrain group, an analysis of its external evidence was performed. Crankshaft rupture cracks were observed close to the coupling flange with the propeller. These cracks had an angle of 45 degrees (Figure 7).

The type of deformation found in one of the propeller blades, associated with the crankshaft breaking due to overload (sudden stop) indicated that the engine was developing power at the moment of impact.

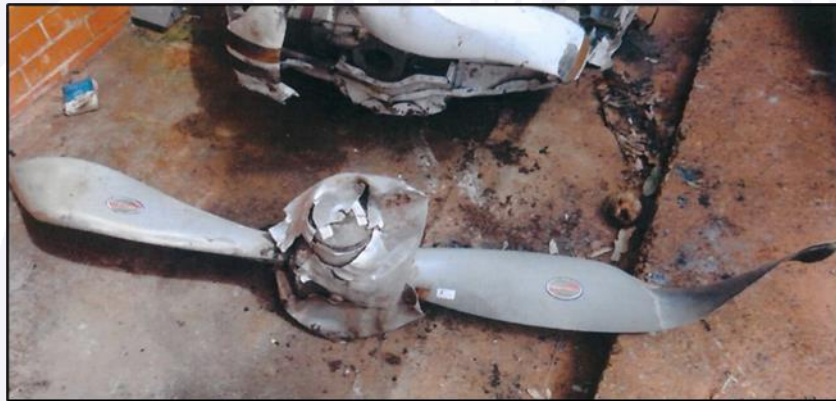
Figure 8 – Bending on the propeller blades.

The propeller had one of its blades bent forward and the other facing backwards (Figures 8 and 9).

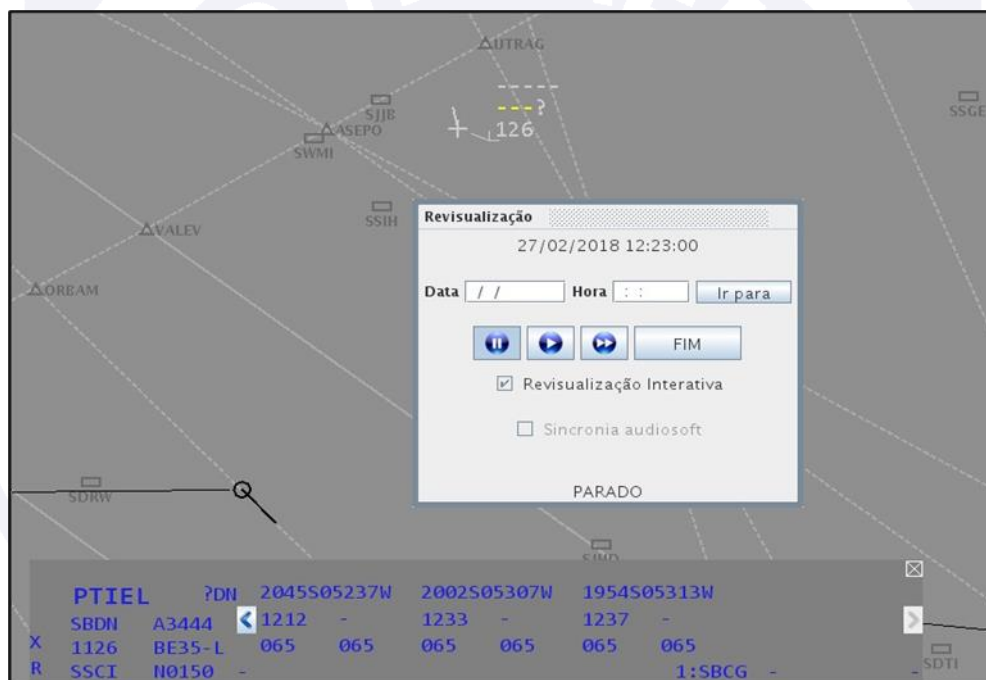
Figure 10 - RADAR Review with last position at 1223 UTC.

Through the RADAR review, some changes in the direction of flight in the accident region were noticed, between 1214 and 1223 UTC.

Only the primary surveillance RADAR information was captured (no aircraft altimetry information). At 1223 UTC, the last RADAR synthesis of the aircraft was captured, close to the fixed UTRAG and ASEPO (Figure 10).

According to the RADAR revisualization, the pilot started a series of turns, characterized by successive changes in direction. This situation may have led to spatial disorientation and the consequent loss of control of the aircraft, which may have entered a spin condition, in which it remained until the impact with the ground.

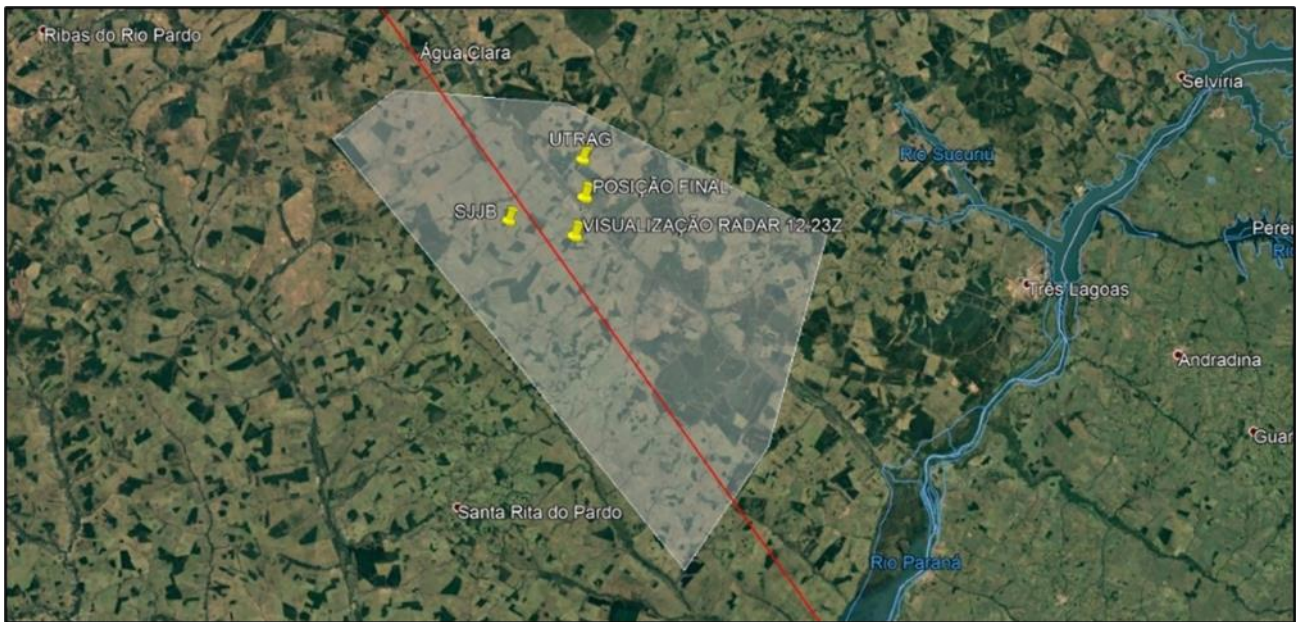
Figure 11 - Known positions of the aircraft, superimposed on the rain polygon (horizontal plane). Red line representing the route of flight.

The information of known positions of the aircraft (last RADAR plot and final position after the accident) and of the fixed and Aerodromes close to it, was superimposed with the polygon determined in item 1.7, related to the rain area captured by the meteorological RADAR of Jaguarari (Figure 11).
