**FINAL REPORT**  
**IG - 047/CENIPA/2021**

<b>OCCURRENCE:</b>	<b>SERIOUS INCIDENT</b>
<b>AIRCRAFT:</b>	<b>PT-JGA</b>
<b>MODEL:</b>	<b>MU-2B-25</b>
<b>DATE:</b>	<b>22MAR2021</b>

This is the Final Report of the 22MAR2021 serious incident with the MU-2B-25 aircraft model, registration PT-JGA. The serious incident was classified as “[SCF-NP] System/Component Failure or Malfunction Non-Powerplant – with Landing Gear”.

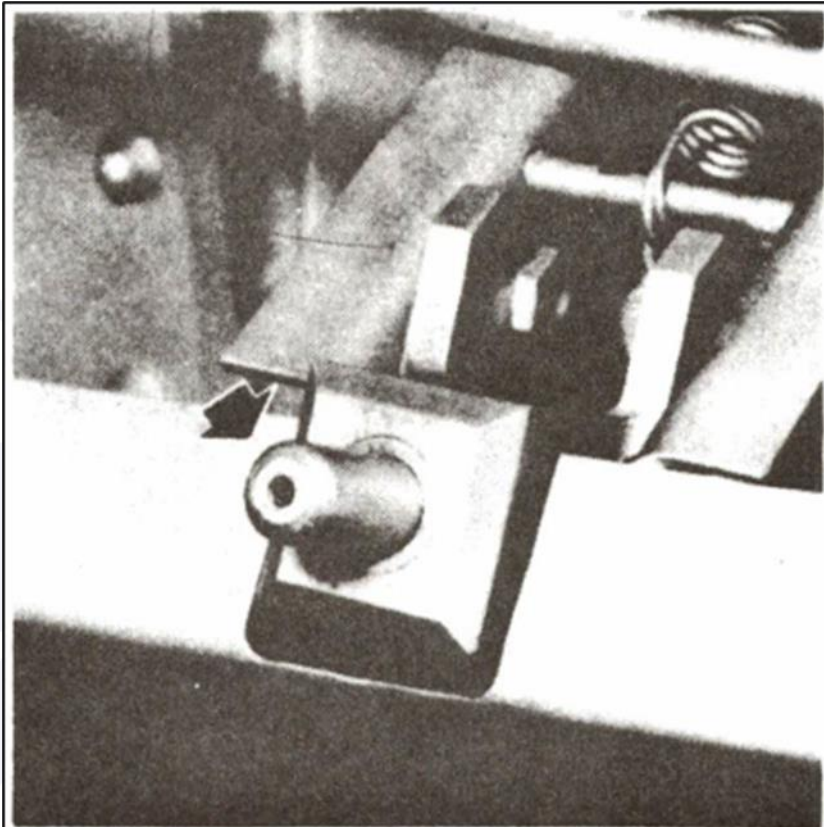
Fig. 4 - 38 Check lock pin  
for stroke

Figure 1 shows the sensor that sent the door closed signal.

Figure 1 - Extract from the MU-2 maintenance manual, dated 27DEC1999. The black arrow indicates the pin that sent a signal to the landing gear light in transit.

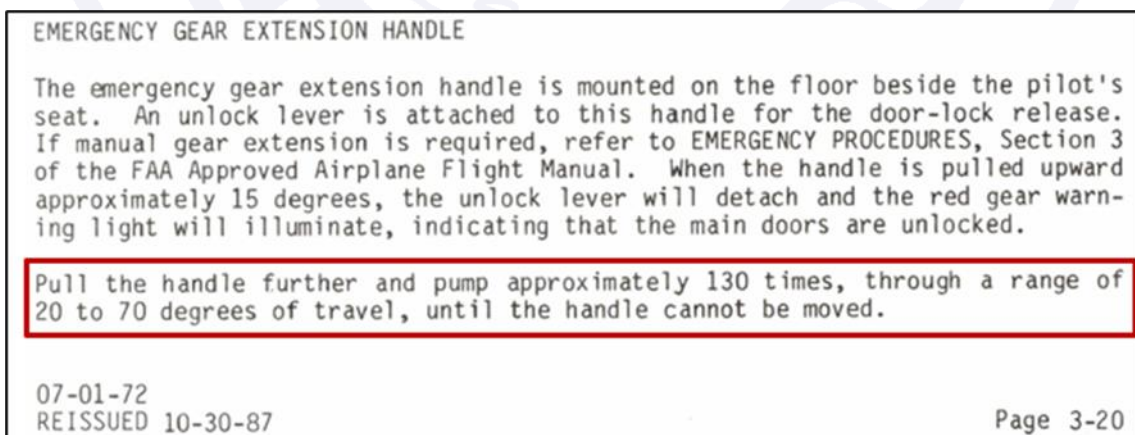
When a failure of the regular system was detected, the emergency system should be used to lower the landing gear. A lever in the cockpit was activated to release the doors and activate the landing gears. It should be pumped until it stopped, which happened after being moved approximately 130 times, moment that the lowering cycle would be completed (Figure 2).

Figure 2 - Extract from the MU-2 maintenance manual, dated 30OCT1987. In the red highlight, it is possible to check the reference number of movements on the lever.

However, the emergency lever could only be moved 3 times until it locked. According to the aircraft manual it would take 130 movements of this lever to lower the landing gear.

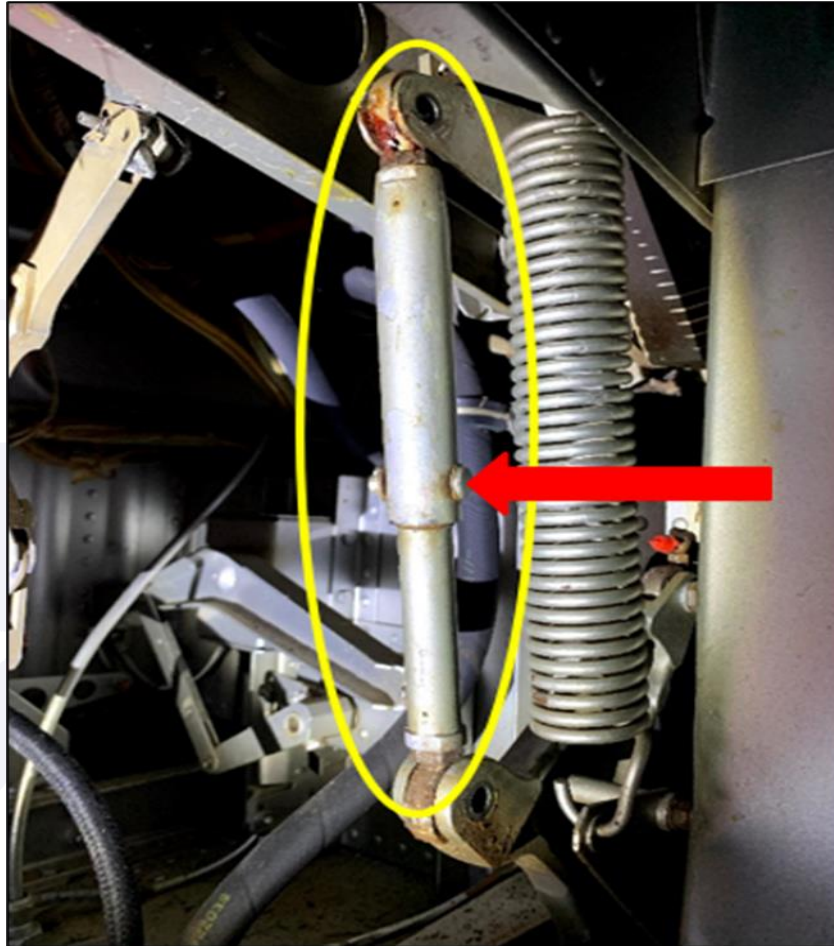
The activation of the emergency landing gear lowering lever acted directly on the safety pin, which was located on the left main landing gear (Figure 3).

Figure 3 - Close-up photo of the landing gear housing on the left side. In the detail indicated by the red arrow, the safety pin in its original position.

The Safety Pin, when shearing, released the entire mechanism of the doors causing them to open by gravity, allowing the landing gear to be lowered through lever movements. There were two maintenance interventions on the landing gear set, one on 15MAY2019 by the Conal company, according to service order number 5604/19, and another by the Fênix company, on 17OCT2020, in accordance with service order 259/020. There were not found records of tasks performed on the safety pin.

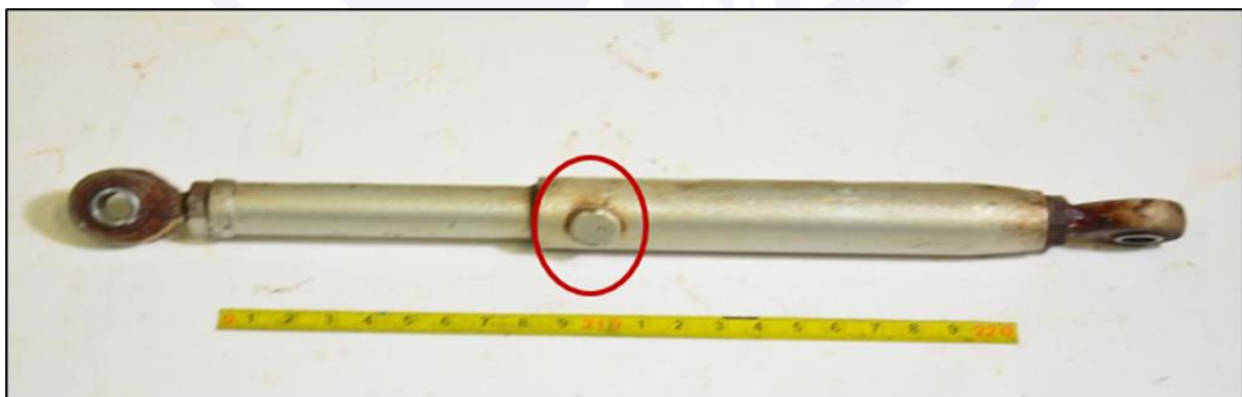
The rod assy, Part Number (PN) 010A-38754, is shown in Figure 4.

Figure 4 - Photo of the rod removed from the aircraft. In the red detail, the safety pin that did not break and did not allow the emergency procedure to be carried out.

According to the results obtained, it was possible to conclude that the tested pin presented a greater mechanical resistance than expected, which avoided its breakage and, consequently, that the pilot was unable to succeed in the emergency procedure of lowering the landing gear.

Disclose the lessons learned in this investigation to maintenance organizations certified to perform services on the MU-2B-25 model aircraft.

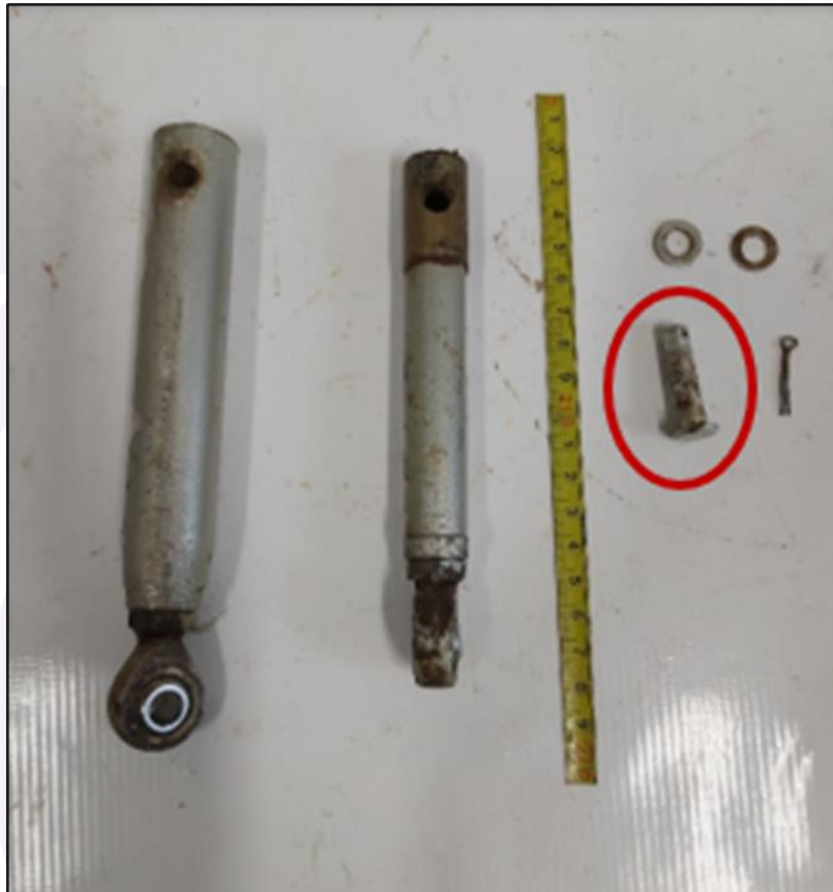
The chemical analysis verified the material composition of the pin (Figures 5 and 6) that was installed in the stem, which should be AA6061 (Aluminum Alloy 6061-T651 QQ-A-225/8).

Figure 5 - Photo of the disassembled rod. In the red detail, the pin that was analyzed.

The result of the chemical composition analysis obtained indicated that the alloy used in the pin was the AA7075. This alloy had a much higher shear strength than the AA6061 alloy, which according to the manufacturer's information, was the expected material.

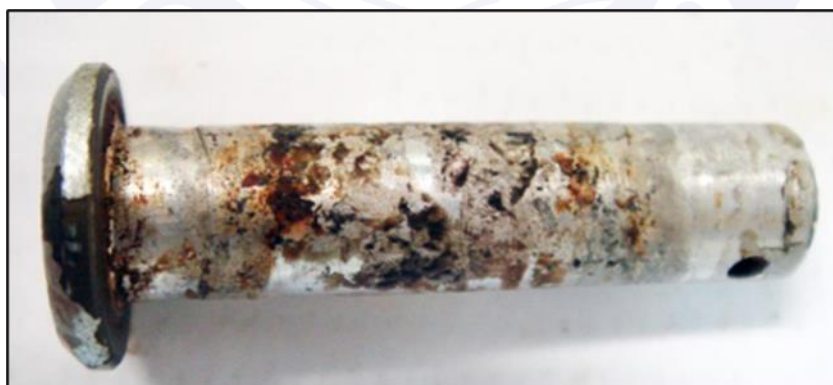
Figure 6 - Photo of the pin without any sign of deformation.

The image above (Figure 6) shows the safety pin intact and without damage, even after consecutive attempts of the emergency procedure and the test performed on the bench.

In the mechanical test, the shear test reached a load of 1,553.3 kgf (15,232.2 N). At that moment, the test was interrupted, as the pin had not sheared, even exceeding the reference values. As for the chemical analysis of the material, it was found that the aluminum alloy was the AA7075, that is, more resistant and different from what was foreseen by the manufacturer.

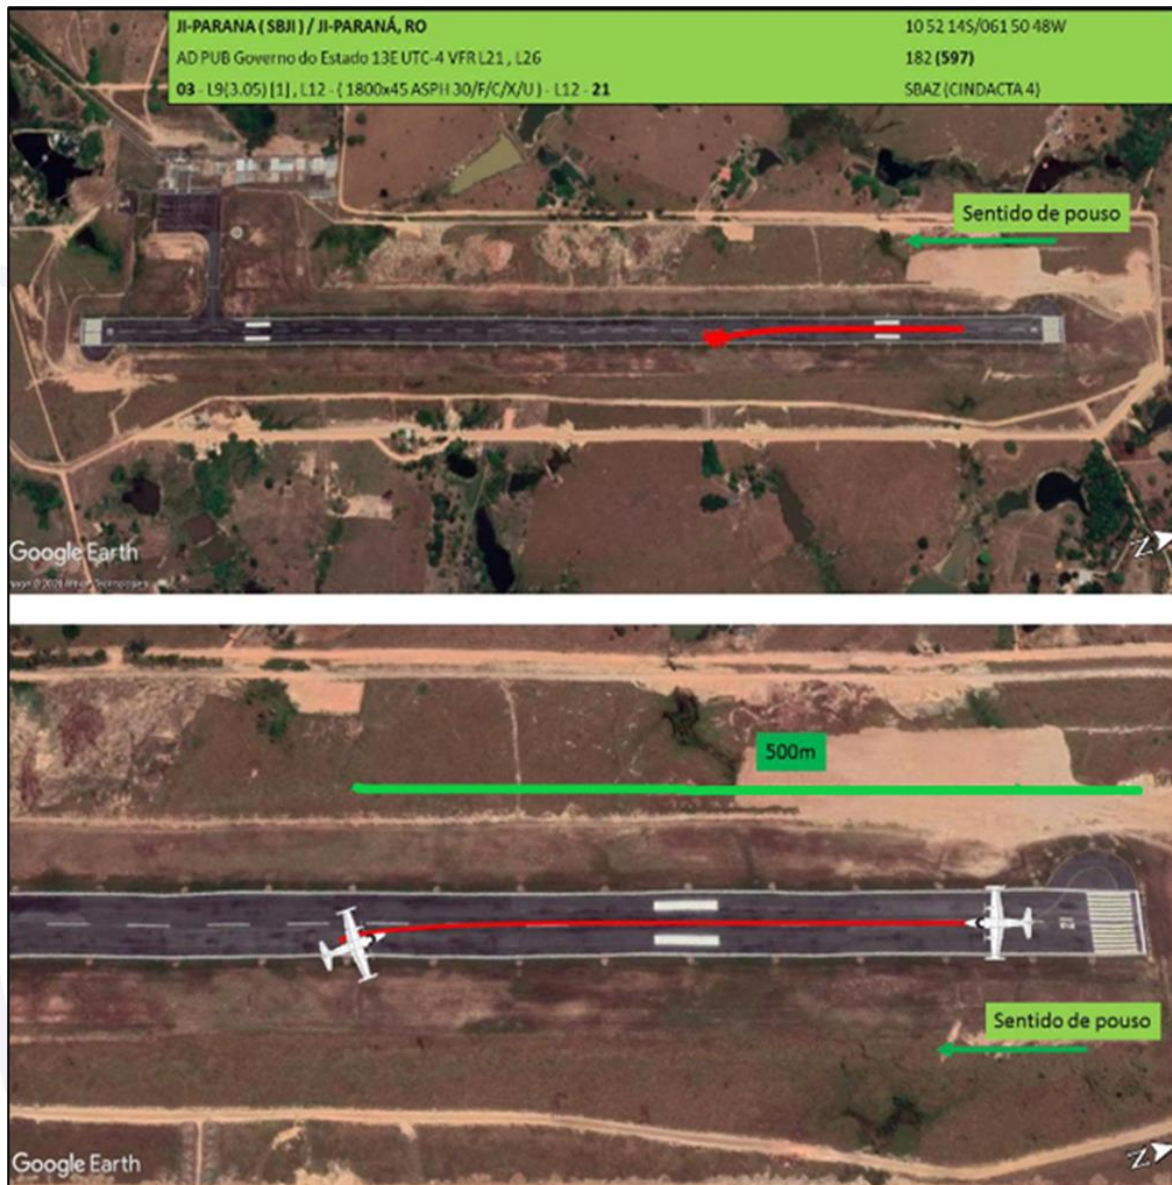
After the touchdown, the aircraft traveled approximately 300 meters on the runway until it came to a complete stop, with the fuselage touching the side strip. In the last 50 meters, the aircraft turned 180° to the left in relation to its axis of displacement, with its total stop occurring close to the left side of the runway (Figure 7).

Figure 7 - Sketch of the occurrence.
