FINAL REPORT
A-102/CENIPA/2021

OCCURRENCE:	ACCIDENT
AIRCRAFT:	PT-JIH
MODEL:	182P
DATE:	10SET2021

This is the Final Report of the accident involving the 182P aircraft, registration PT-JIH, on 10 September 2021. The accident was typified as “[UNK] Undetermined”.

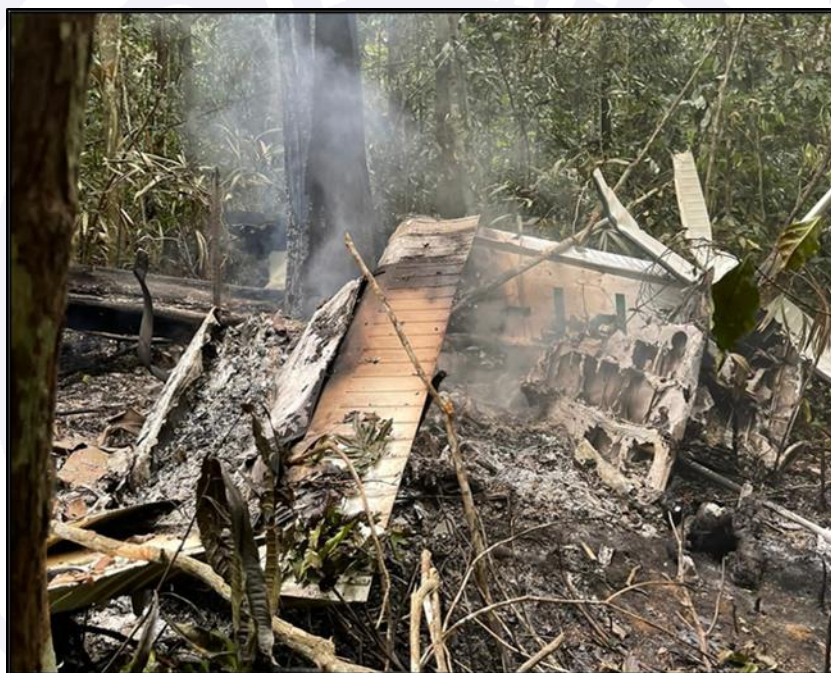
Figure 1 - Wreckage of the aircraft after the impact with a tree.

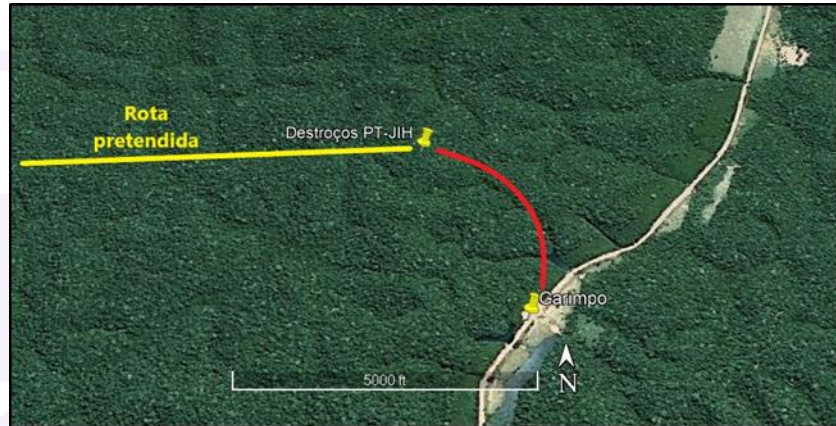
The impact occurred in a region of forest to the northwest of the unregistered airstrip of *Garimpo Carolina*, at a distance of approximately at 0.68 nm (Figure 5).

Figure 5 – Croquis showing the turn after takeoff, the intended route and the wreckage site.

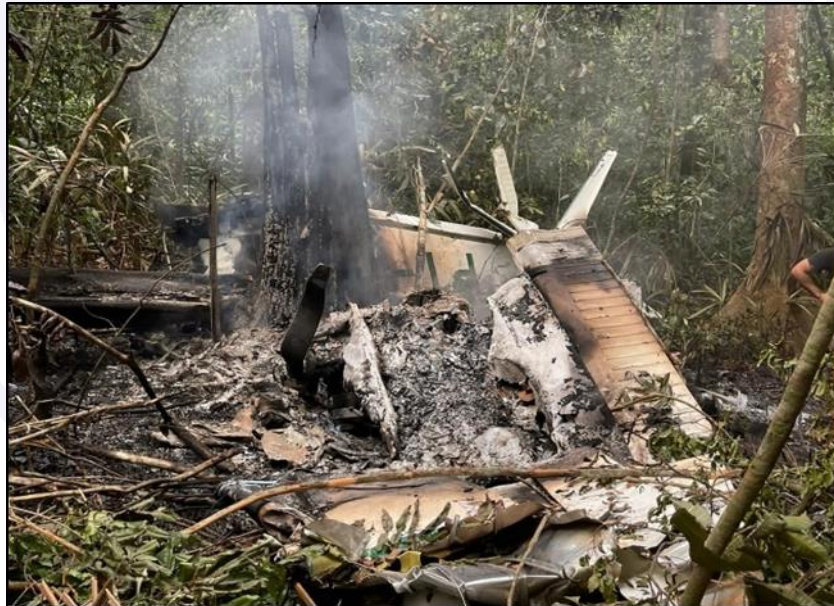
In the center of the area, there was a fallen tree with marks consistent with being struck by the falling aircraft. At the lower part of the tree trunk, there was a piece of the right-hand wing-strut of the plane “fitted” in a slot opened vertically. The rest of that wing was on the ground, with its leading edge facing downwards (Figure 6).

Figure 6 – Wreckage of the aircraft close to the impacted tree.

In the lower part of the aforementioned tree trunk, a piece of the right-side wing-strut was found fitted in a slot, opened in the vertical direction. In addition, the rest of that wing was on the ground, with the leading edge facing downward.

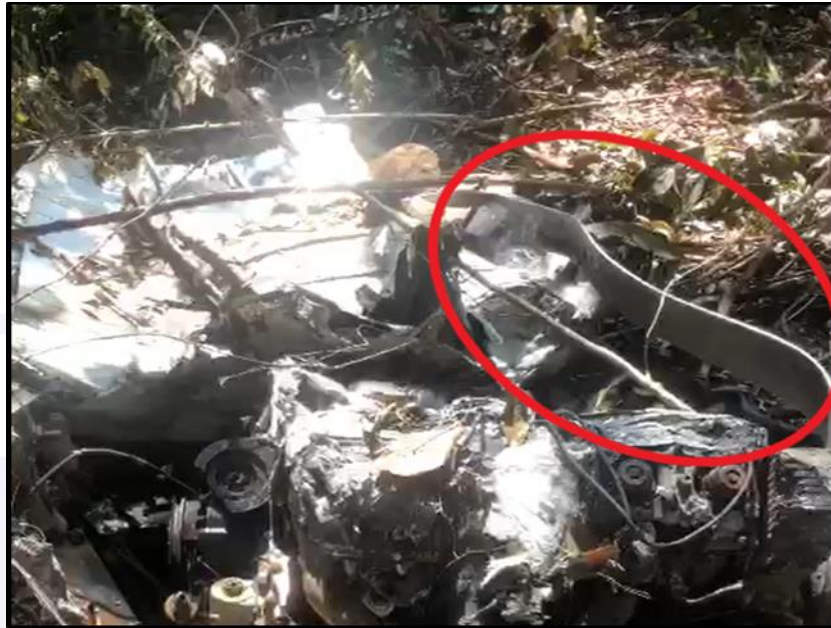
After the impact, the aircraft caught fire, together with its powerplant, which received severe damage. The propeller blade, seen in Figure 7, presented a backward bending, compatible with collision against obstacles.

Figure 7 – Aircraft powerplant and one of the propeller blades in highlight.

Since the powerplant was severely damaged by the post-impact fire, it was not possible to determine whether there was a failure of the *SN 451946 Teledyne Continental Motors (TCM) O-470-R* engine, as well as of the magnetos, cabling harnesses and igniters.

Upon assessment of the condition of one of the aircraft's propeller blades, the investigators observed evidence compatible with vertical travel of the aircraft until impact with the ground; however, it was not possible to determine whether the engine was developing propulsive power at the time of impact.
