COMANDO DA AERONÁUTICA
CENTRO DE INVESTIGAÇÃO E PREVENÇÃO DE
ACIDENTES AERONÁUTICOS

FINAL REPORT
A-071/CENIPA/2022

OCCURRENCE:	ACCIDENT
AIRCRAFT:	PT-JUM
MODEL:	182P
DATE:	15JUN2022

This is the Final Report of the June 15, 2022, accident involving the 182P Cessna aircraft of registration marks PT-JUM. The occurrence was typified as “[ARC] Abnormal runway contact.”

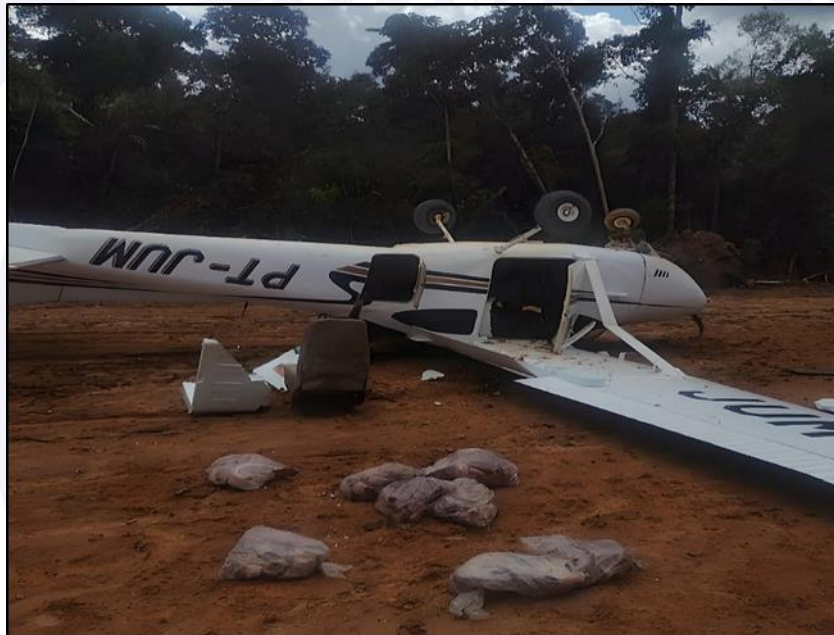
During the landing roll, the aircraft tipped over and overturned. (Figure 1).

Figure 1 - Side view of the aircraft after the accident, and the cargo it was transporting.

According to reports, the PT-JUM airplane was found in one piece, with flaps fully extended, showing damage to the nose landing gear and to the tips of the propeller blades.

According to information, the cargo being transported was found on top of the pilot inside the cockpit.

The transported cargo was thrown forward inside the aircraft during the overturn and was found on top of the pilot, suggesting it had not been properly secured, and ended up shifting and striking the pilot.

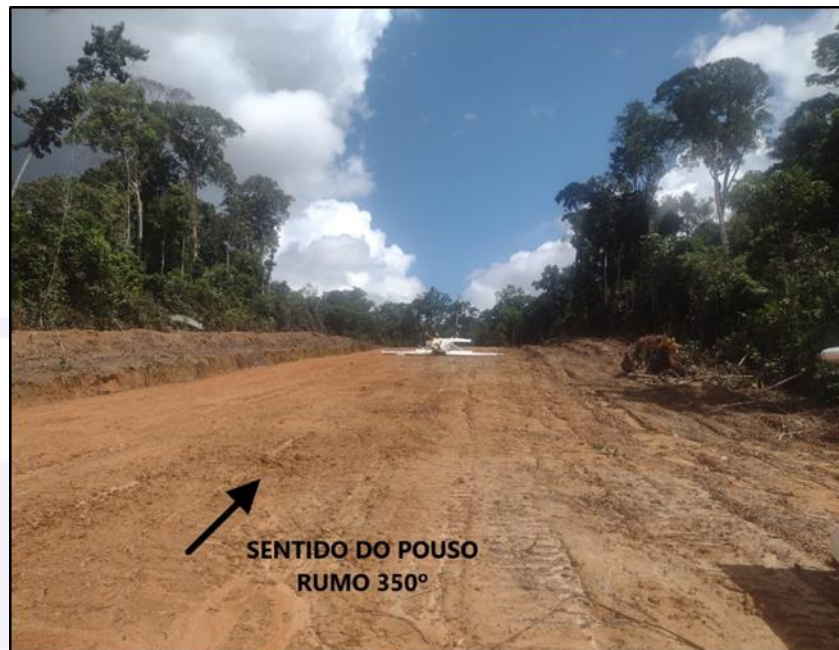
The occurrence took place at the unregistered airstrip of the *Estrela do Norte* mining site, in the municipality of *Itaituba*, State of *Pará*, which reportedly had potholes and a waterlogged (muddy) surface, as described by the pilot who visited the crash site.

According to this report, on the approach path for landing (heading 350°), the first 100 meters of the runway were level, followed by a 150-meter uphill slope. The runway was approximately 40 meters wide (Figures 2 and 3).

Figure 2 - View of the aircraft and of the runway in the direction of landing.

However, in accordance with information obtained, the physical conditions of the airstrip on the day of the accident were not suitable for safe operation, as it contained potholes and mud resulting from heavy rains in the previous days.

Based on the reported dynamics of the aircraft flip over forward and the substantial damage to the nose landing gear, one raised the hypothesis that, during landing, the aircraft came across a pothole or a muddy area, which caused it to flip over.

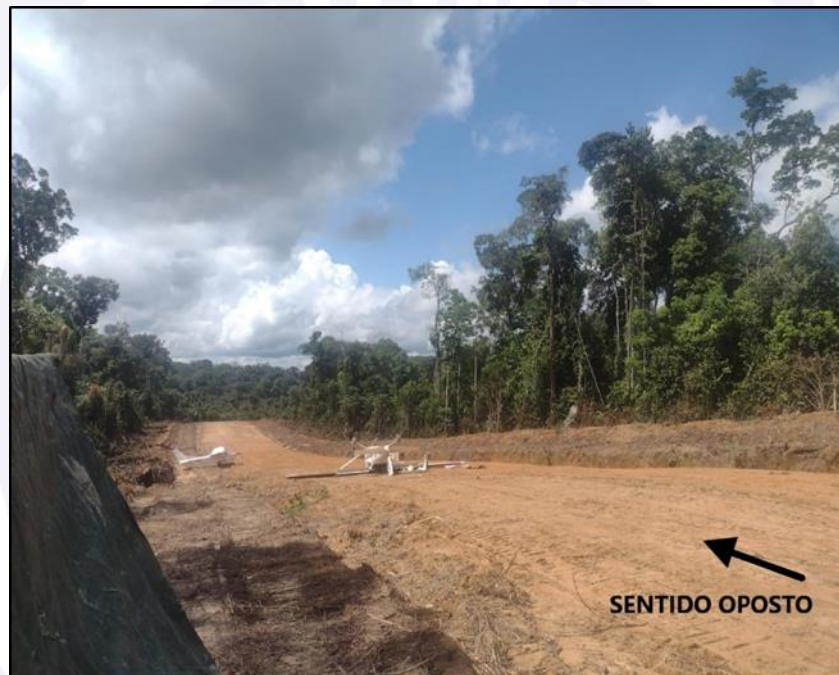
Figure 3 - View of the aircraft and of the runway in the direction opposite to landing.
