COMANDO DA AERONÁUTICA
CENTRO DE INVESTIGAÇÃO E PREVENÇÃO DE
ACIDENTES AERONÁUTICOS

FINAL REPORT
A-160/CENIPA/2020

OCCURRENCE:	ACCIDENT
AIRCRAFT:	PT-KCK
MODEL:	177B
DATE:	29DEZ2020

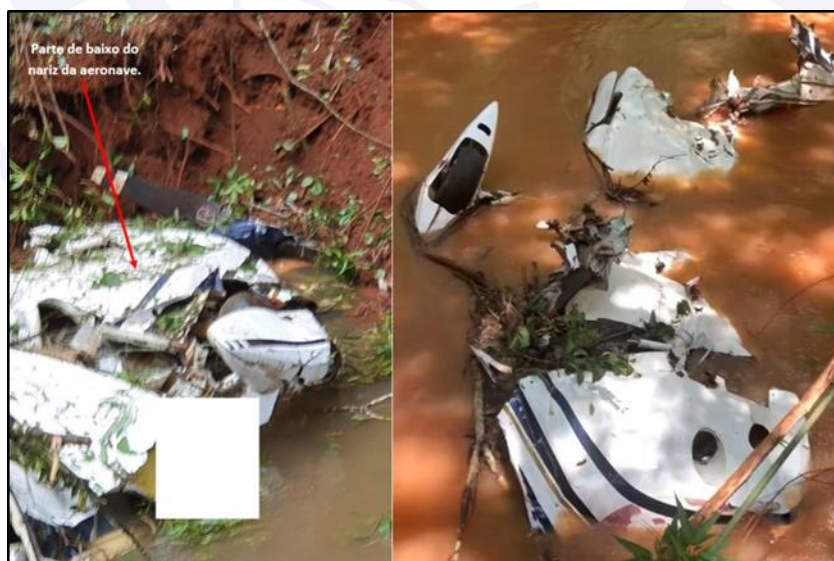
The aircraft was destroyed in the crash (Figure 1).

Figure 1 – Upside-down view of the aircraft, and view of the aircraft submerged in the river.

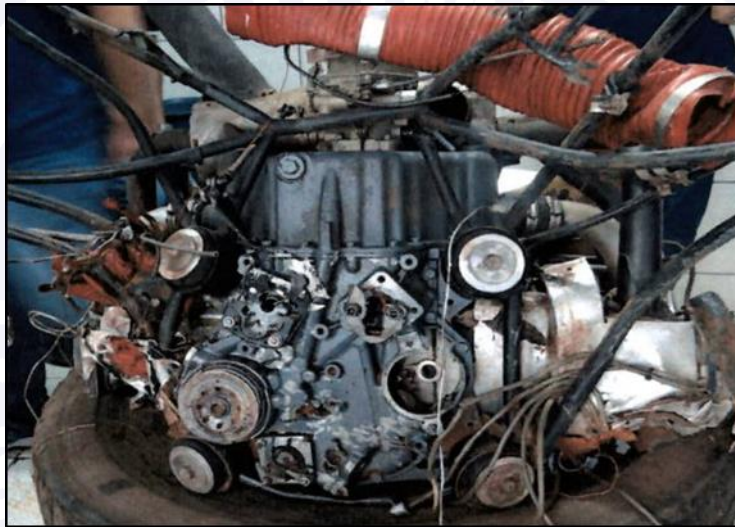
In the initial analysis, investigators verified that the damage sustained by the engine resulted from the PT-KCK accident. In addition, they found a large amount of clay inside the engine, due to the fact that the aircraft was found submerged in a river. Some components, such as magnetos, main oil filters, and the fuel pump, were ripped off their housing at the moment of impact with the ground, as shown in Figure 15.

Figure 15 - Rear view of the engine.

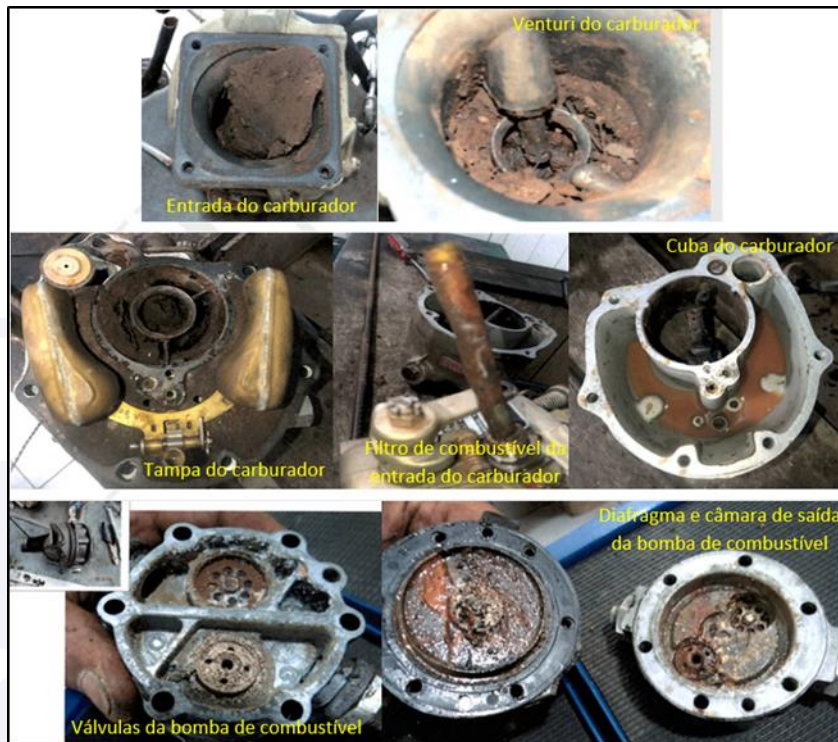
As for the fuel system, one was not able to perform functional tests of either the carburetor or the fuel pump. In the carburetor, a large amount of earth, mud and water was found inside the vat. In the fuel pump, one observed that the pump body had broken as a result of the impact. After the pump was disassembled, corrosion was observed on account of the presence of water in its interior.

Figure 16 - View of engine components.

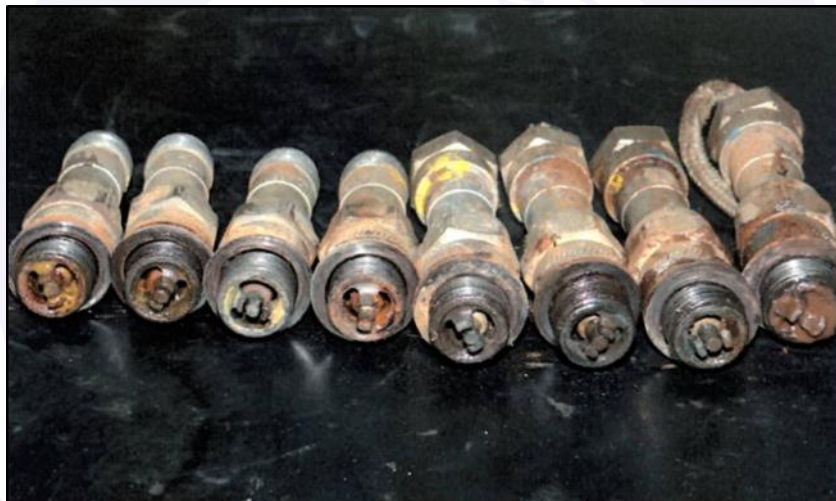
In the ignition system, only the spark plugs were examined, since the magnets were not found. The spark plugs analyzed had an aspect and color indicative of normal operation.

Figure 17 – General view of the spark plugs.

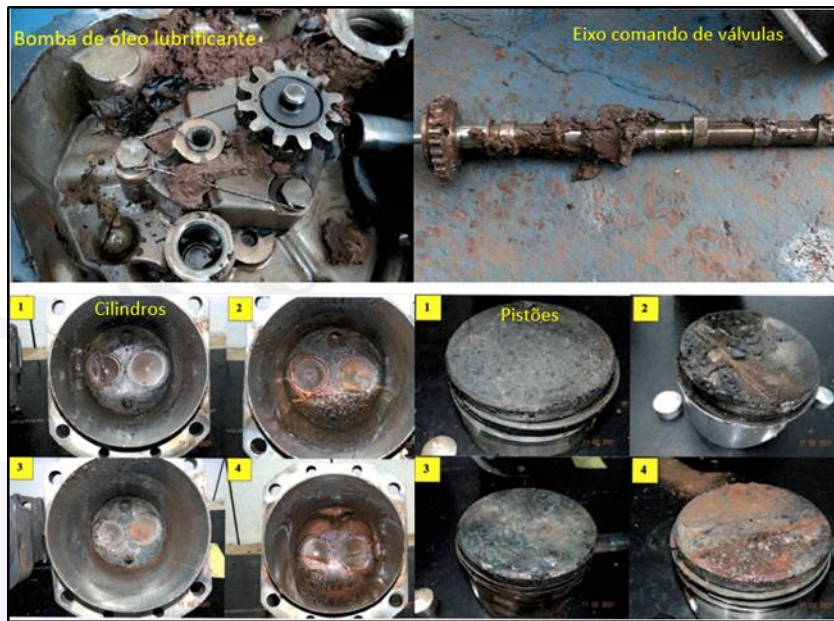
Regarding the cylinders and pistons of the engine, an attempt was made to identify aspects such as marks, pre-ignition, lubrication, and detonation. However, no abnormality was found, except for the existence of oxidation of the components due to the presence of water inside the cylinders, as shown in Figure 18.

Figure 18 - View of engine components.

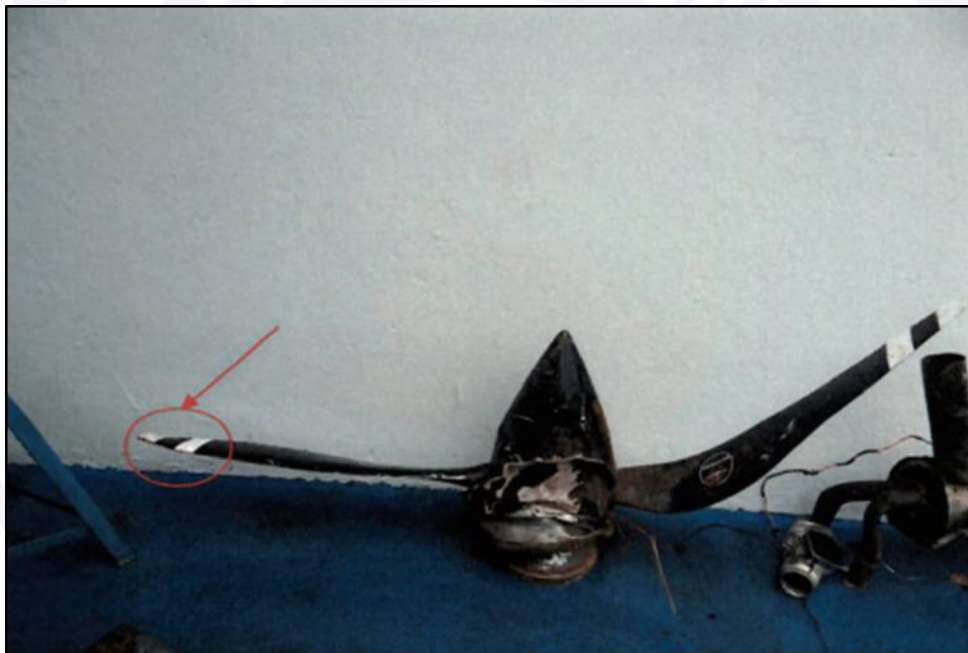
The propeller was the component showing evidence of normal engine operation at the moment of the accident: a slight forward bend, observed at the tip of one of the blades, indicated by the arrow and highlighted by the circle (Figure 19).

Figure 19 - General view of the propeller, with one blade showing a slight forward bend (left), while the other blade had a more accentuated forward bend close to its root.

The bend of the other blade (right) close to its root may be explained by the inertia of the aircraft, which, while still in motion, may have moved over the propeller with the blade caught in some obstacle.

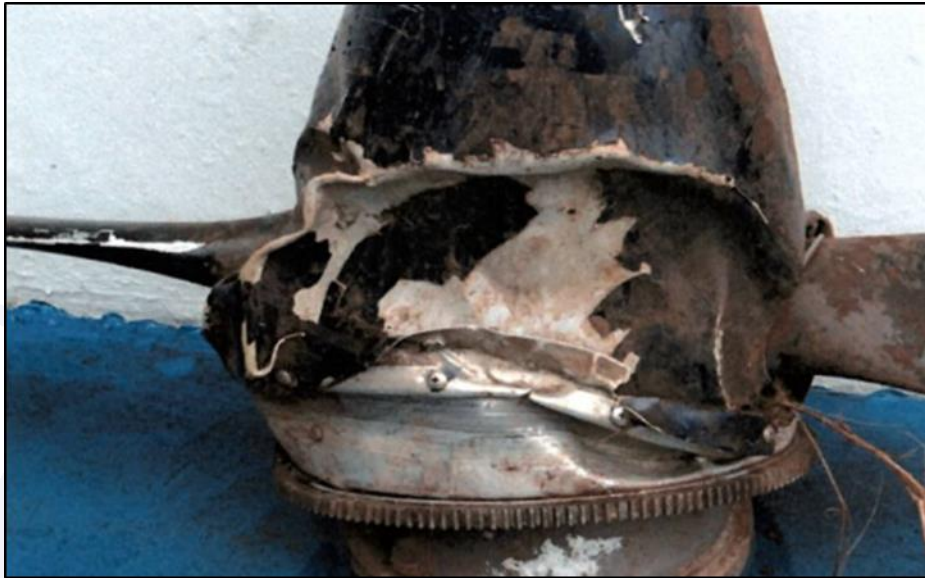
The left blade was probably the first to collide with the obstacle, and then the spinner impact occurred, leaving the mark shown in Figure 20. There was also a rupture of the crankshaft next to the coupling flange with the propeller.

Figure 20 - Mark on the spinner.

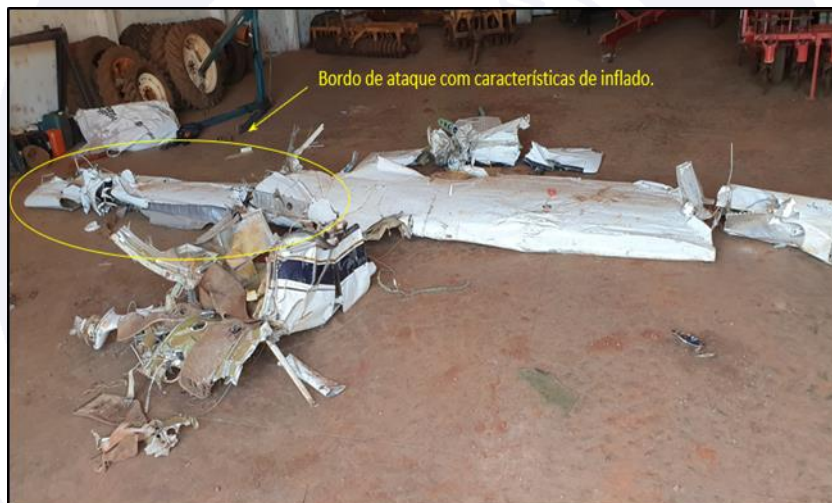
At the analysis of the aircraft wreckage, it was verified that the right-hand wing had separated in flight, and that its leading edge was inflated from the inside out, as shown in Figure 21.

Figure 21 - View of the aircraft, reassembled after the initial action, with details on the leading edge of the right wing, which showed characteristics of inflation.

They verified that all the material analyzed presented failure characteristics typical of overload. The right-hand wing featured overload on the lower spar, in the riveted region of the trailing edge, and breakage of the wing-tip fairing also due to overload.

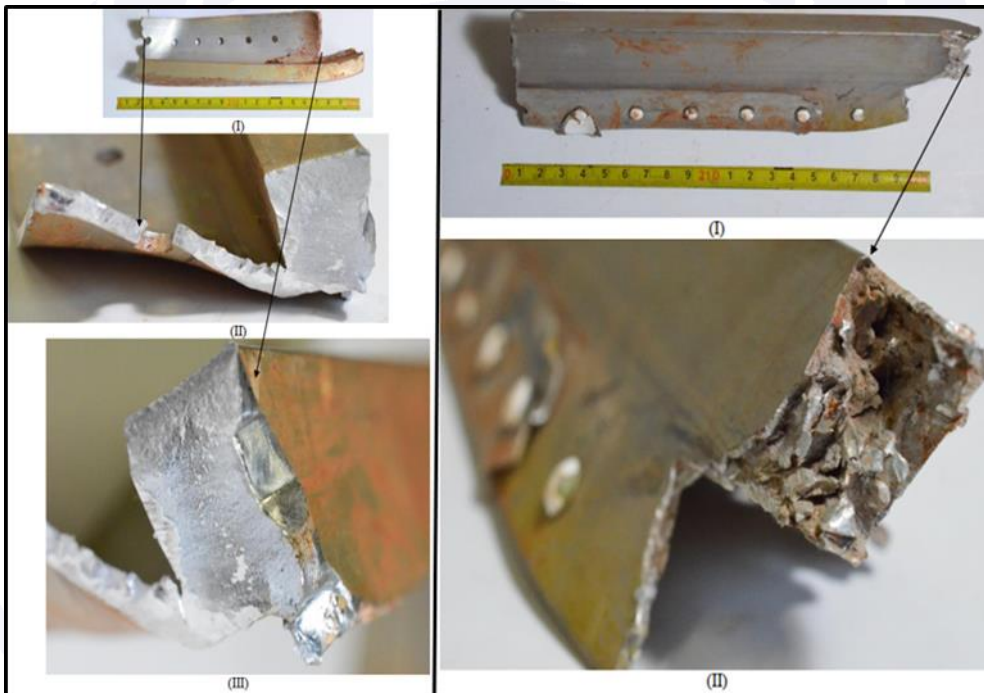
In the analysis of the support structures of the right-hand wing, as shown in Figure 22, in the fragments of the lower right-hand spar, it was possible to observe details of surfaces with fracture characteristics consistent with overload.

Figure 22 - Fragments of the lower right-hand spar. In (I) an overview, in (II, III) detail of surfaces with fracture characteristics compatible with overload.

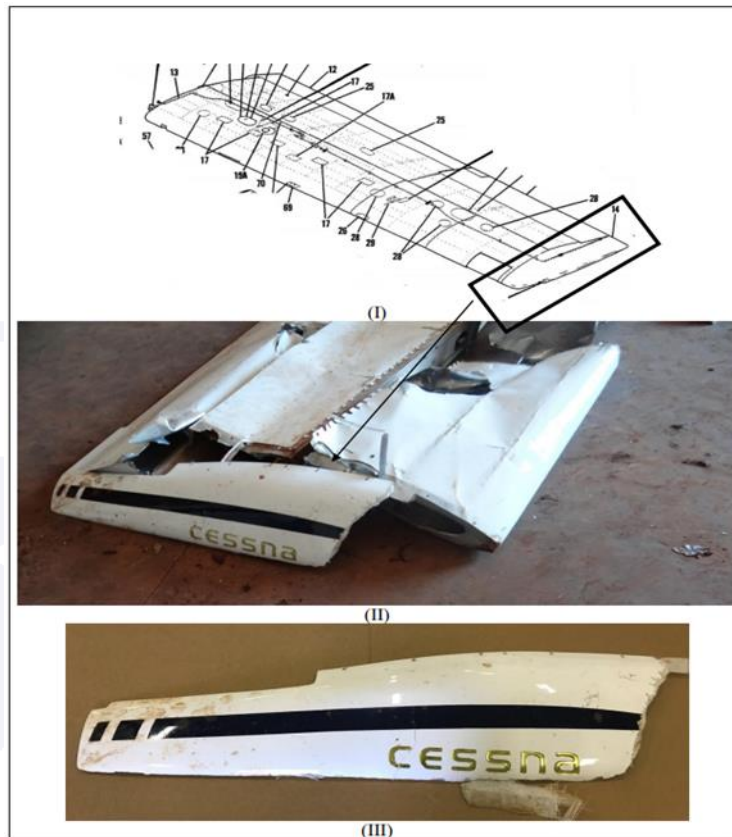
Figure 23 - Schematic view of the wing (I), mockup of the right wing (II), and detail of the fractured fairing (III).

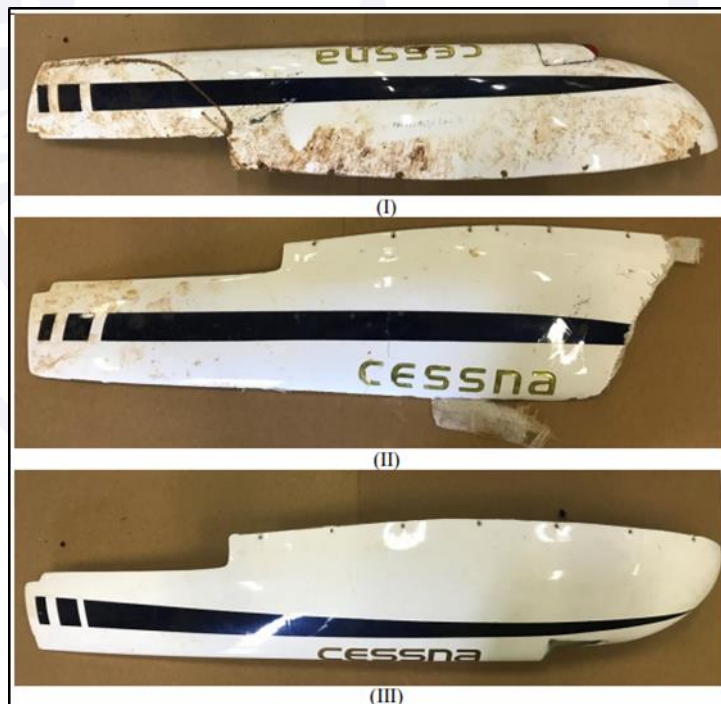
The right and left wingtips equipping the PT-KCK at the time of the occurrence were identified, compared, and analyzed, as well as another right wingtip which had formerly equipped the aircraft prior to the accident (Figure 24).

Figure 24 - Fairing of the left-wing tip (I); fractured fairing of the right-wing tip (II); and original fairing that had equipped the PT-KCK prior to the accident (III).

After verifying that the thickness of the wing-tips equipping the aircraft (1.50 mm) was not the same as the thickness of the replaced right-wing tip (3.50 mm) that once equipped the aircraft prior to the accident, the investigation committee identified that the thinner right-wing tip had been purchased from a company named *Aeroservice Comércio de Peças e Importação Ltda.*, according to the Electronic Invoice (NF-e) no. 6084, series 1, issued on 03Sep2020, as described below:

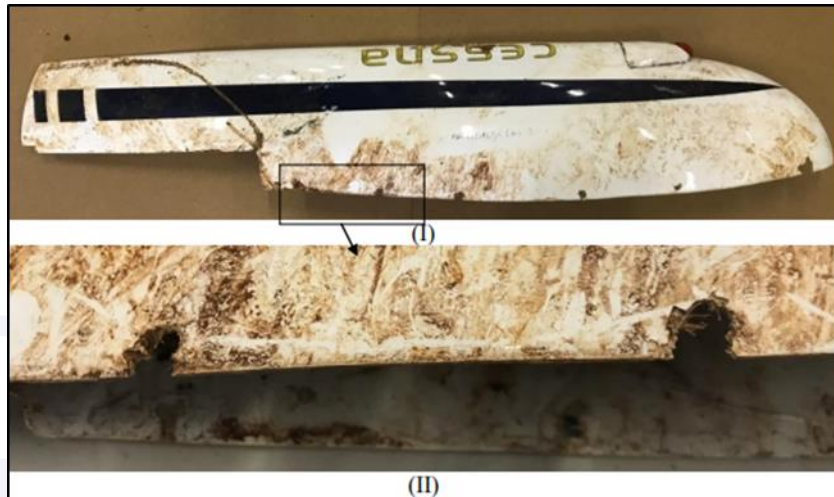
Upon analysis of the fairings of the left- and right-wing tips, it was found that both had overload-related tears in the riveted region, and that the average thickness of the material (measured by means of a caliper) was 1.50 mm (Figures 25 and 26).

Figure 25 - Details of the left-wing tip fairing, emphasizing the overload tears in the riveted region.

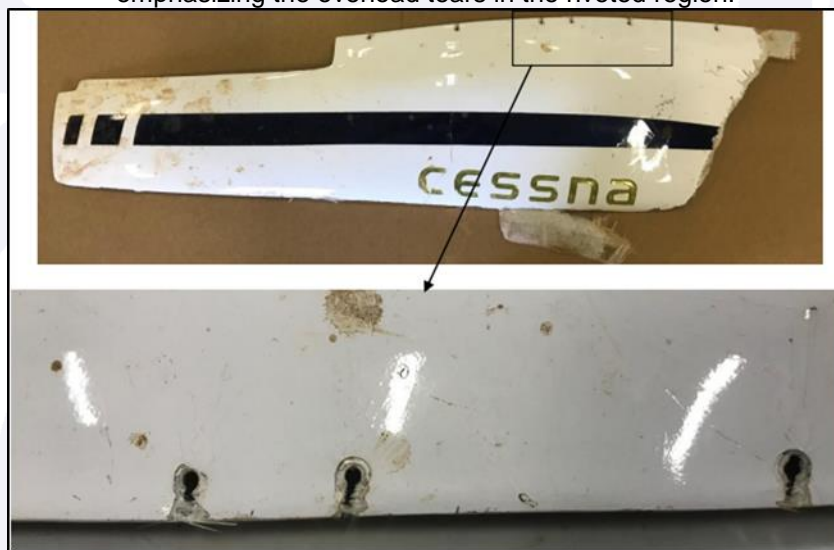
Figure 26 - Details of the right-wing tip fairing, emphasizing the overload tears in the riveted region.

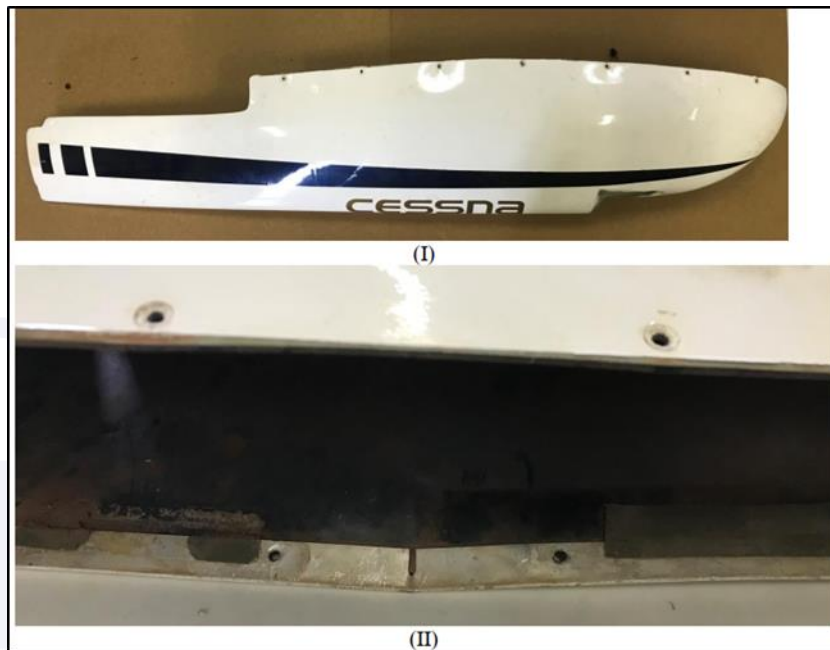
By means of a digital caliper, it was verified that the average thickness of the original part was 3.50 mm (Figure 27).

Figure 27 – Right-wing tip that ha equipped the aircraft prior to the accident (I); detail of the holes for fairing attachment (II).

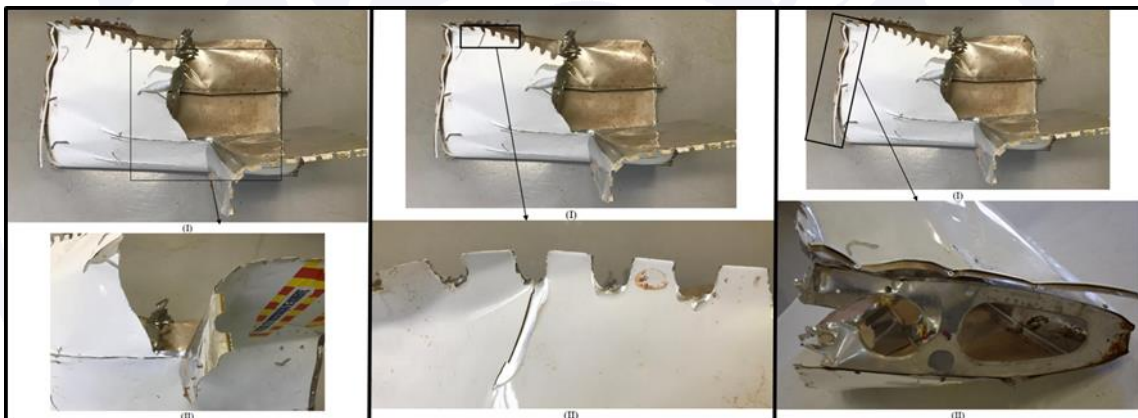
It was also observed that the wing surfaces in contact with wingtip fairings showed fractures with overload characteristics (Figure 28).

Figure 28 - Overview of a fractured surface (I), and details of the fractured surfaces with overload characteristics (II).
