COMANDO DA AERONÁUTICA
CENTRO DE INVESTIGAÇÃO E PREVENÇÃO DE
ACIDENTES AERONÁUTICOS

FINAL REPORT
A-190/CENIPA/2013

OCCURRENCE:	ACCIDENT
AIRCRAFT:	PT-KGK
MODEL:	PA-34-200
DATE:	21OCT2013

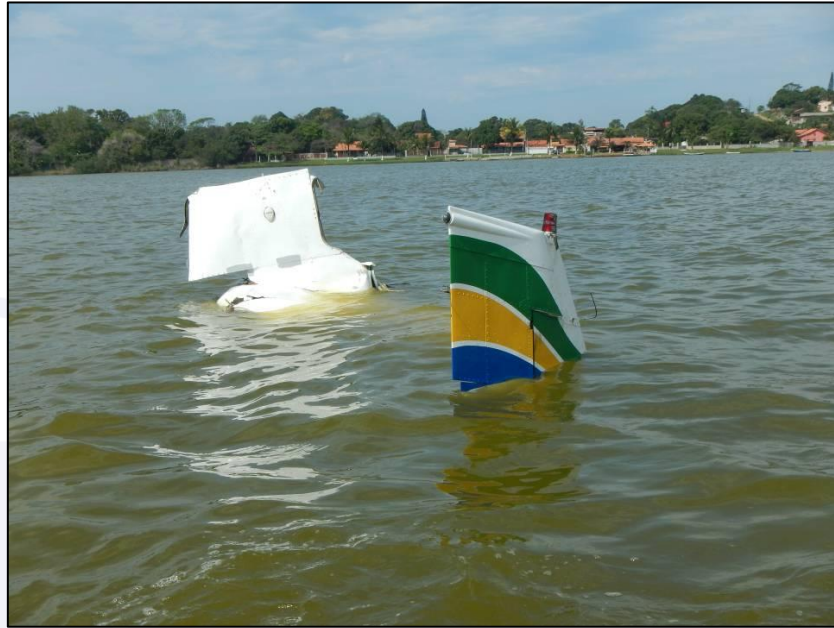
The aircraft wreckage remained partially submersed (Figure 2).

Figure 2 - Aircraft wreckage partially submerged in *Maricá* Lagoon.

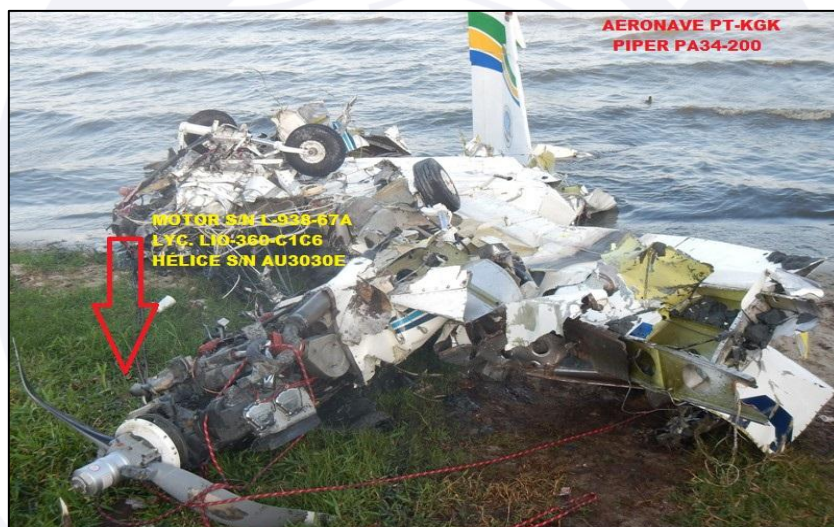
After the aircraft was removed from the lagoon, only the right engine was found with the main part of the wreckage. The left engine was missing (Figure 3).

Figure 3 - Aircraft wreckage after retrieval from *Maricá* Lagoon with only the right engine.

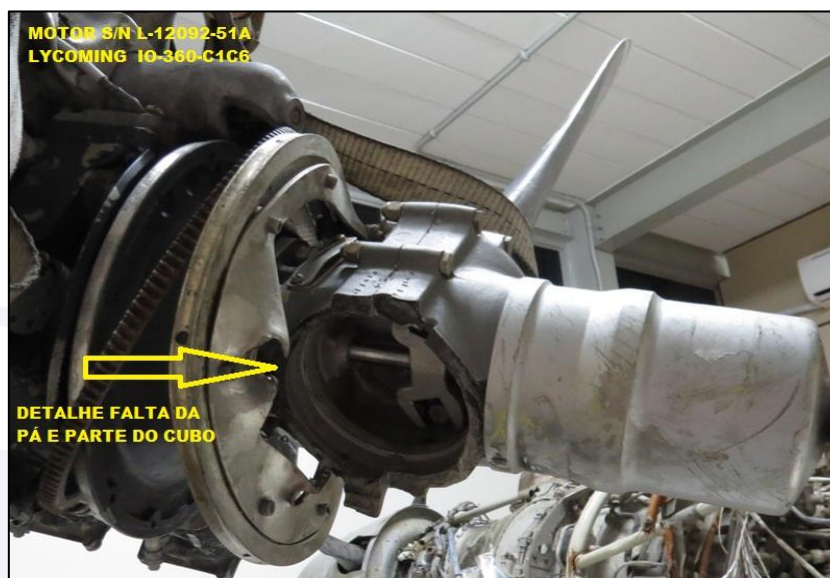
A new search was made in the lagoon, and the left engine was eventually found. Part of the propeller-hub and one of the blades had detached and were missing (Figure 4).

Figure 4 - Left engine without one of the blades and part of the propeller-hub.

Despite many attempts, the missing parts of the left propeller could not be found, on account of the poor visibility under the water and the large area of the lagoon.

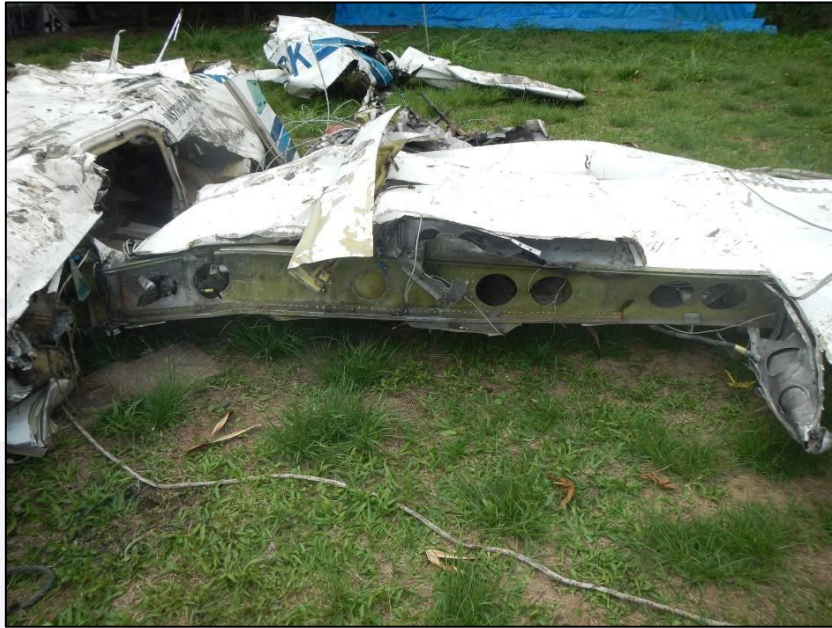
During the reconstitution, the investigating committee observed that the left wing did not have the engine nacelle and the supporting structure of the engine cradle (Figure 6).

Figure 6 - Part of the left wing, without the engine nacelle.

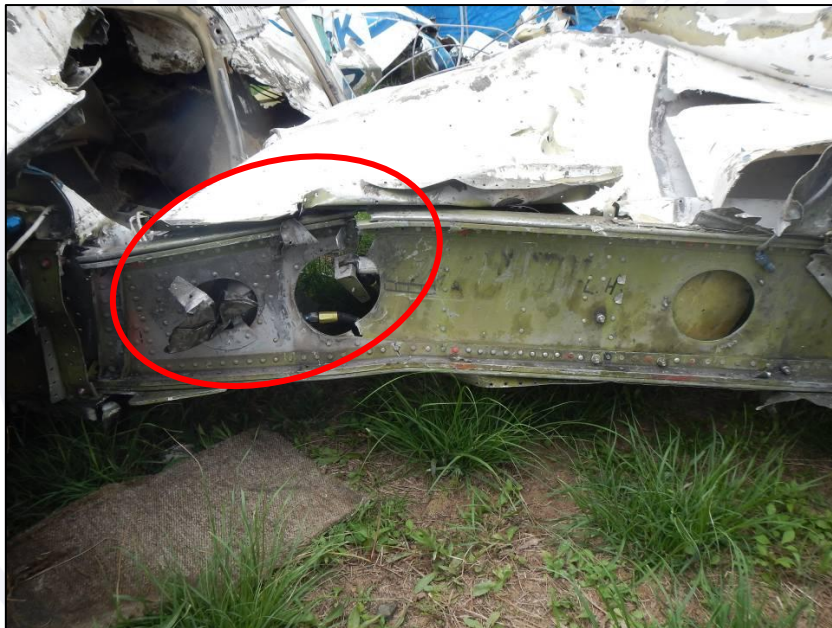
The left wing spar had a breakage at the attachment points of the engine nacelle (Figures 7 and 8).

Figure 7 - Aspect of the left wing spar at the point of attachment of the engine nacelle.

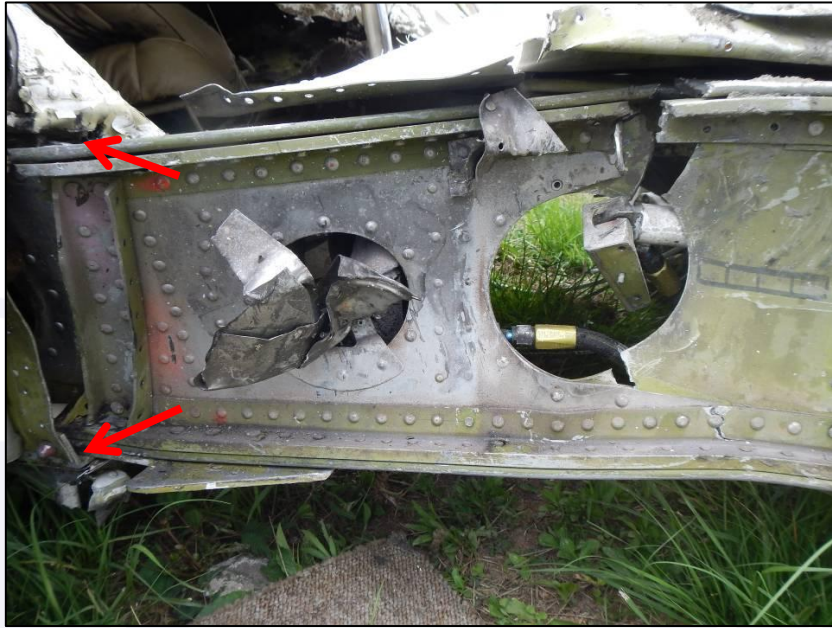
Figure 8 - Aspect of the engine nacelle attachment points.

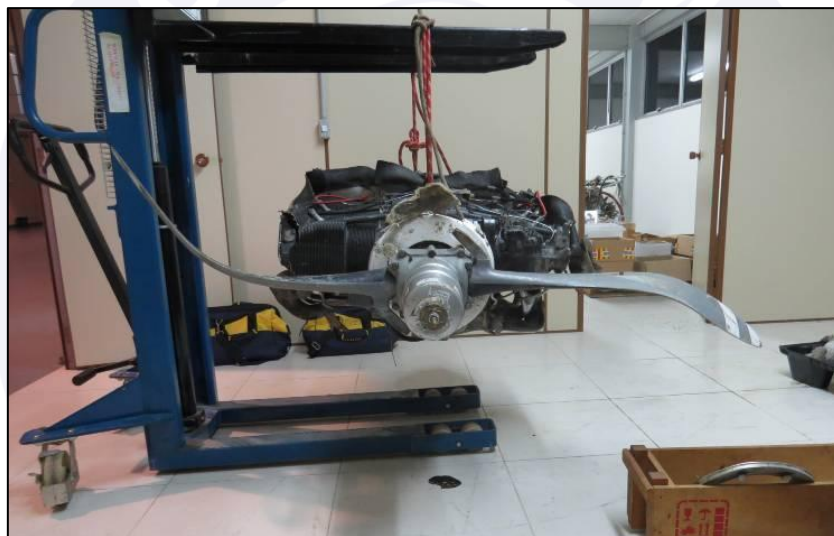
- The nuts of the stop minimum pitch valves of both propellers presented torque values well above the manufacturer's specification;
- The propeller blades of the engine number 2 were bent (Figure 9);
- The propeller-hub closing screws, being six in the intact hub (propeller #2) and four remaining in the fractured hub (propeller #1), had excessive torque;
- The four closing screws which remained in the fractured hub (#1) did not have the sealing marks made after application of the torque during the process of assembly (line of faith); and
- The 3 grease nipples of the fractured hub (#1) appeared to have different values of thickness and different spiral threads.

Figure 9 - Number-2 engine bent propeller blades.

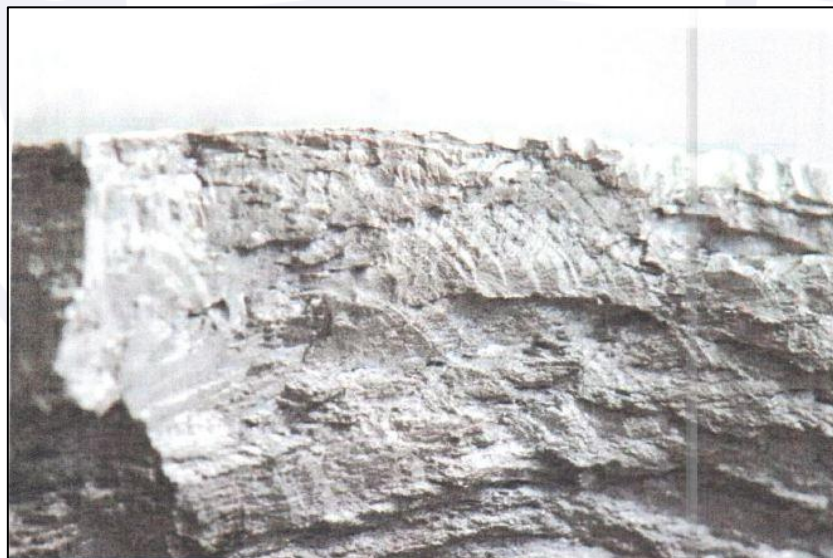
The result of the analysis was that the surface of the fracture of the propeller-hub had characteristics of failure due to fatigue (Figure 11), and that the grease nipples had differences, being two of them equal to each other, while the third one was of different size, thickness, and thread (Figure 12). In spite of the differences, one verified that the nipples seemed not to have connection with the origin of the fracture which resulted in the hub failure.

Figure 11 - Propeller-hub fracture surface showing characteristics of fatigue.

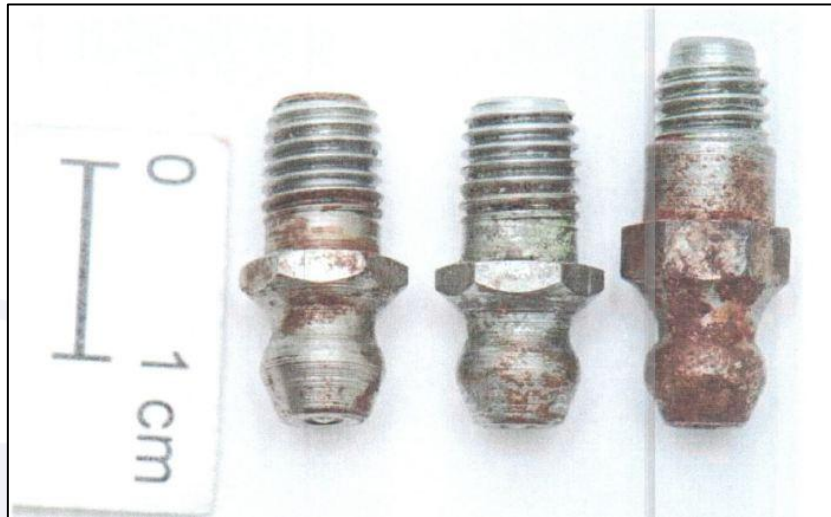
Figure 12 - Difference between the nipples.

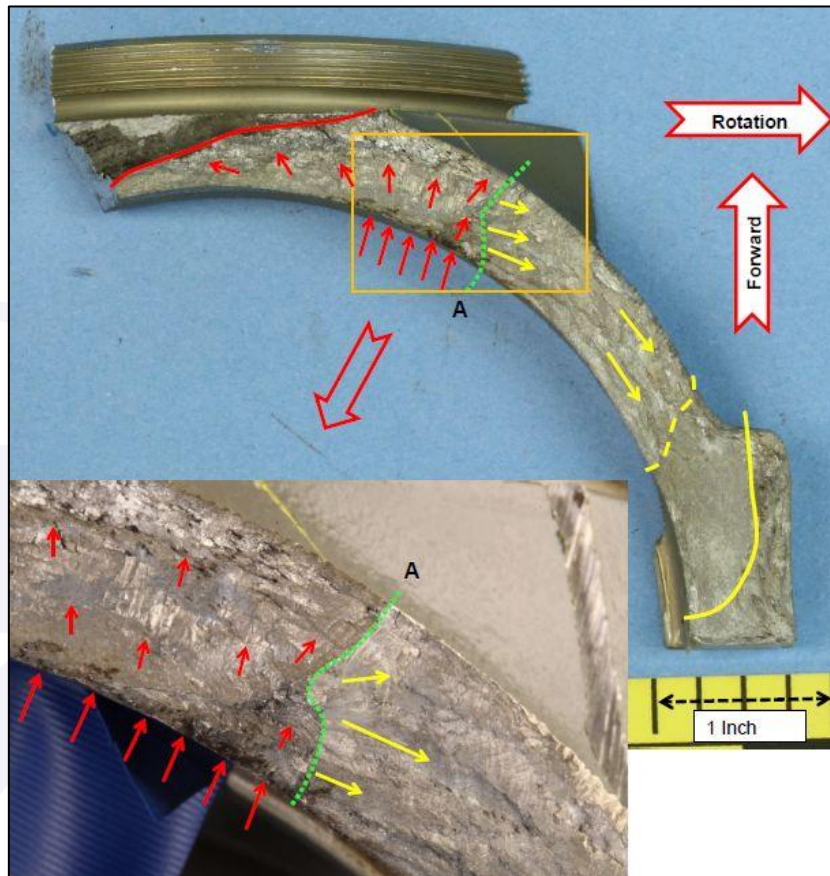
The report identified two breakage areas, a primary one (yellow arrows) and a secondary one (red arrows), with different lines of propagation, separated by a linear element represented by the green dotted line and identified by the letter "A" (Figure 13).

Figure 13 - Front view of the hub fracture region. The image in the background shows the whole fracture region, with two breakage areas and distinct forms of propagation separated by a green dotted line. In detail, in the foreground image, an augmented view of the fracture area.

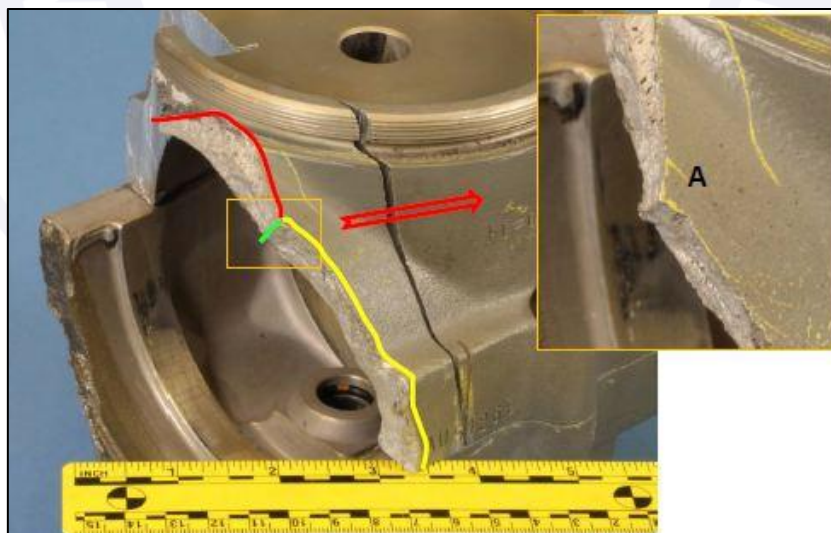
The NTSB report also showed the lines of breakage (red and yellow), as viewed from above, together with the linear element separating the typed of propagation (green), and highlighting the geometrical peak identified by the letter “A” (Figure 14).

Figure 14 - Fractured hub viewed from above, showing the lines of breakage (yellow and red), together with the linear element (green) separating the types of propagation. In the highlight, the geometrical peak identified with the letter “A”.

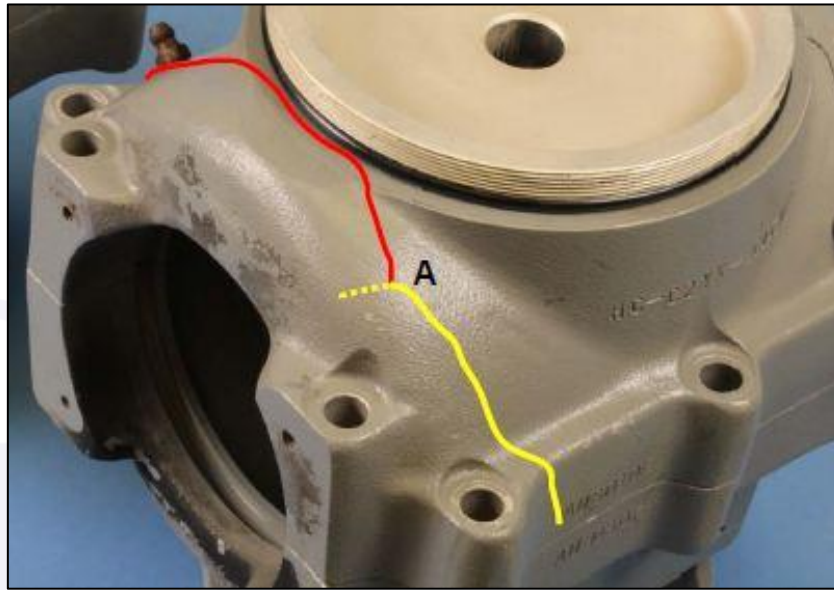
Additionally, the reported simulated the lines of breakage on an intact hub, indicating an unknown area of the missing part of the fractured hub as the point of origin of the fracture (Figure 15).

Figure 15 - An intact hub as viewed from above showing superimposed lines of breakage. The material of the hub to the left of the lines was not recovered. The dotted yellow line indicates an unknown part of the origin of the breakage.

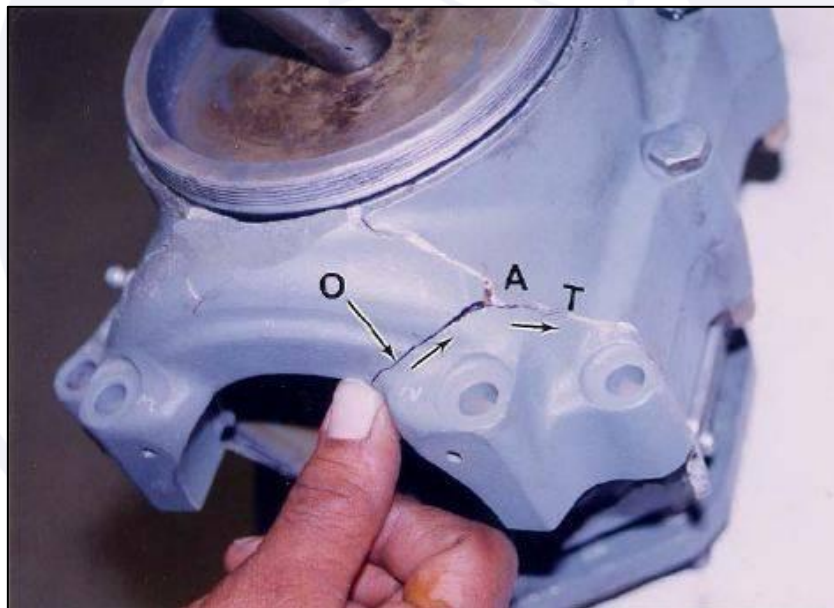
The NTSB report stated that the fracture pattern present in the left engine propeller-hub of the PT-KGK aircraft was very similar to the failure which occurred with another Hartzell HC-C2YR-2CUF propeller-hub (SN AU4504) in Panama Republic on 21 July 2009 (Figure 16), mainly in relation to the characteristics and location of the point “A” in both cases.

Figure 16 - The image shows the similarities between the two events. The hub parts were placed together to show the origin of the fracture (point “O”) and the direction of the failure propagation, indicated by the arrows. The point “A” and the end of the fatigue are identified by the letters “A” and “T”, respectively.
