COMANDO DA AERONÁUTICA
CENTRO DE INVESTIGAÇÃO E PREVENÇÃO DE
ACIDENTES AERONÁUTICOS

FINAL REPORT
A-024/CENIPA/2021

OCCURRENCE:	ACCIDENT
AIRCRAFT:	PT-KQE
MODEL:	A36
DATE:	13FEV2021

This is the Final Report of the 13 February 2021 accident with the A36 aircraft, registration marks PT-KQE. The accident received the typification of “[SCF-PP] Engine failure or malfunction | In-flight engine failure”.

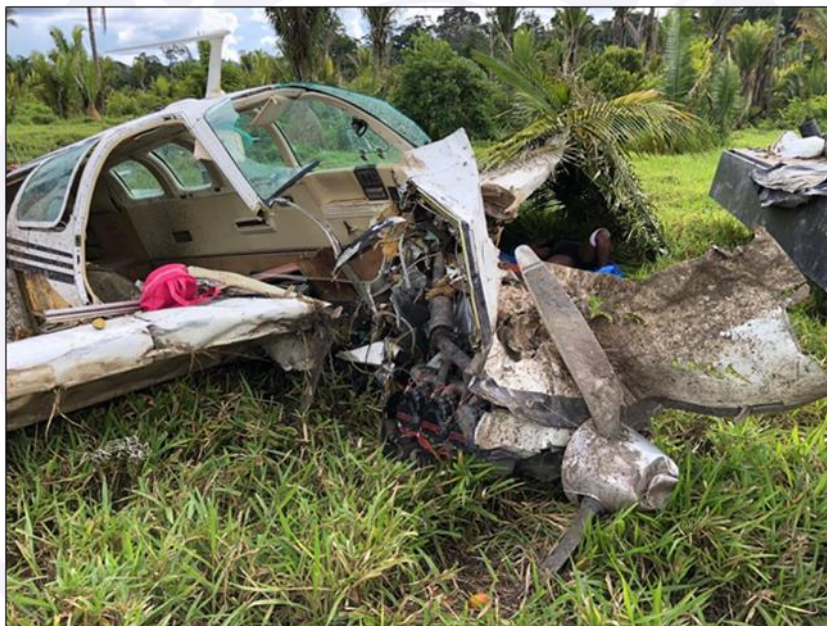
Figure 1 – The aircraft after the occurrence.

The aircraft sustained substantial damage to its entire structure after colliding with trees and subsequently with the ground.

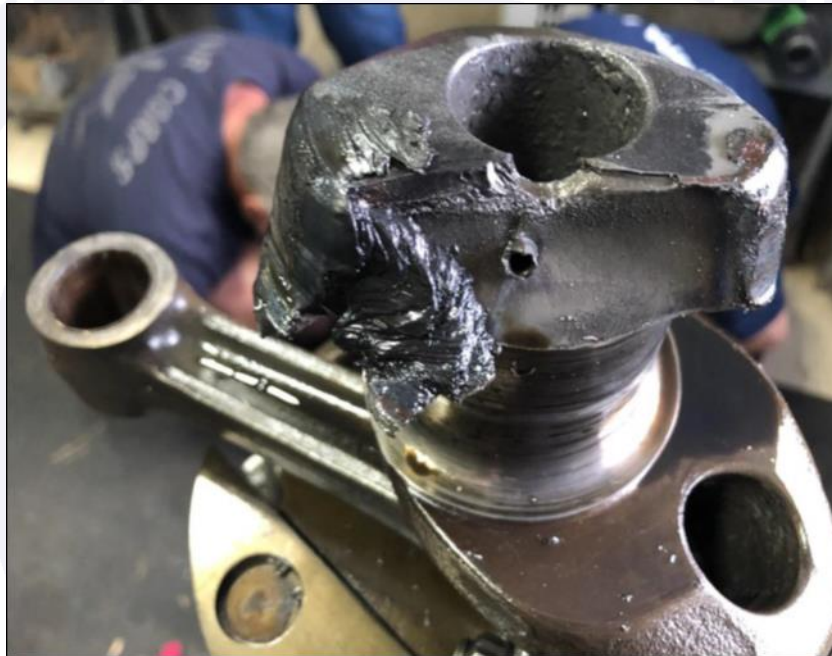
In the examination of the engine block and its components, one verified that the dynamic counterweights were intact, however, there was fragmentation of the crankshaft next to the second trunnion, close to the connecting rod of the cylinder number 2. Due to such fragmentation, the broken shaft degraded the bearing of the second trunnion, as well as its housing in the block (Figure 7).

Figure 7 - Fracture in the crankshaft.

Such flaws explain the presence of filings and chips distributed by the block and gears of activation of the accessories. Likewise, the broken crankshaft damaged the actuation tappet of the intake valve of the cylinder no. 1, besides warping the camshaft.

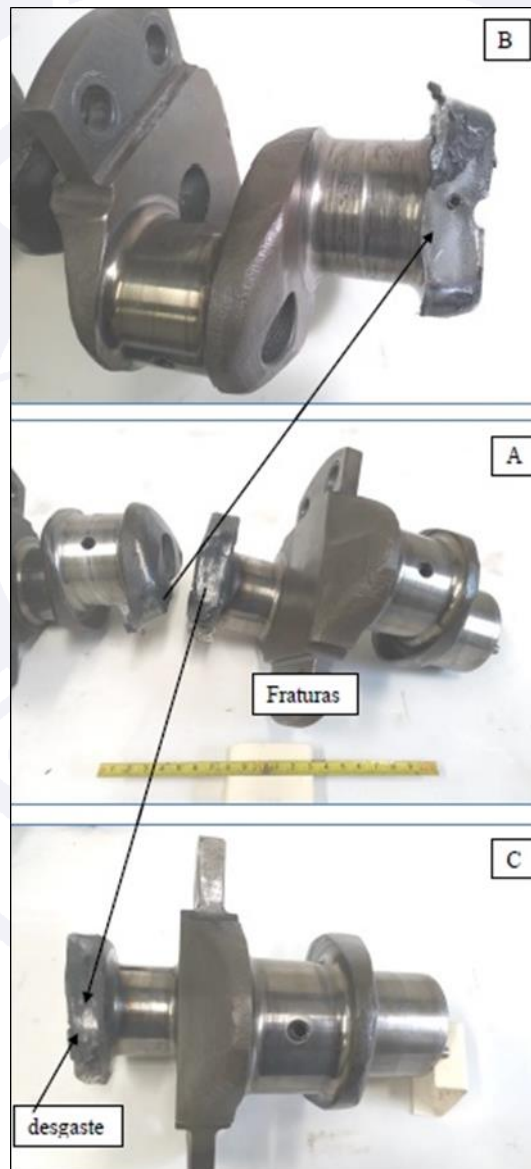
In the visual exams of the crankshaft, one observed that the fracture occurred in the region of the concordance radius, the place of stress concentration. The damage observed on both sides of the fractures, such as friction-related wear-off, and discoloration from overheating, indicated that the fracture occurred during the operation of the aircraft (Figure 8).

Figure 8 - General view of the fracture region (A).
Details of fracture regions (B and C).

The analysis also showed that the fracture in the crankshaft occurred during the operation of the aircraft, that is, it was not caused by the impact with the ground.

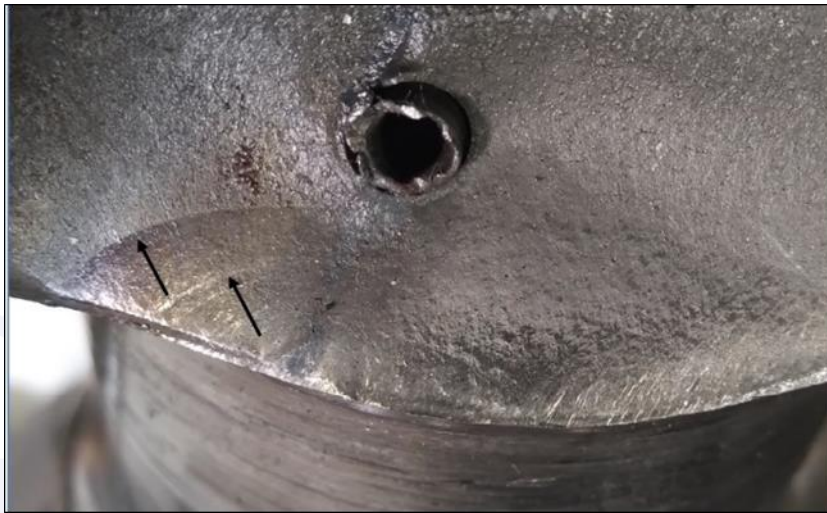
In the stereoscopic examinations performed on the crankshaft, one observed beach marks indicative of failure resulting from the fatigue mechanism (Figure 9).

Figure 9 - Examination by means of stereoscopy. In the detail of the fracture surface, one observes beach marks indicative of fatigue (arrows).

From the results obtained, one may affirm that the crankshaft failed due to a fatigue mechanism. It was not possible to determine, however, the origin of the fatigue, on account of the damage sustained by the component after the fracture.

The analysis of the fragmented crankshaft established that the failure was the result of a fatigue mechanism, but it was not possible to determine its origin due to the damage sustained by the component after the fracture.
