FINAL REPORT
A-105/CENIPA/2023

OCCURRENCE:	ACCIDENT
AIRCRAFT:	PT-KUM
MODEL:	170A
DATE:	19JUN2023

This is the Final Report of the June 19, 2023, accident involving the model 170A aircraft of registration marks PT-KUM. The occurrence was typified as “[SCF-PP] Powerplant failure or malfunction.”

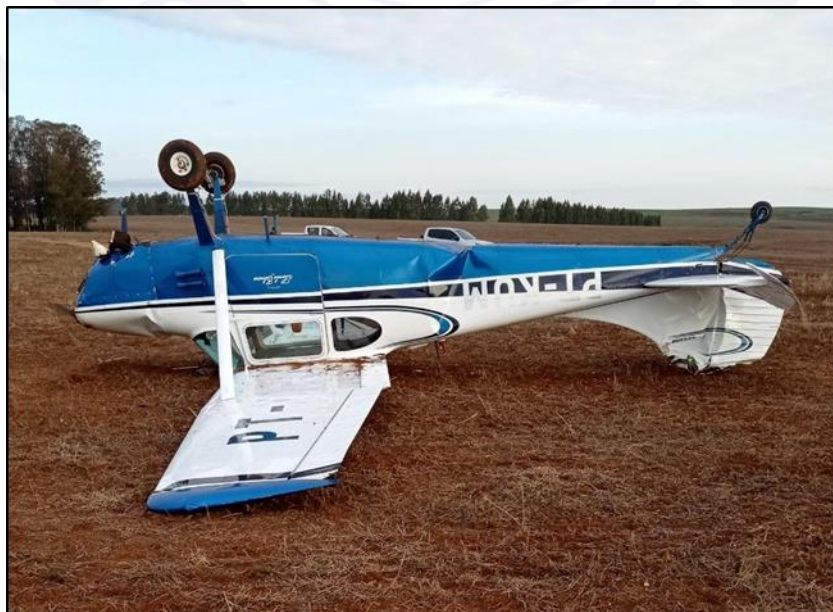
Figure 1 – General view of the aircraft after the accident.

There was substantial damage to the aircraft, including to the powerplant system, fuselage, tail cone, and vertical stabilizer.

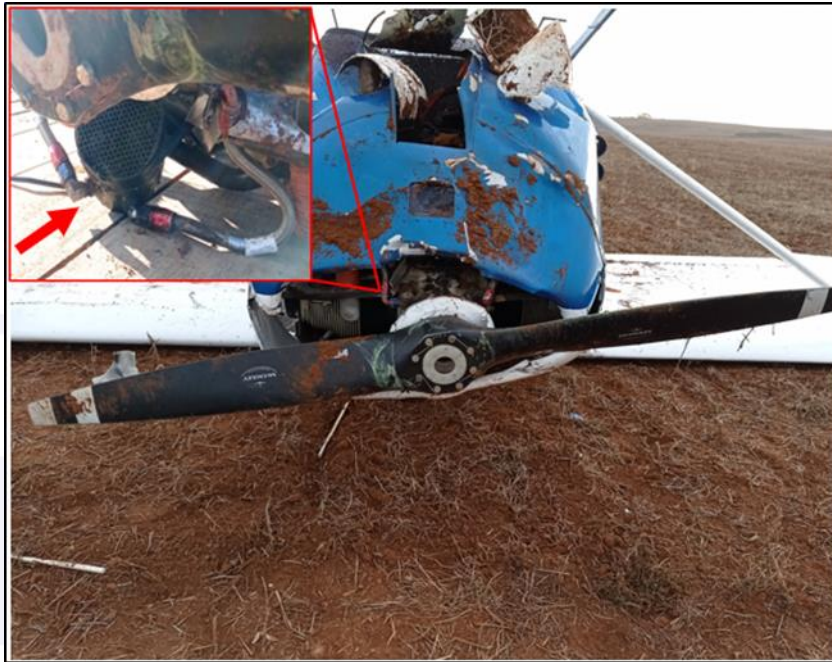
During the investigation, it was verified that the PT-KUM airplane was equipped with a heat exchanger (radiator) installed at the front of the engine, which was different from the component originally certified in the aircraft manufacturer's design. According to reports, this was an alternative cooling system installed at the request of a previous owner.

There was no identification on the mentioned item, nor any records regarding its manufacturing date, installation on the aircraft, or any maintenance activities performed on the component.

Figure 4 – Frontal view of PT-KUM. In highlight, the item found after the engine cowling was removed.

It was observed that modifications had been made to the system originally developed by the manufacturer, with the installation of a heat exchanger device for engine oil cooling. The item did not have any type of identification. Furthermore, there were no records regarding its manufacturing, installation, or maintenance, in violation of the RBAC-45, which was in force at the time of the accident.

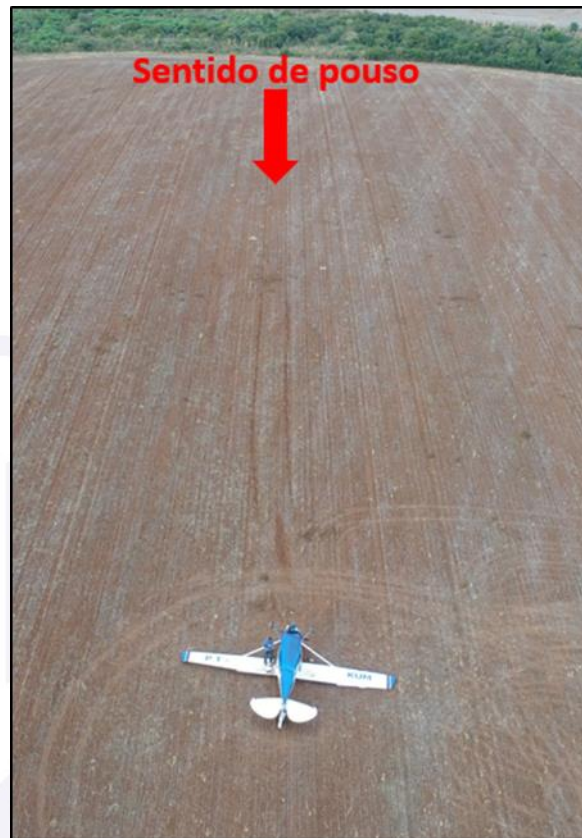
Figure 5 – Aerial view of the aircraft.

While landing, the aircraft overturned and came to rest in an upside-down position.

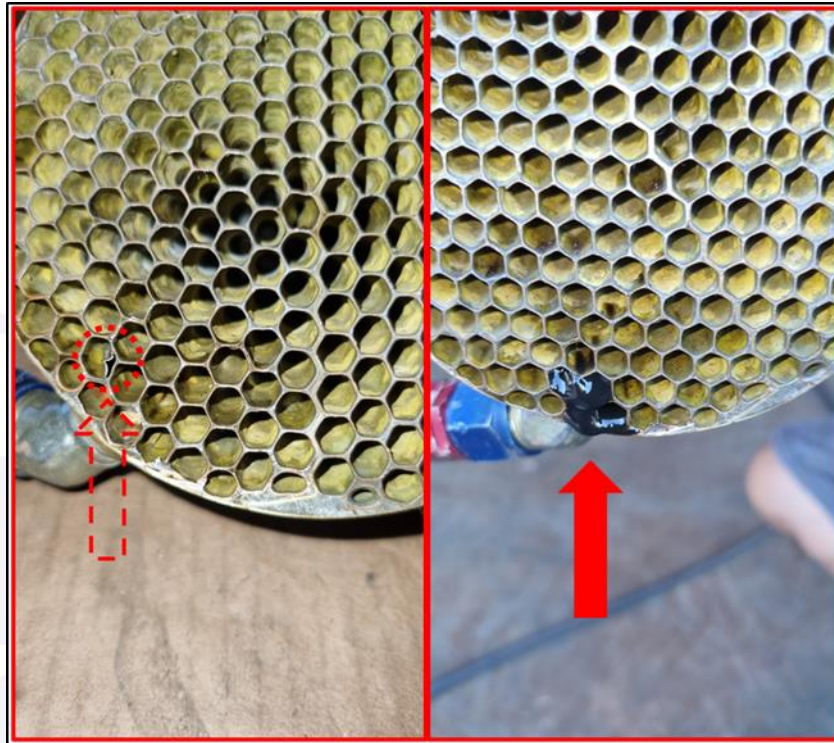
A visual inspection of the component revealed a sectioned area where signs of oil leakage were observed.

Figure 6 – Component installed on the PT-KUM airplane. In highlight, the sectioned area with oil leakage.

The item in question did not have any identification plate or markings. Similarly, the hoses connecting it to the powerplant had no identification.

During the investigation, a significant oil stain was observed at the location where the aircraft aligned for takeoff, indicating a possible oil leak from the engine. In this context, a visual inspection of the heat exchanger device found on the aircraft revealed a hole in its structure through which oil was leaking, compromising the lubrication of the aircraft's powerplant and, consequently, the performance of the engine.

It was not possible to determine when the rupture of the heat exchanger structure occurred. However, reports that the aircraft had already shown fluctuations in engine oil pressure indication suggest that the issue was present prior to the flight that resulted in the accident.

Coordinate with the *SANAGRI Manutenção de Aeronaves* Maintenance Organization (COM 0210-01/ANAC), responsible for the most recent “100-hour” inspection and the issuance of the CVA for the PT-KUM aircraft, to verify whether the procedures adopted by that maintenance organization are effective in identifying the installation of components and systems that are not in compliance with the aircraft's original design and configuration.

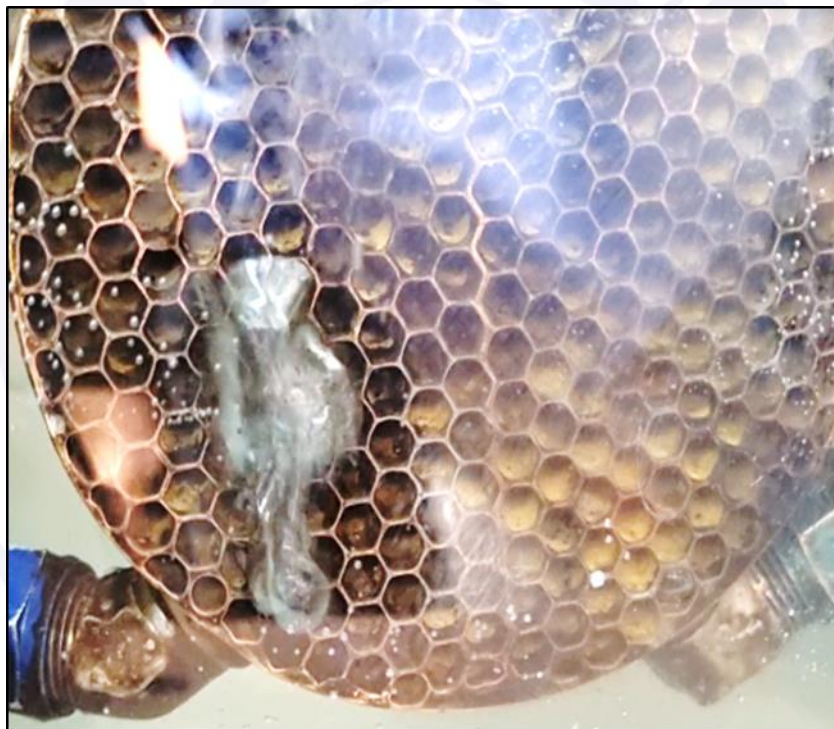
Figure 7 – Detail of the area with leakage.

- p) visual inspections revealed that there was a hole in the heat exchanger device through which oil leakage occurred;
- q) the aircraft sustained substantial damage; and

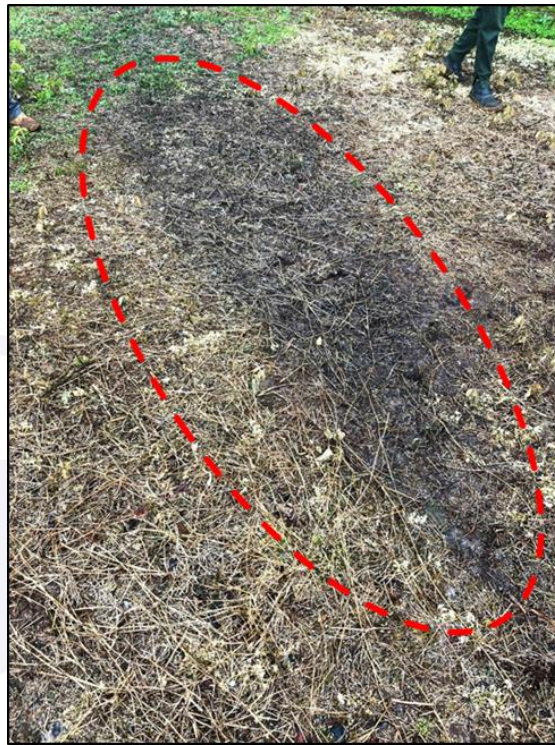
During the investigation, it was found that there were oil stains concentrated in the area where the aircraft aligned and subsequently accelerated for takeoff (Figure 8).

Figure 8 – Oil stains at the PT-KUM takeoff starting point.
