COMANDO DA AERONÁUTICA
CENTRO DE INVESTIGAÇÃO E PREVENÇÃO DE
ACIDENTES AERONÁUTICOS

FINAL REPORT
A-111/CENIPA/2021

OCCURRENCE:	ACCIDENT
AIRCRAFT:	PT-LMU
MODEL:	Baron 58
DATE:	29SET2021

This is the Final Report related to the accident of 29 September 2021 involving the Beechcraft Baron 58 aircraft, registration PT-LMU. The accident was typified as “[SCF-PP] Engine failure or malfunction | In-flight engine failure”.

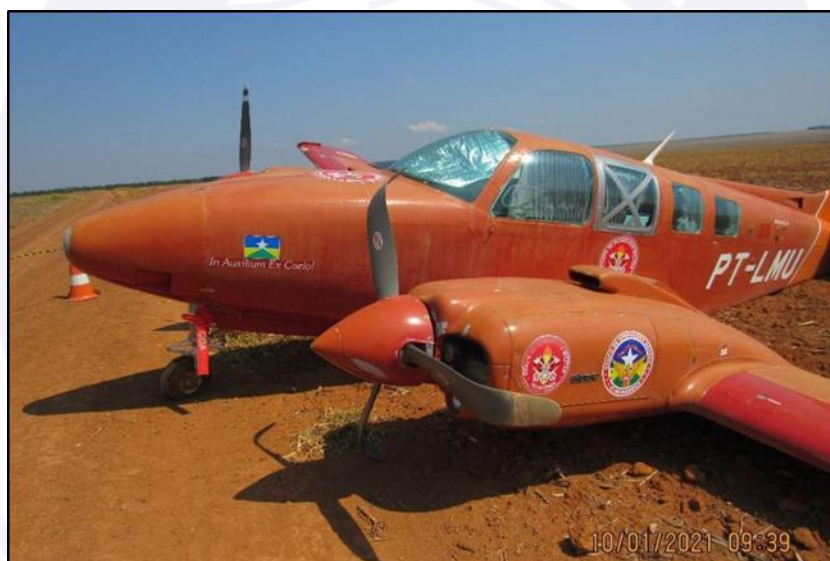
Figure 1 – View of the aircraft after the occurrence.

There was substantial damage to the left-hand main landing gear, left-hand engine, left-hand propeller assembly, left-hand wing, and to the left-hand flap and aileron. In addition, the left-hand elevator received slight damage.

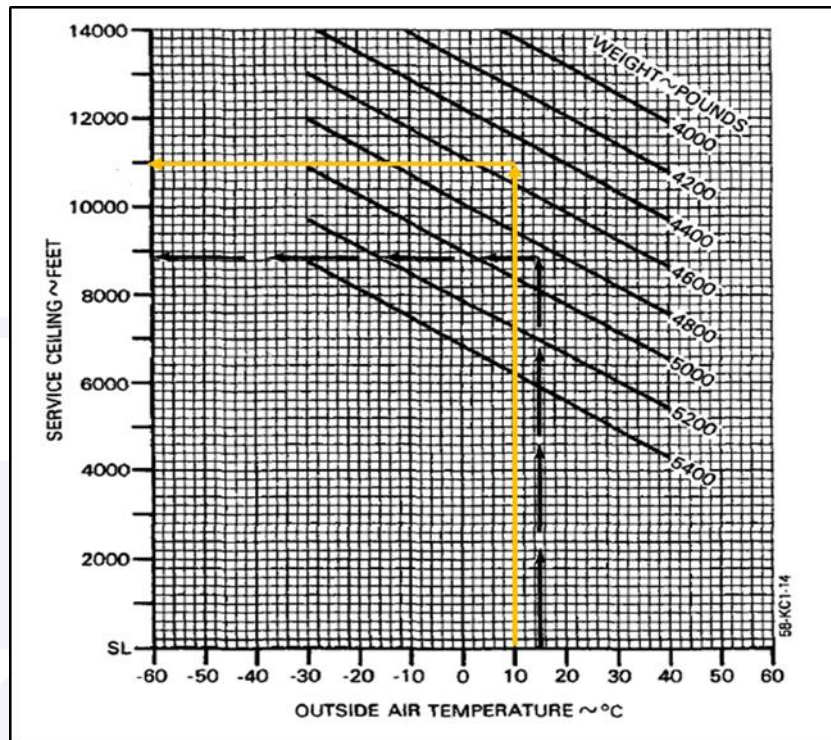
Figure 5 - Service ceiling diagram. The yellow arrows indicate the calculation reasoning.

The diagram shown in Figure 5, extracted from the Performance Section of the aforementioned POH, illustrates the calculation. It shows that the aircraft, weighing 4,453 lb., would maintain straight and level flight up to 11,000 ft., given the approximate condition of the external air temperature (10° C).

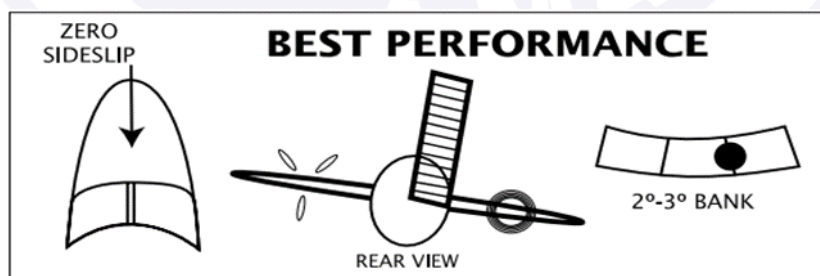
Figure 6 - Image extracted from *Flying Light Twins Safely*. It shows the proper positioning of the aircraft, and how the pilot sees it through the turn-and-bank indicator. In the example above, the inoperative engine is the one on the left-hand-side.

In practice, the recommendation was to apply both the pedal and the yoke to the left-hand side, leaving the aircraft with a banking of approximately three degrees to the same side of the operating engine.

Figure 6 depicts the use of the flight controls for a left-hand engine failure situation, in a way different from the occurrence in question. Therefore, one must bear in mind that the banking, application of the pedal, and visualization of the pilot would be to the left side.
