COMANDO DA AERONÁUTICA
CENTRO DE INVESTIGAÇÃO E PREVENÇÃO DE
ACIDENTES AERONÁUTICOS

FINAL REPORT
A - 010/CENIPA/2021

OCCURRENCE:	ACCIDENT
AIRCRAFT:	PT-LYG
MODEL:	95-B55
DATE:	24JAN2021

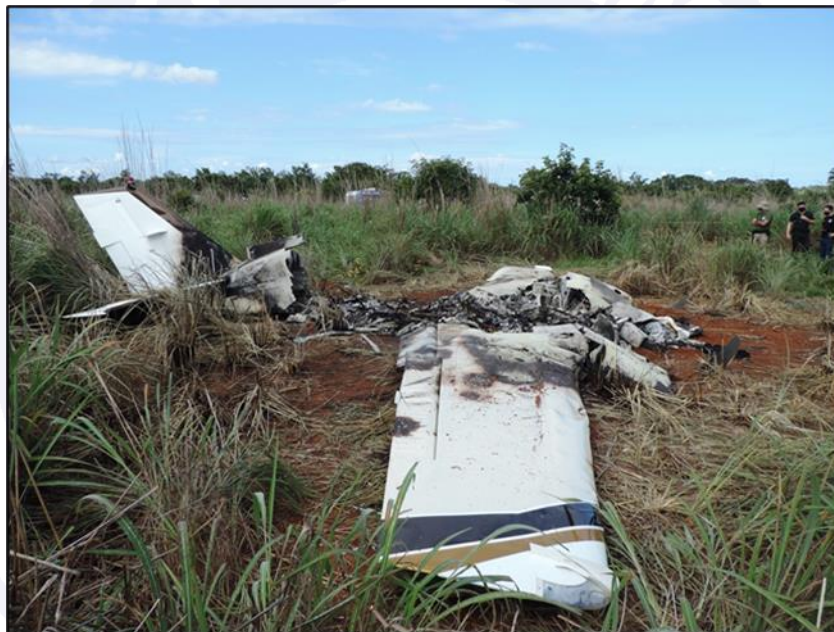
Figure 1 - Aircraft after the occurrence.

The aircraft was consumed by fire, which started after the impact and was destroyed.

The fire consumed the entire fuselage structure, as well as the objects inside, leaving only parts of the wings, engines, and tail cone.

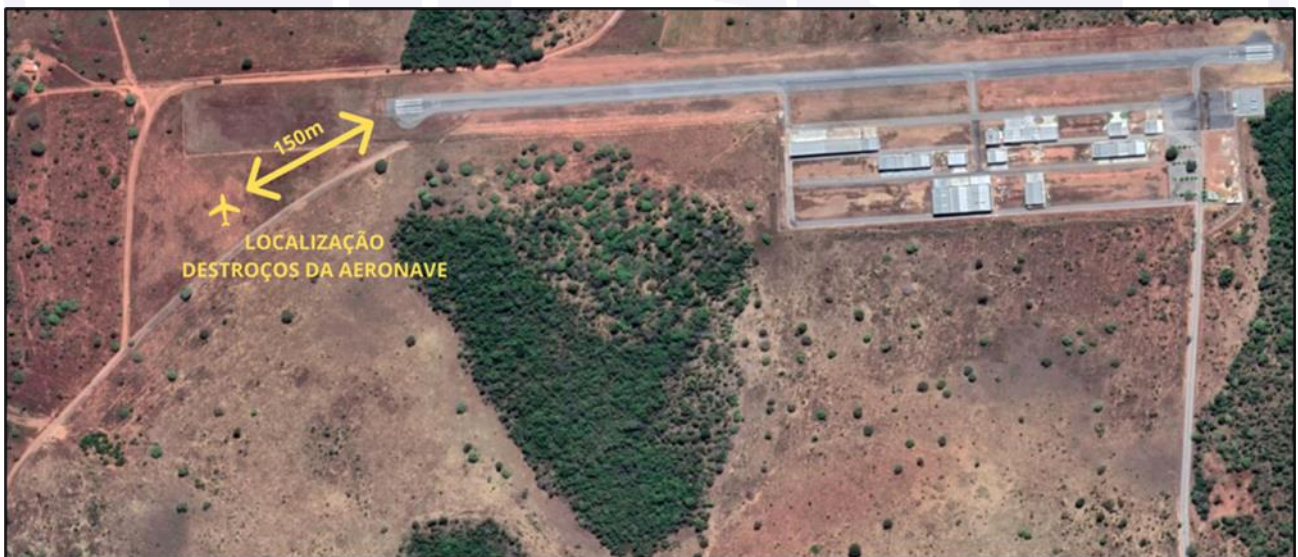
The impact occurred in a leveled attitude and with neutral inclination, 150 meters away from threshold 11, apparently causing the simultaneous collision of the fuel tanks, wings, central cone, and stabilizers against the ground.

The wreckage was concentrated and there was fire after the collision.

Figure 2- Sketch of the occurrence and location of the aircraft wreckage in relation to the runway.
