COMANDO DA AERONÁUTICA
CENTRO DE INVESTIGAÇÃO E PREVENÇÃO DE
ACIDENTES AERONÁUTICOS

FINAL REPORT
A - 041/CENIPA/2020

OCCURRENCE:	ACCIDENT
AIRCRAFT:	PT-LZC
MODEL:	PA-25-260
DATE:	18MAR2020

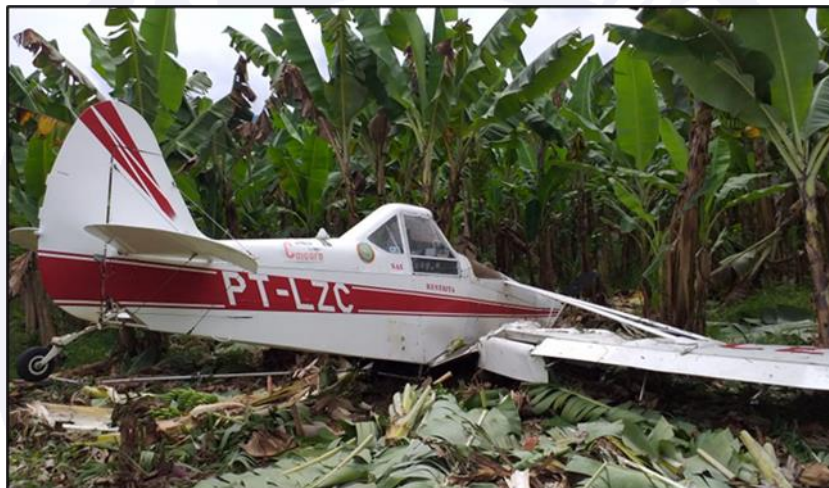
Figure 1 - Aircraft position after a forced landing.

The aircraft had substantial damage to the powerplant, landing gear, wings, and control surfaces.

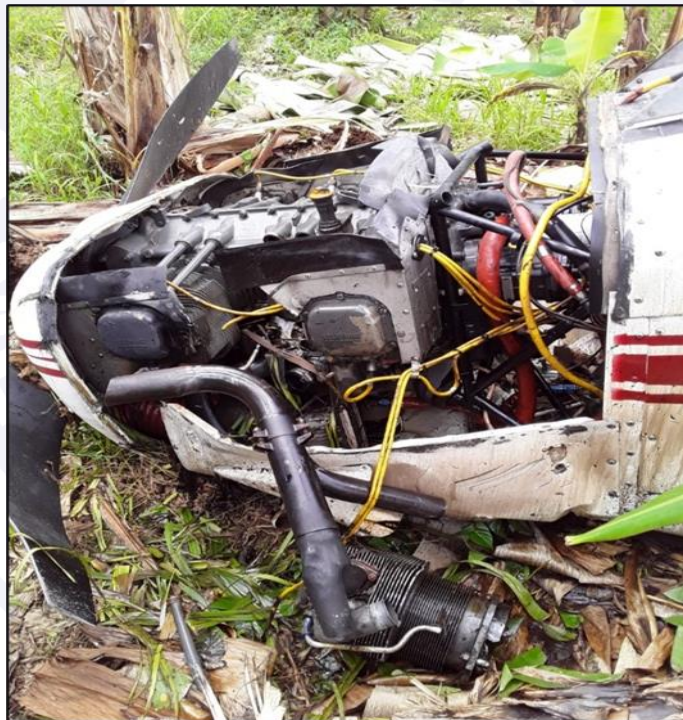
During the flight, cylinder nº 4 came off the engine block, which was found next to the aircraft, as shown in Figure 2.

Figure 2 - Cylinder nº 4 next to the aircraft.

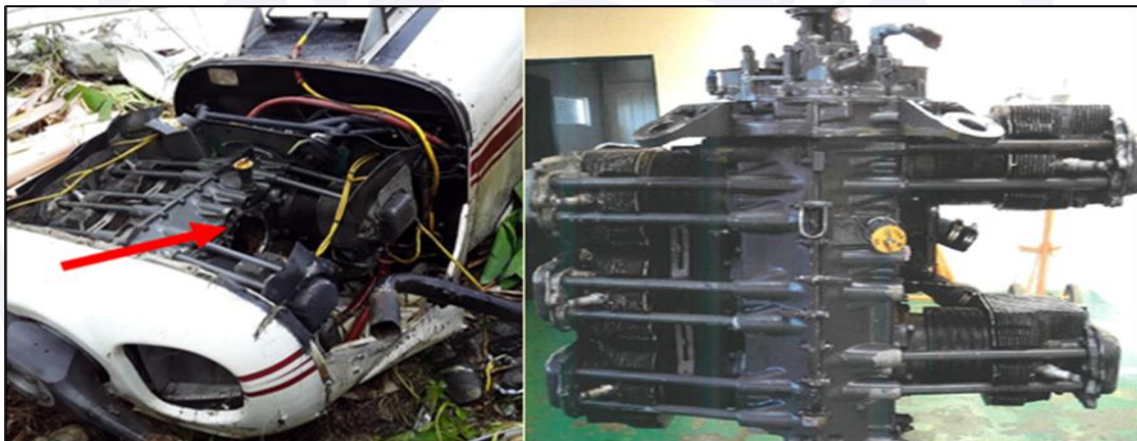
After the occurrence, the Textron Lycoming engine, model O-540-G1A5, SN L-24367-40A, was subjected to the DCTA experts' analysis, which reported that the engine failure was related to the release of cylinder nº4.

Figure 3 - View of the engine without the cylinder nº 4.

The sequence of failures could not be established, because some bolts were torn out of their respective housings and could not be found for analysis.

The segments of the bolts that were stuck in the block suffered several dents, and it prevented the failure analysis.

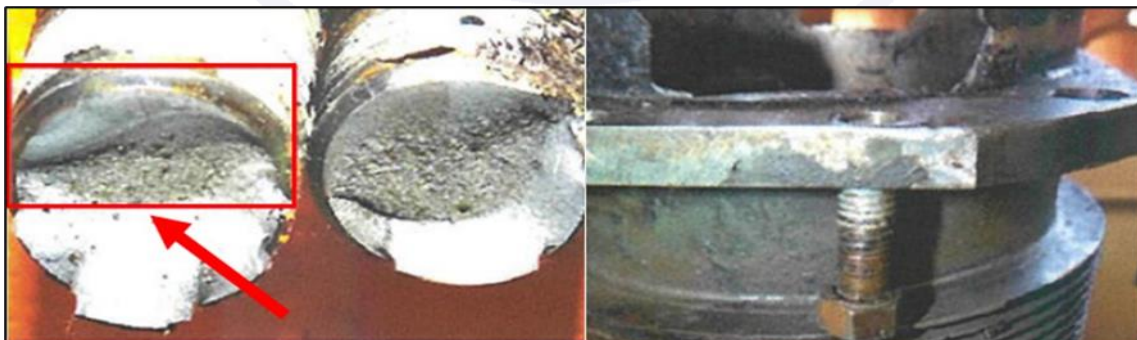
Figure 4 - The image on the left shows the fatigue that was observed in the passing stud. The image on the right shows the only stud remaining at the cylinder's base.

- failure of a bolt due to fatigue or detachment from the block;
- failure of the cylinder fixing nuts due to cracking or loss of torque; and
- failure in the engine block structure that may have allowed the stud bolt to come loose.

Considering the information gathered, it is possible to conclude that the most likely hypothesis for the detachment of cylinder n° 4 was the embrittlement of at least one of the stud bolts by fatigue process, leading to its rupture, which caused the rupture of other stud bolts by overload, causing the detachment of the cylinder from the engine block, the beginning of fire and smoke, and the consequent loss of power.

It is noteworthy that only one service was identified, on 13NOV2014, in which cylinder disassembly took place, and the aircraft flew almost 1.000 hours after it was performed. It could not be ruled out that, on this occasion, the cylinder was assembled with an inadequate application of torque, which would have allowed the beginning of the fatigue process due to the failure of the nuts' fixation.

Disclose the lessons learned in this investigation to the Tangará Aero Center Ltd., so that this OM uses these lessons in the promotion of operational safety within that organization, disclosing the consequences arising from the lack of effective quality control in engine maintenance services during preventive and corrective procedures.

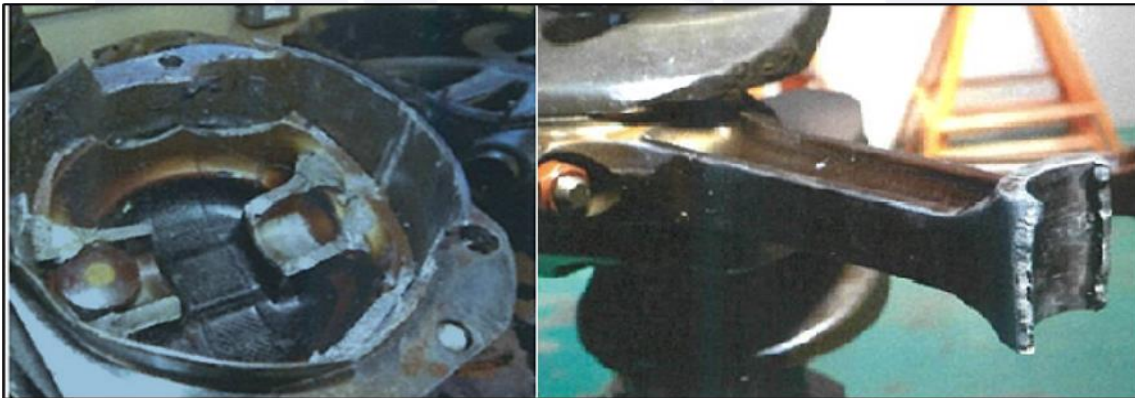
Thus, at the moment when the cylinder was released, its misalignment occurred in relation to the block so that the piston, also misaligned, when moving to the bottom dead center, due to the rotation movement of the crankshaft, collided against the base of the engine block, resulting in the fractures observed in the pin housing and also in the piston skirt, in addition to the connecting rod head, as shown in Figure 5.

Figure 5 - The image on the left shows the destruction of both the skirt and the piston pin housing of cylinder nº 4. The image on the right shows the fracture in the connecting rod foot of cylinder nº 4.

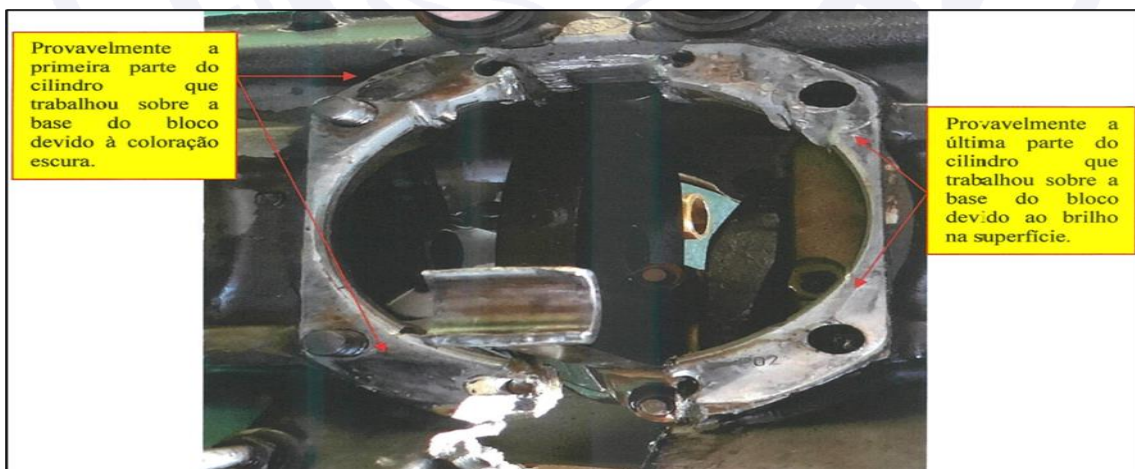
Figure 6 also shows that the left side of cylinder nº 4 was the first part that worked on the base of the block, due to the dark color, and the right side was the last part, due to the glow on the surface.

Figure 6 - Close-up view of the base of cylinder number 4, showing dents and fractures.

After the initial failure, the remaining bolts could not withstand the cylinder's efforts and failed due to overload, causing the entire assembly to come off.
