**COMANDO DA AERONÁUTICA**  
**CENTRO DE INVESTIGAÇÃO E PREVENÇÃO DE**  
**ACIDENTES AERONÁUTICOS**

**FINAL REPORT**  
**A - 132/CENIPA/2019**

<b>OCCURRENCE:</b>	<b>ACCIDENT</b>
<b>AIRCRAFT:</b>	<b>PT-MHC</b>
<b>MODEL:</b>	<b>208B</b>
<b>DATE:</b>	<b>16SEPT2019</b>

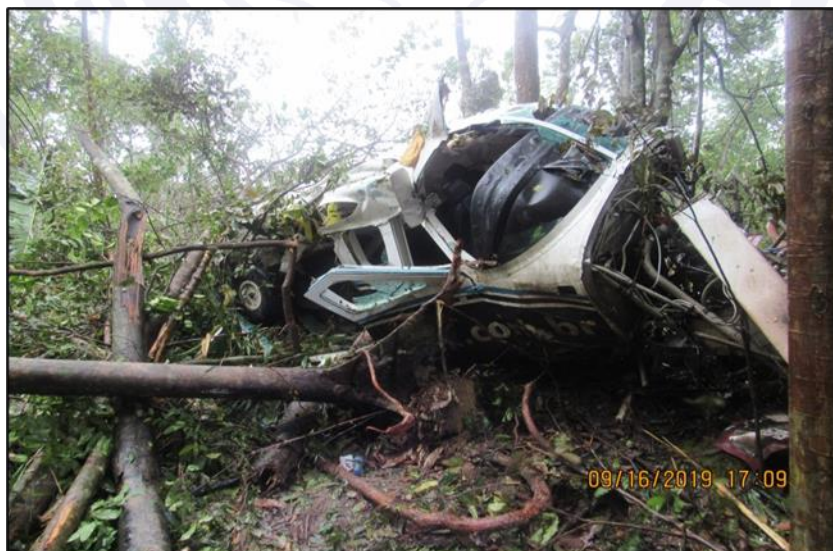
The aircraft had substantial damage to the fuselage, wings, landing gear, horizontal stabilizer, and an elevator (Figures 1 and 2).

Figure 1 - View of the right front of the aircraft, after the impact and complete stop.

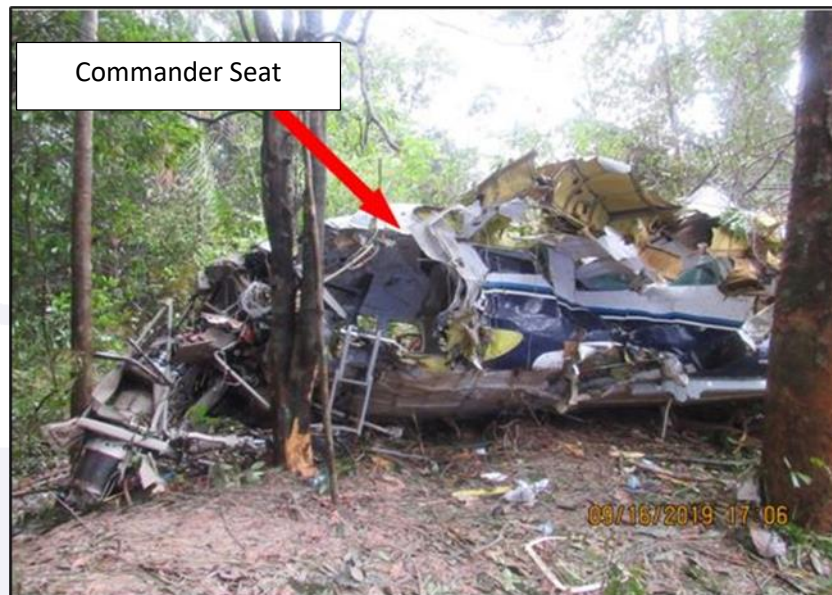
Figure 2 - View from the left side of the aircraft, after coming to a complete stop.

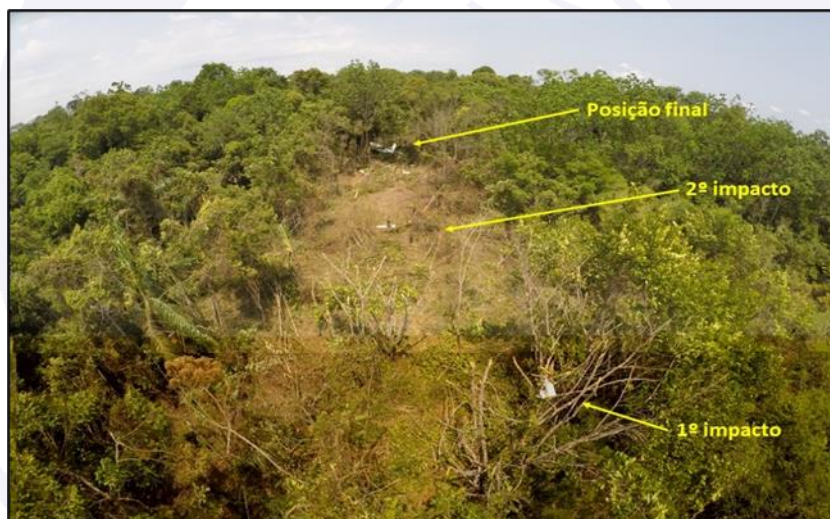
The first impact occurred in a pitch-up attitude. The horizontal stabilizer (right side) collided with a tree branch and the elevator on that side came off. The second impact occurred against another tree, causing the separation of the meteorological RADAR, located on the right wing, and a part of the horizontal stabilizer (left side).

After the second impact, the aircraft stopped at heading 240°, approximately, 30° to the left concerning the trajectory of the fall, and at 50° about the take-off axis (290°).

Figure 22 - Aerial view of the accident site. The details show the points of impact and the final position of the aircraft.

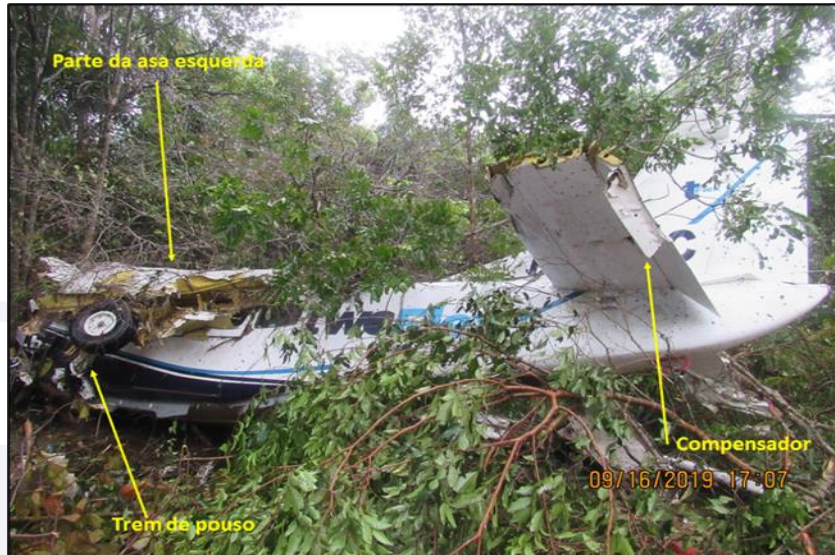
The landing gear, of the fixed type, was twisted upwards. According to the crew's report, the flaps were lowered to the take-off position, however, due to the impacts, it was not possible to verify the exact position they were in, and it was not possible to specify the position of the trim tabs (Figures 23, 24 and 25).

Figure 23 - Close-up view of the aircraft after coming to a complete stop. The yellow arrows indicate the position of the left landing gear, the broken elevator trim, and the part of the left wing that has bent up from the aircraft.

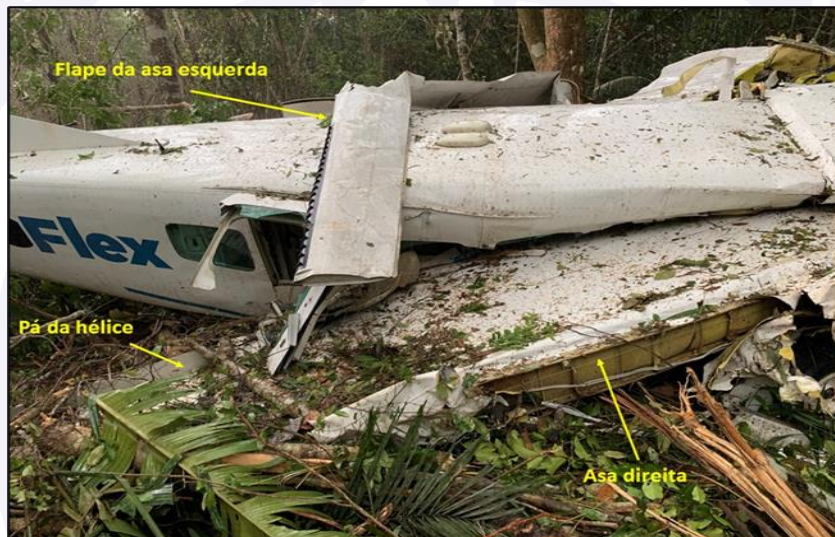
Figure 24 - Close-up view of the right side and top of the aircraft. In the details, the position of the right-wing, the left-wing flap, and a blade of the propeller assembly.

The propeller assembly was found next to the passengers` door. The left-wing flap was above the roof of the aircraft. The right-wing was twisted back and down.

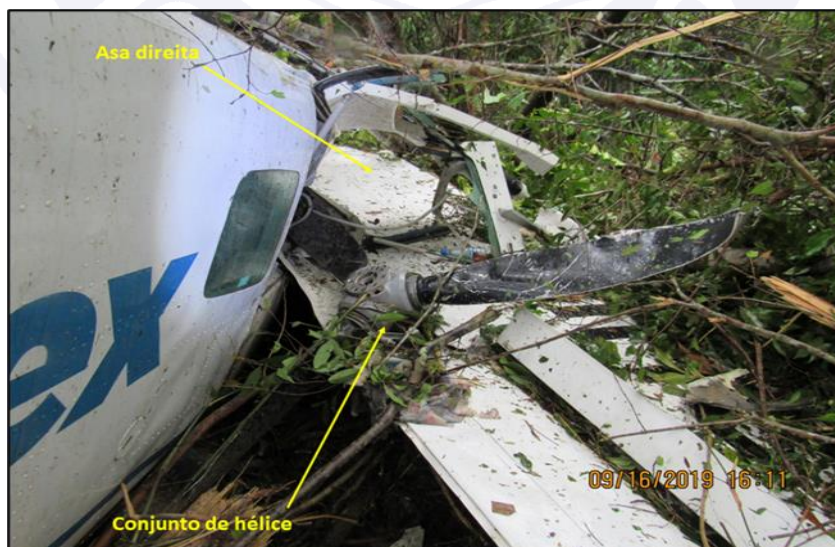
Figure 25 - Close-up view of the right side of the aircraft, near the passengers` door. In the details, the position of the right-wing and the final position of the propeller assembly.

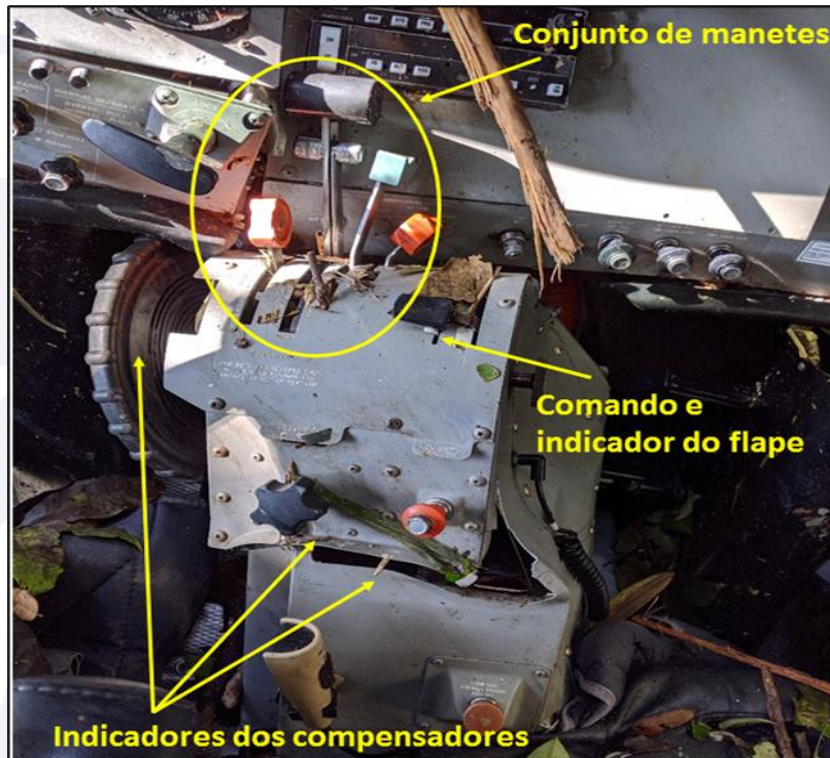
The set of levers was found with the power, propeller, and fuel levers forward, normal position for take-off, however, it is possible that they moved on the impact. In addition, the emergency power lever (EPL) was at half-stroke. However, according to the commander's report, this control was not activated. (Figure 26).

Figure 26 - Close-up view of the aircraft's central panel. In the details, the positions of the levers, the indicators of the tabs, the command, and the indicator of the flap.

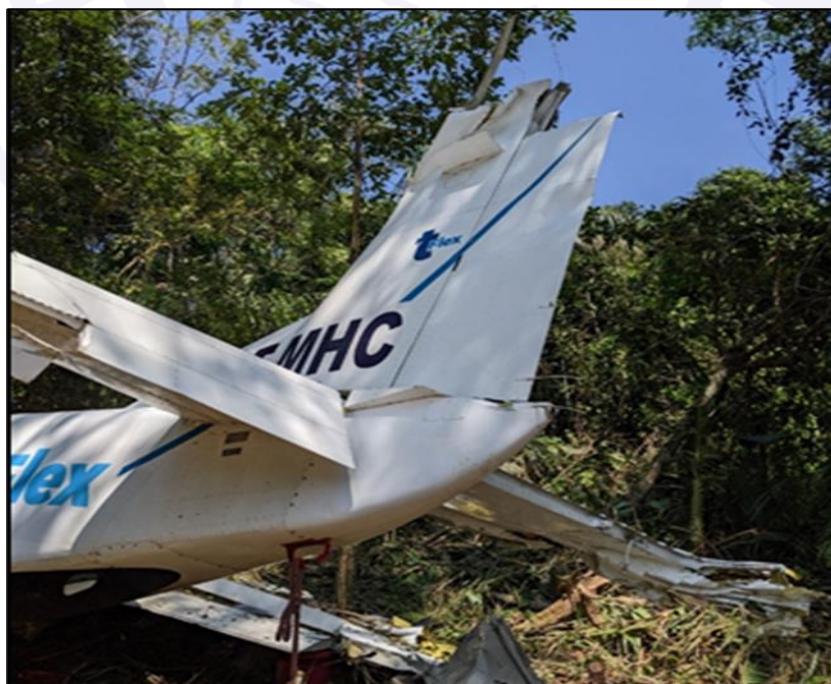
The horizontal stabilizer was missing the right elevator. The vertical stabilizer and the rudder were missing their upper parts (Figure 27).

Figure 27 - Close-up view of the empennage.

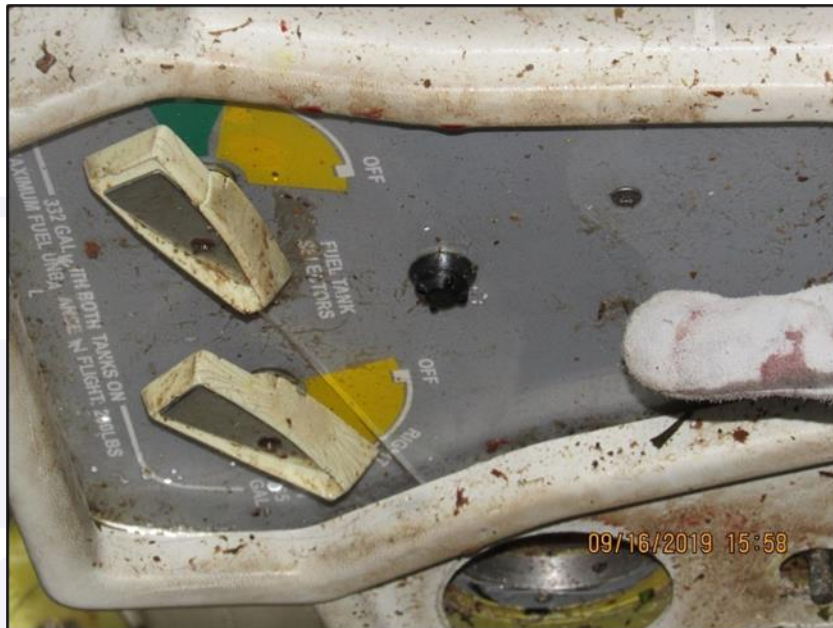
The position of the fuel selectors was modified by the impact, and it was not possible to conclude which positions they were in before the accident (Figure 28).

Figure 28 - Close-up view of the fuel selector panel. The selectors were moved by the impact.

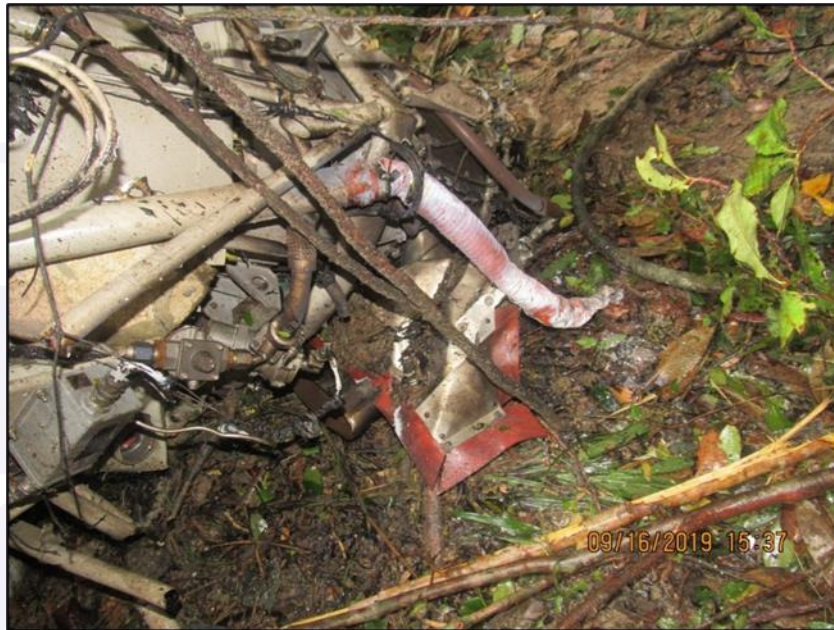
A fire started on the right side of the engine, which was contained by the SIC using the aircraft's portable fire extinguisher (Figure 29). The origin of the fire was undetermined.

Figure 29 - Close-up view of the right part of the aircraft engine. The yellow arrow shows the presence of white powder where the fire extinguisher was used.
