FINAL REPORT
IG - 045/CENIPA/2014

OCCURRENCE:	SERIOUS INCIDENT
AIRCRAFT:	PT-MZX
MODEL:	A320-232
DATE:	28FEB2014

This is the Final Report of the 28FEB2014 serious incident with the A320-232 aircraft, registration PT-MZX. The serious incident was classified as “[SCF-NP] System/Component Failure or Malfunction Non-Powerplant / Unintentional/Combustion Decompression”.

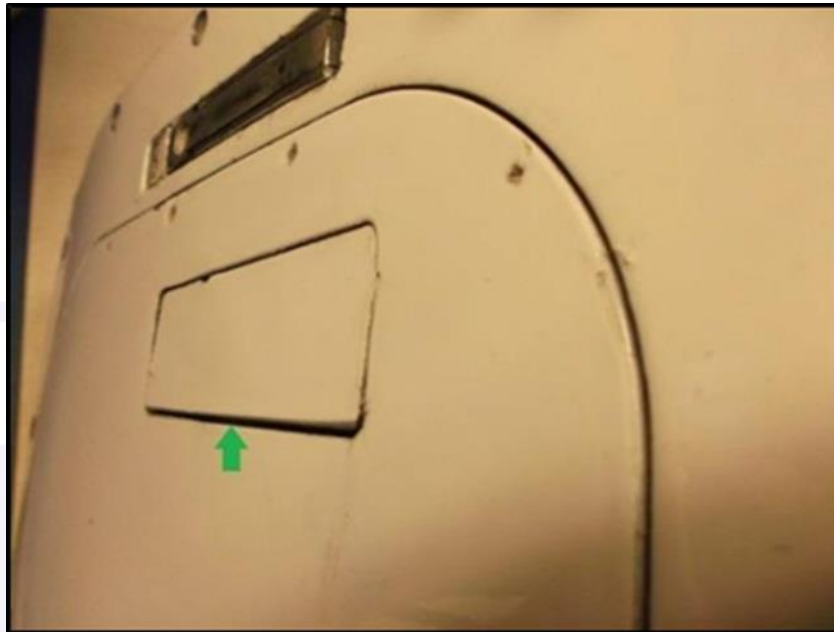
During the research related to the pressurizing system and its components, tests were performed on the Skin Air Outlet Valve, conducted by SAFRAN Technofan LLC. During the tests, it was found that the small flap did not close completely when the valve was electrically driven. It remained open of 1 to 2 millimeters. In Figures 2 and 3 it is possible to see the gap (opening) of 1 to 2 millimeters, indicated by the green arrows.

Figure 2 - External view of the small flap partially open, after closing by electric activation.

The leakage caused by the gap was considered small, insufficient to have generated the depressurization of the cabin.

Tests performed on Skin Air Outlet Valve found that the small flap did not close completely when the valve was electrically driven, leaving a gap of 1 to 2 millimeters. However, the leakage caused by the small flap opening was considered small.

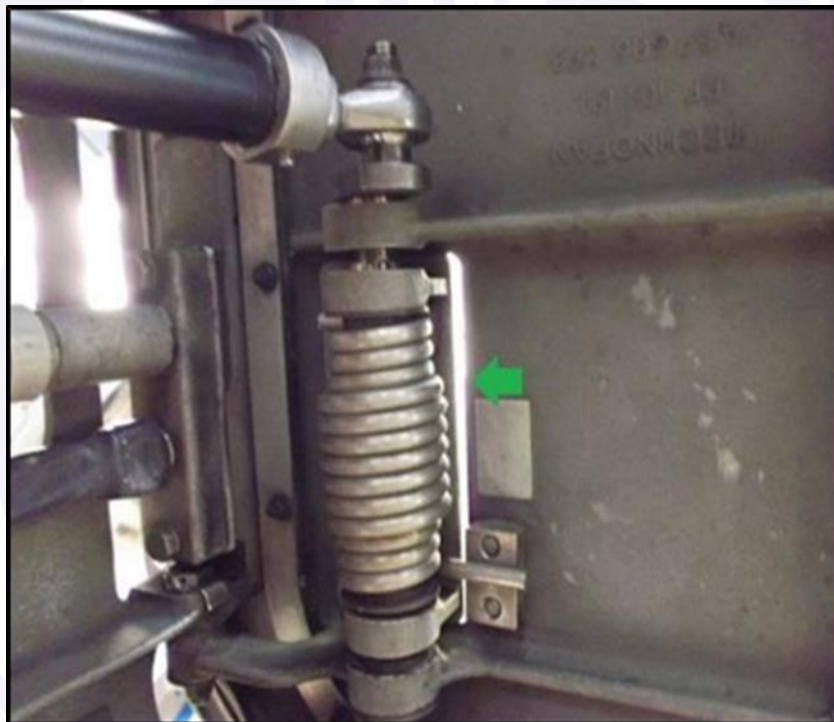
Figure 3 - Internal view of the small flap partially open, after closing by electric activation.

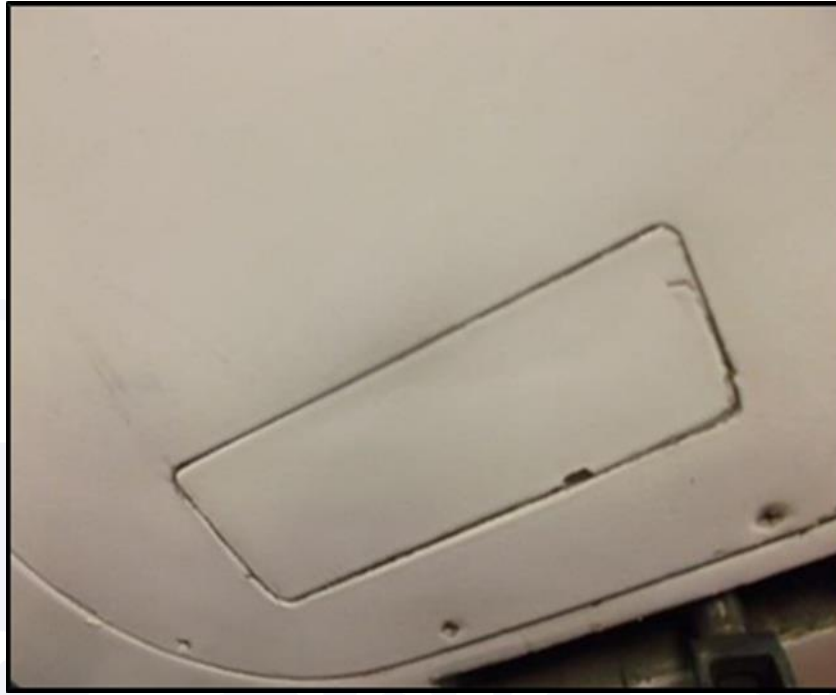
However, when the valve was manually operated, the small flap closed completely, as shown in Figures 4 and 5.

Figure 4 - External view of the fully closed small flap, after manual activation.

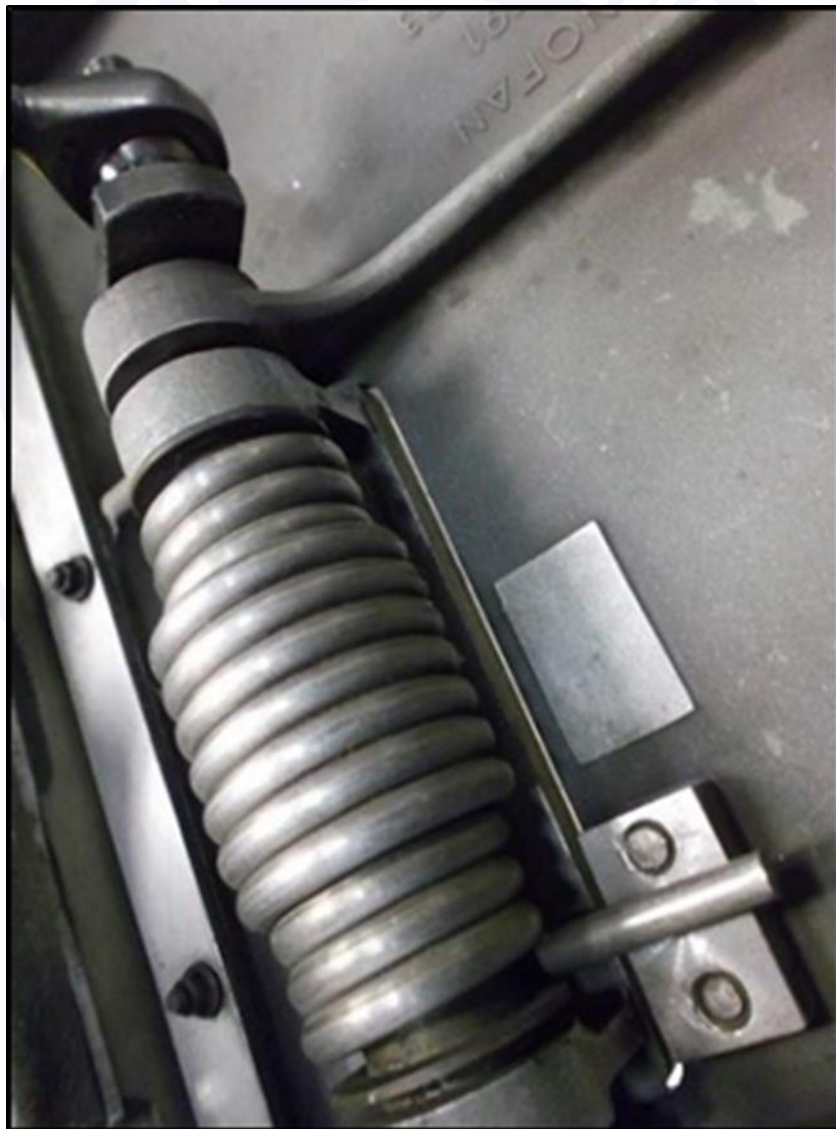
Figure 5 - Internal view of the small flap fully closed, after manual activation.
