FINAL REPORT
A - 119/CENIPA/2019

OCCURRENCE:	ACCIDENT
AIRCRAFT:	PT-NKK
MODEL:	EMB-710C
DATE:	11AUG2019

This is the Final Report of the 11AUG2019 accident with the EMB-710C aircraft model, registration PT-NKK. The accident was classified as “[LOC-I] Loss of Control in Flight”.

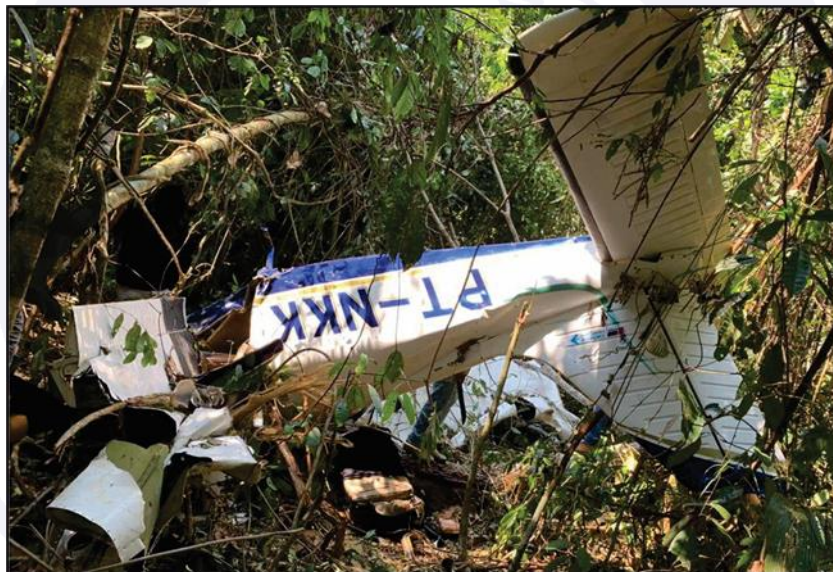
After the take-off, the aircraft turned right, lost height, and, about 1.6 km from the take-off location, collided with the right-wing against a tree, hitting the ground afterward.

There was a rupture of the front structure of the cabin and the entire front section. Cargo and personnel on board were projected 45 m ahead.

Figure 1 - Final position of the aircraft.

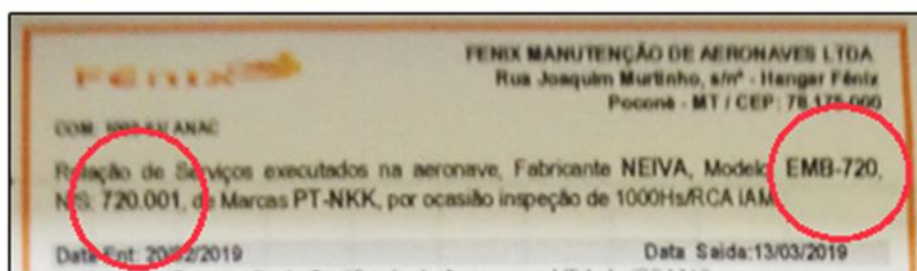
The accident aircraft model was an EMB-710C, and its serial number was 710149. However, it was found in the OS of the last inspection, that in the airframe logbook, Part II, page 106, and in the propeller logbook, Part IV, page 102, the EMB-720 was registered as an aircraft model, and 72000 as a serial number (Figure 2).

Figure 2 - Inspection Compliance Form in Part II of the airframe logbook with incorrect aircraft model and serial number.

Still on the documental context, flaws were found in the OM's Maintenance Technical Control, since, although the Service Order indicated as aircraft model the EMB-710C, and serial number 710149, in the airframe logbook Part II, page 106 and in the propeller logbook Part IV, page 102, the EMB-720 was indicated as aircraft model and the serial number was 720001.

At this point, there was a failure in the supervision of the aircraft operator, who, according to section 91.405(b) of the RBHA 91, should ensure the correct notes in the aircraft maintenance records, indicating that it has been approved for return to service.

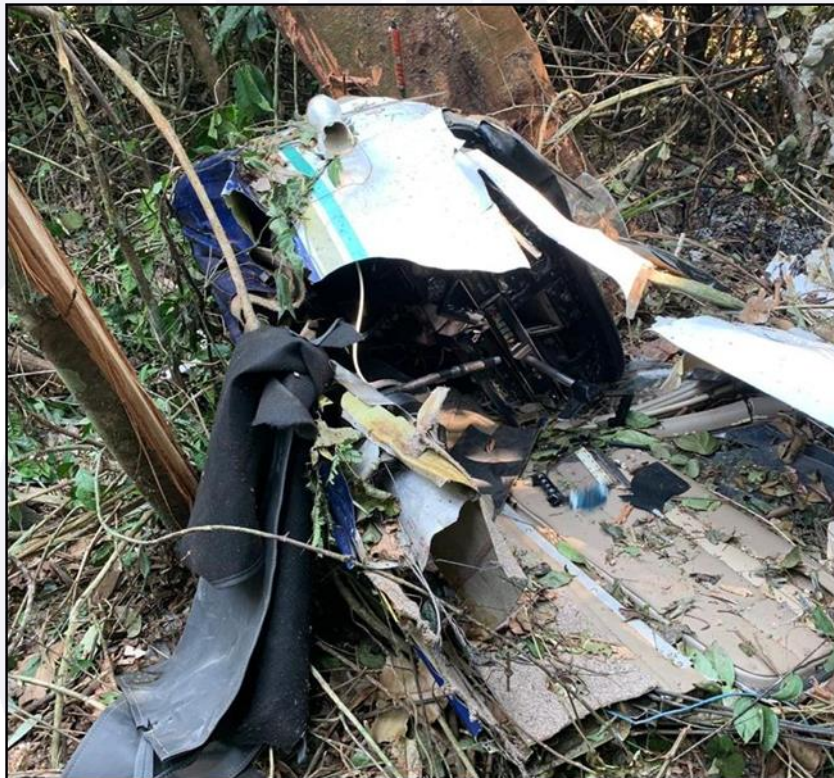
There was a separation of the cabin near the doors, which was projected 45 m ahead on the ground (Figure 7).

Figure 7 - Cabin front structure with the aircraft panel.

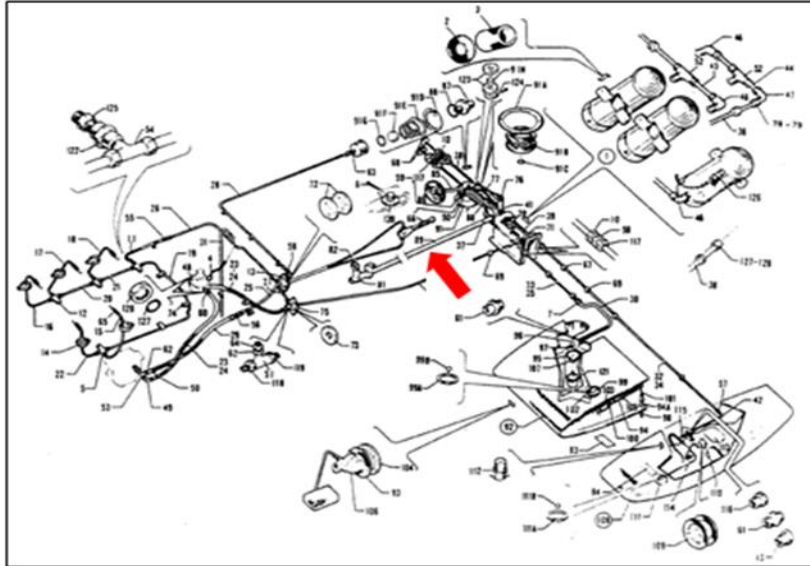
Figure 8 - Torque Tube for activating the fuel selector valve.

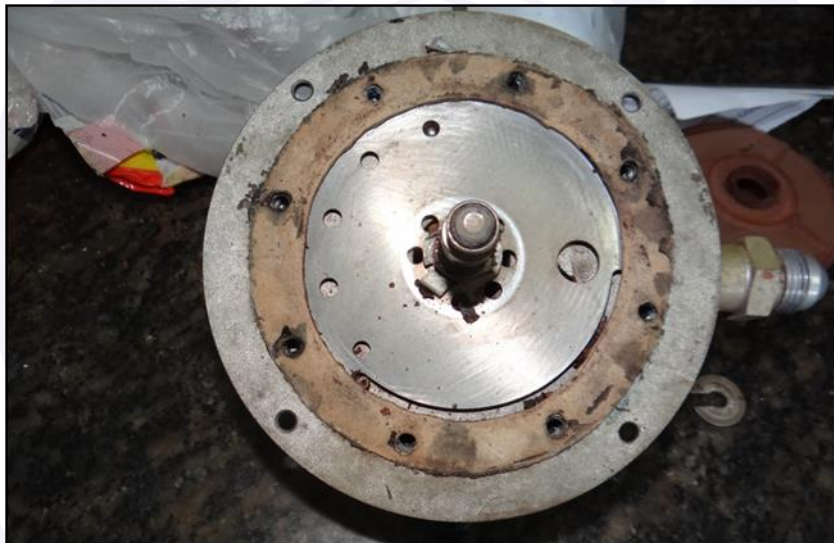
Analyzing the internal disc of the fuel selector valve, it was found that it was in the closed position (Figure 9).

Figure 9 - Fuel selector valve internal disc in the closed position.

As for the tests and analyzes carried out, during the investigation of the fuel selector valve, it was initially found that it was in the closed position, a situation not consistent with the dynamics of the accident.

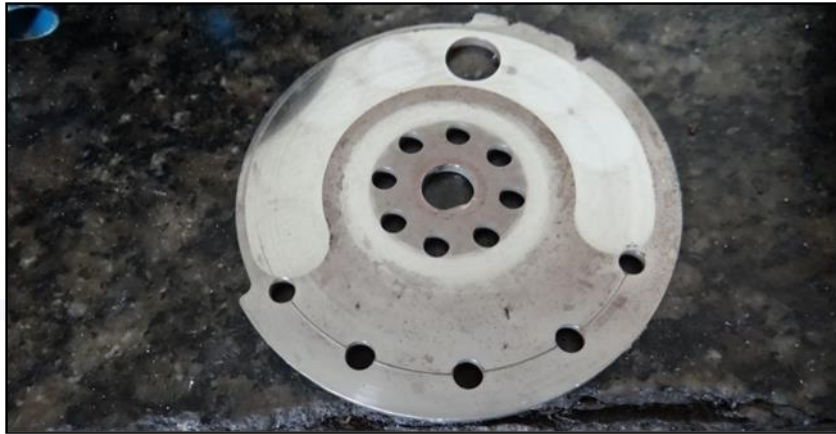
However, during disassembly, when observing the disk face that was in contact with the fuel passage holes coming from the aircraft tanks, it was found that the contact area between the disk and the fuel outlets was clean, that is, without soot (Figure 10).

Figure 10 - Face of the fuel selector valve disc with clean area.

This condition pointed to the fact that the internal disc of the fuel selector valve was in the open position at the time of the accident but was moved to the closed position after the impact.

When disassembling this component, it was found that the contact region with the fuel inlet holes of the tanks was clean throughout, that is, from open to closed.

This condition is in line with the dynamics of the accident, as well as providing an explanation for the clean area on the internal disk of that valve.

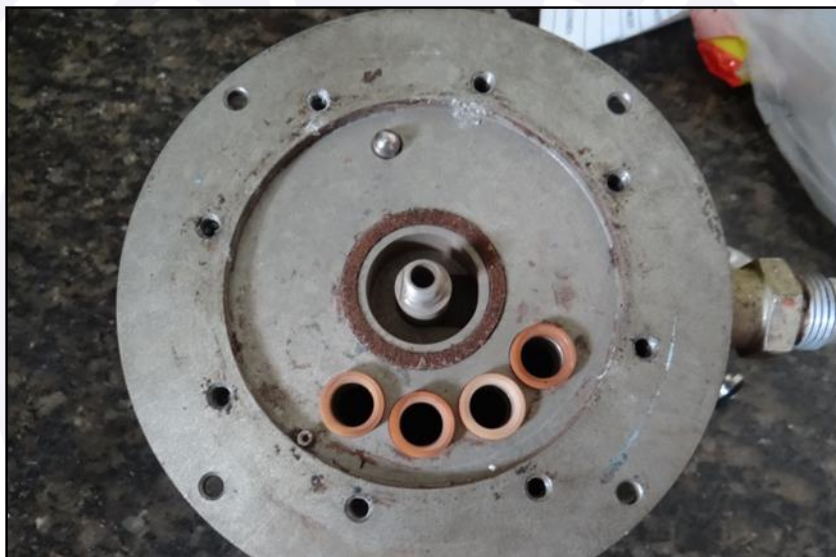
Figure 11 - General view of the fuel selector valve communication holes with the aircraft's fuel tanks.

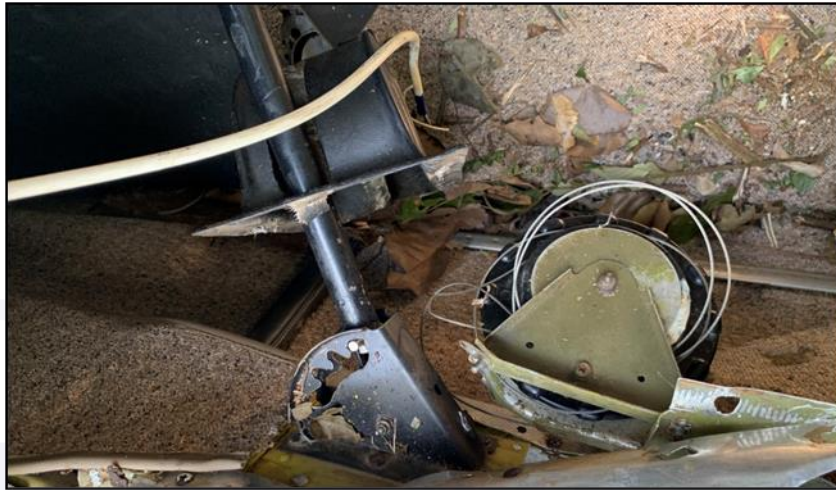
The flap surfaces were in the up position. However, the control lever was fully pulled up to extend the flaps to the 40-degree (full flap) position (Figure 12).

Figure 12 - View of the flap control lever at 40-degree position.

However, considering that the surface of the flaps was in the up position and that the rupture of the trigger cables occurred with the sectioning and projecting of the front part of the aircraft 45 m ahead of the impact site, it is possible that the flap control lever has been moved to the 40-degree position at the time of the accident, by direct mechanical action on the lever, regardless of the pilot's action.

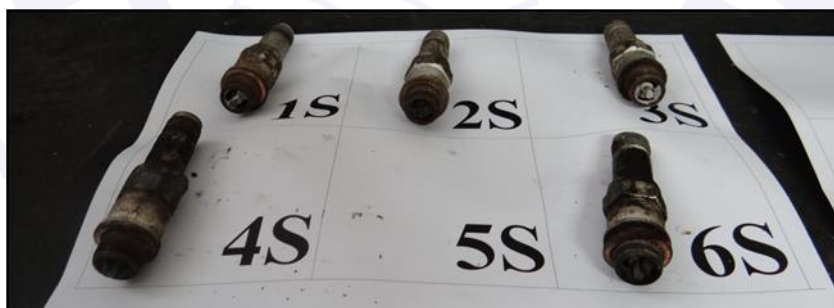
The upper igniters of cylinders 1, 2, 3, 4 and 6 could be removed, but they were oxidized and showed corrosion (Figure 13).

Figure 13 - View of the upper igniters of cylinders 1, 2, 3, 4 and 6.

There was a lot of soot in the upper igniters of cylinders 2, 4 and 6; possibly resulting from the fire that the aircraft suffered.

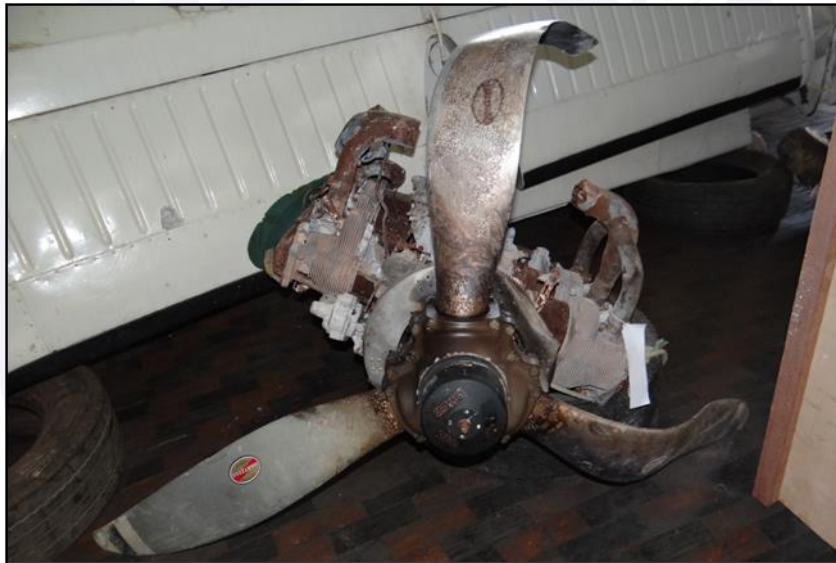
The propeller that equipped the aircraft was analyzed by the DCTA, showing backward bending in the three blades (Figure 14).

Figure 14 - Front view of the Hartzell HC-C3YR-1RF propeller still mounted on the engine.

When evaluating the condition of the PT-NKK propeller, evidence was found that the aircraft was developing power at the time of the accident.

This statement is based on the deformations and marks found on the propeller blades and on the overload rupture of the pin that makes up the pitch change mechanism. These facts are indicative that the engine was running at the moment the aircraft collided.

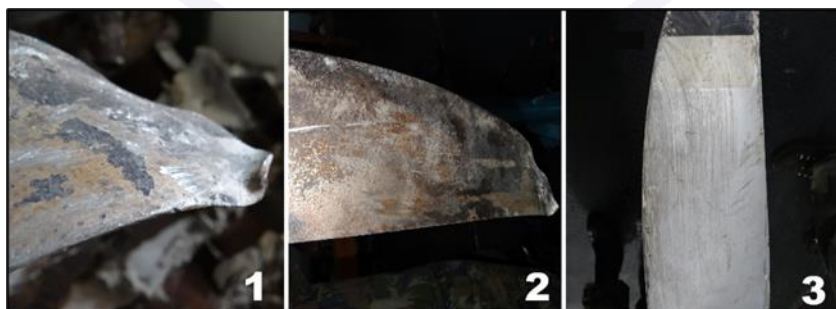
Forward bending was verified at the ends of two propeller blades and, in the third, the presence of longitudinal scratches (Figure 15).

Figure 15 - View of forward-facing bends at the end of two blades and longitudinal scratches at the third.

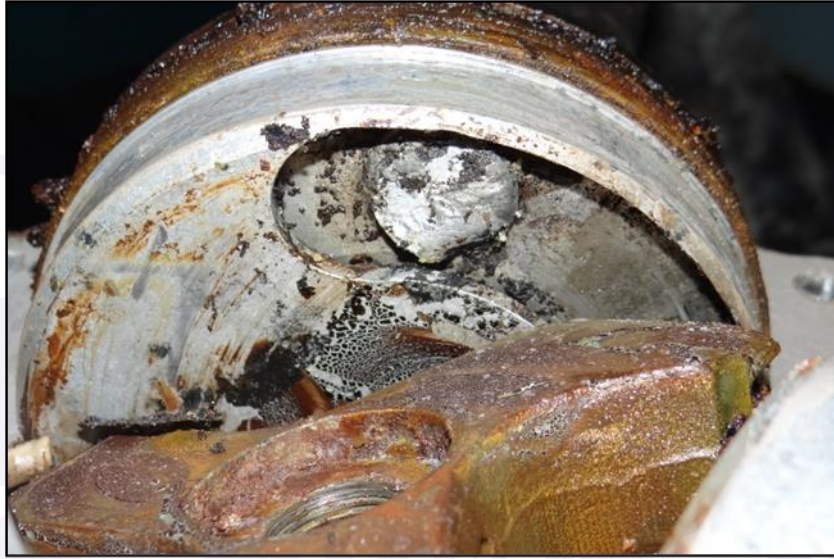
Also in this analysis, in addition to a deformation of the pin that makes up the pitch change mechanism in one of the blades, the rupture of this pin in two blades was also verified, which occurred due to overload (Figure 16).

Figure 16 - View of the overload rupture of the blade pitch change pin.

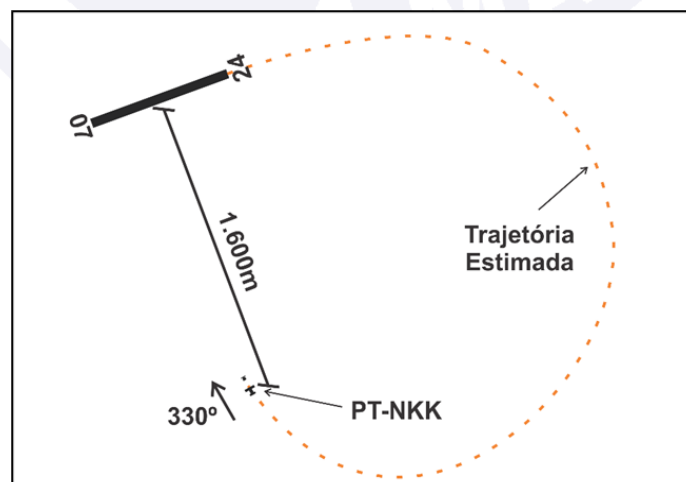
The aircraft described a trajectory that started from a take-off with heading 070°, curving to the right until it reached heading 330° (impact heading), 1.6 km from the area used for take-off (Figure 17).

Figure 17 - Estimated trajectory, heading and distance from the accident site.
