**COMANDO DA AERONÁUTICA**  
**CENTRO DE INVESTIGAÇÃO E PREVENÇÃO DE**  
**ACIDENTES AERONÁUTICOS**

**FINAL REPORT**  
**IG-138/CENIPA/2019**

<b>OCCURRENCE:</b>	<b>SERIOUS INCIDENT</b>
<b>AIRCRAFT:</b>	<b>PT-OGH</b>
<b>MODEL:</b>	<b>208</b>
<b>DATE:</b>	<b>18OUT2019</b>

This final report relates to the serious incident involving the model 208 aircraft, registration marks PT-OGH, on 18<sup>th</sup> October 2019. The occurrence was typified as SCF-PP (engine failure or malfunction) and RE (runway excursion).

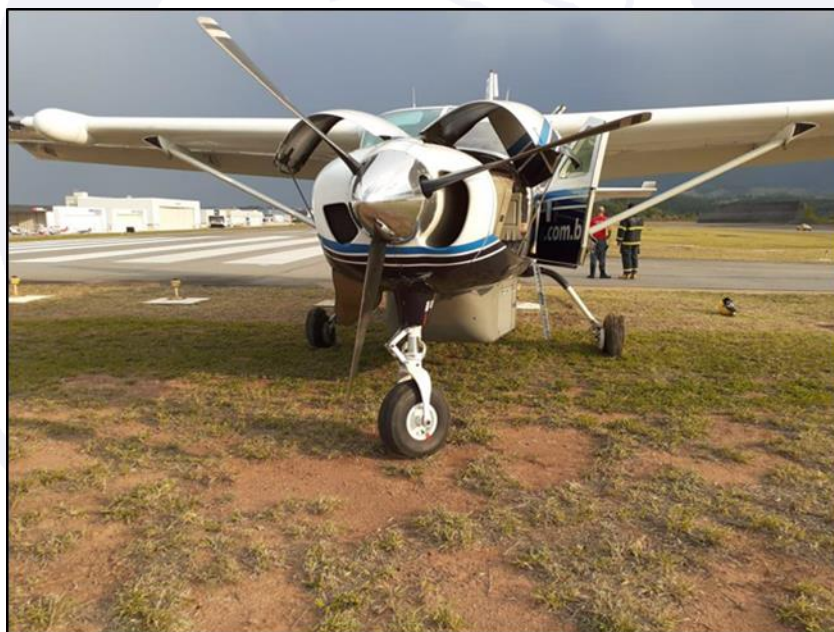
During the landing run, two tyres of the main landing gear wheels burst. The aircraft overran the longitudinal limits of the runway and came to a stop at a distance of about 10 meters beyond the runway threshold.

Figure 1 – View of the aircraft after coming to a complete stop.

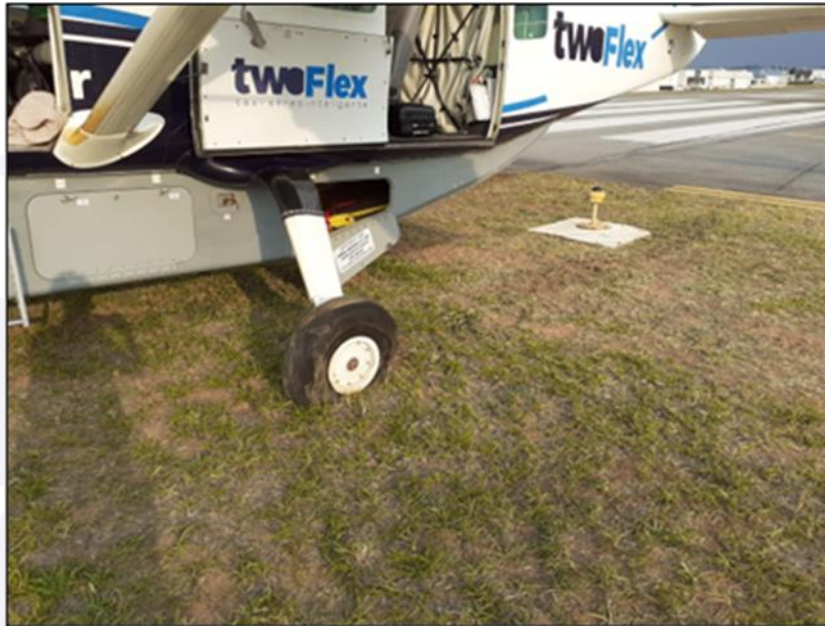
The aircraft sustained minor damage restricted to the set of wheels and tyres of the main landing gear and to the engine (Figure 2).

Figure 2 – Left-hand side view of the aircraft. It is possible to observe damage to the wheel-tyre set, and the final position of the aircraft after overrunning the RWY end.

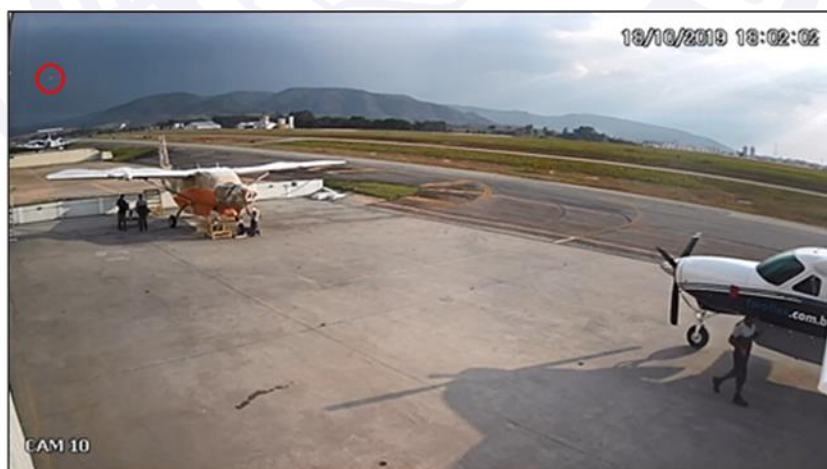
Images recorded by a security camera showed the airplane approaching meteorological formations near the aerodrome (Figure 5).

Figure 5 – The aircraft on the final for landing on RWY 36 of SBJD.

Although the prevailing weather conditions were consistent with visual flights, the METAR and Aerodrome Warning information in force at the time of landing, showed winds of 230° with intensity between 4 kt and 10 kt, gusting to 27 kt, as well as the image of heavy weather formations to the rear of the airplane during the approach, suggesting the possibility of a tailwind component during landing.

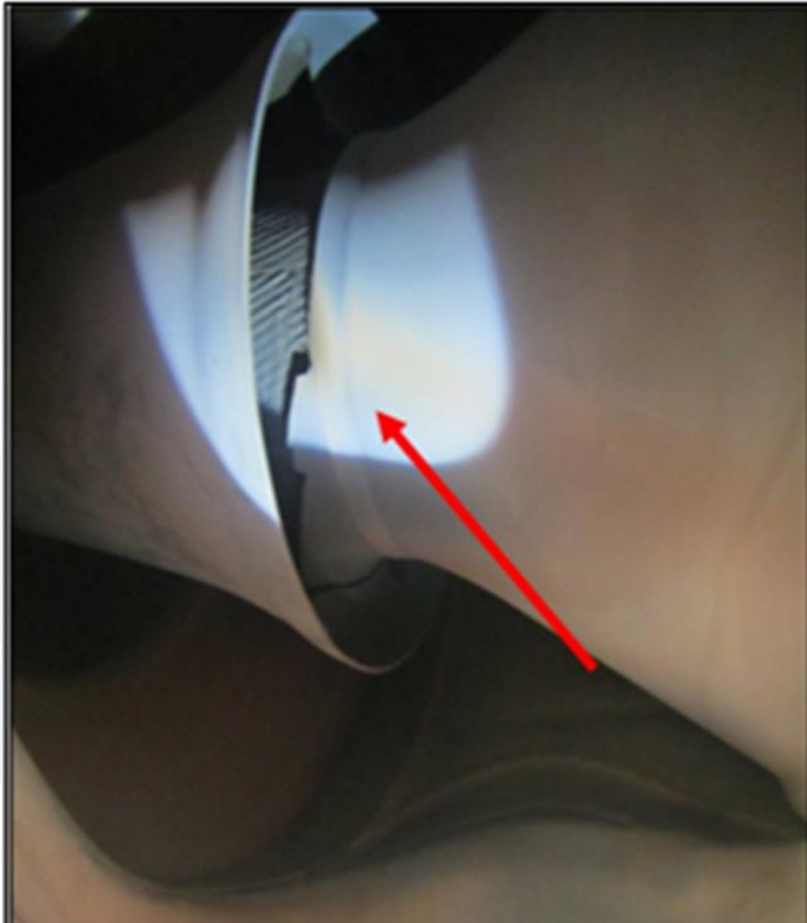
During the preliminary exams carried out at *Two Táxi Aéreo Ltda.* OM, the engine exhaust was removed to allow for a visual inspection of the engine's internals. Straightaway, a large damaged area was observed, with material missing from the internal part of the Exhaust Duct, in the region where it would receive gases from the power turbine (PT Disk) and would deflect them towards the exhaust (Figures 6, 7 and 8).

Figure 6 - Image of the Exhaust Duct. The arrow indicates the damaged region.

Considering that the exams of the aircraft's engine showed that a large area of the Exhaust Duct had been damaged, and that material was missing from the internal part of the component, it is possible that the vibration moments before the loss of power was due to the disturbance of the exhaust-air flow from the aircraft resulting from the changes in the geometry of the very Exhaust Duct.

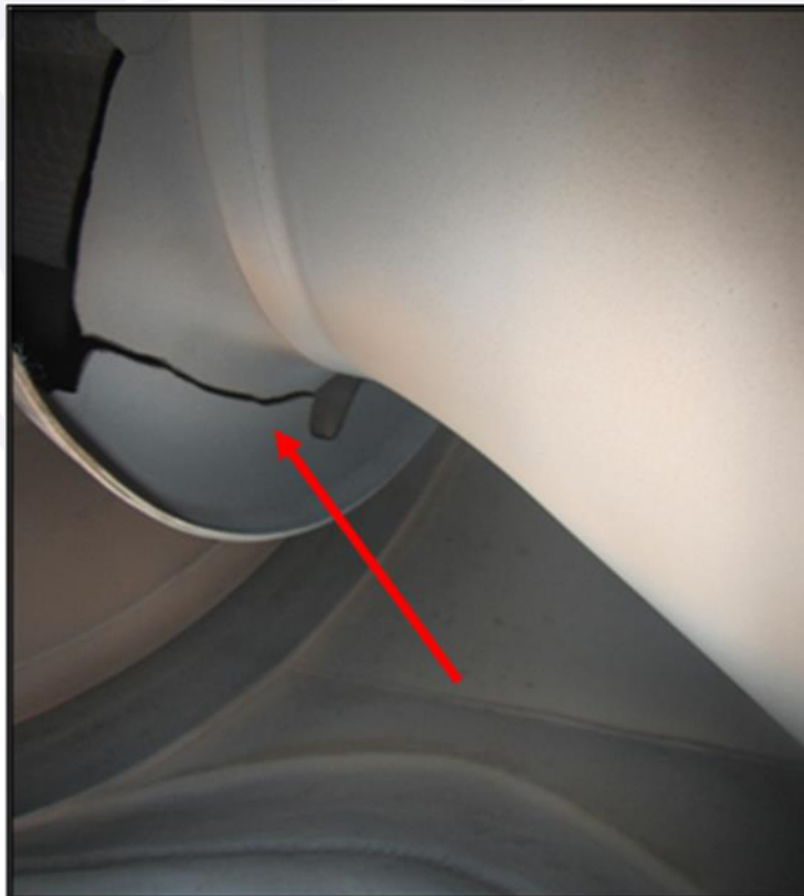
Figure 7 - Approximate image of the interior of the Exhaust Duct.  
The arrow indicates the damaged region.

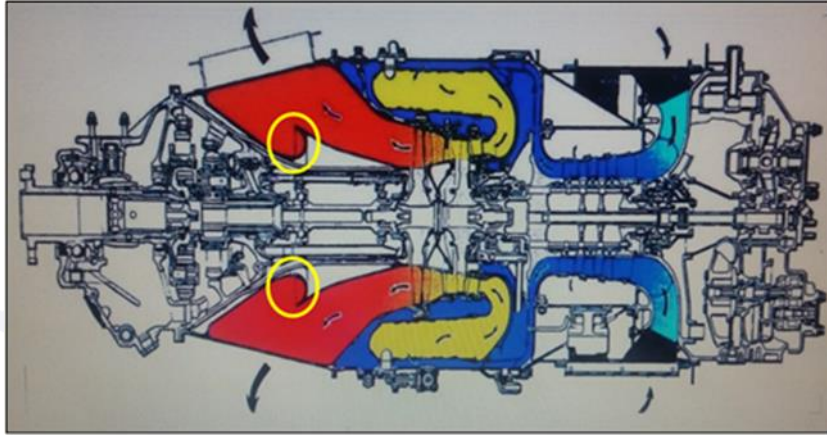
Figure 8 - Schematic diagram of the air flow in the engine.  
The highlights (yellow circles) show the fracture region.

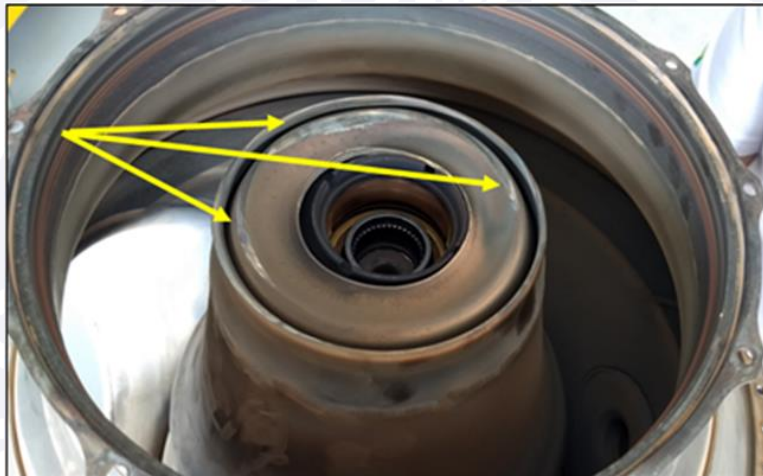
With the access obtained after the opening of the engine, one could observe rubbing (friction) marks on the rear part of the Exhaust Duct (Figure 9).

Figure 9 - Rear part of the Exhaust Duct with friction/rubbing marks, highlighted by yellow arrows

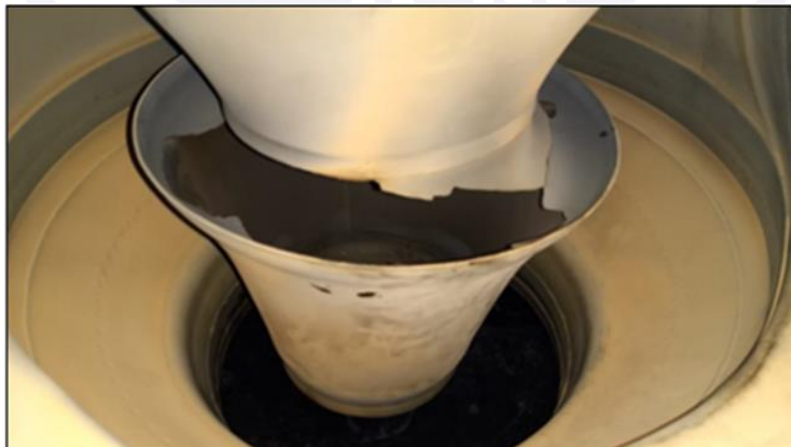
After separation of the Exhaust Duct from the Gearbox, one found that there had been loss of material from its structure (Figure 10).

Figure 10 - Internal damage with loss of material in the Exhaust Duct.

- l) during exams of the Exhaust Duct, a large damaged area was observed, with material missing from its internal part;
- m) metallographic exams of the internal and external surfaces of the fracture region in the Exhaust Duct showed that they had corrosion pits;

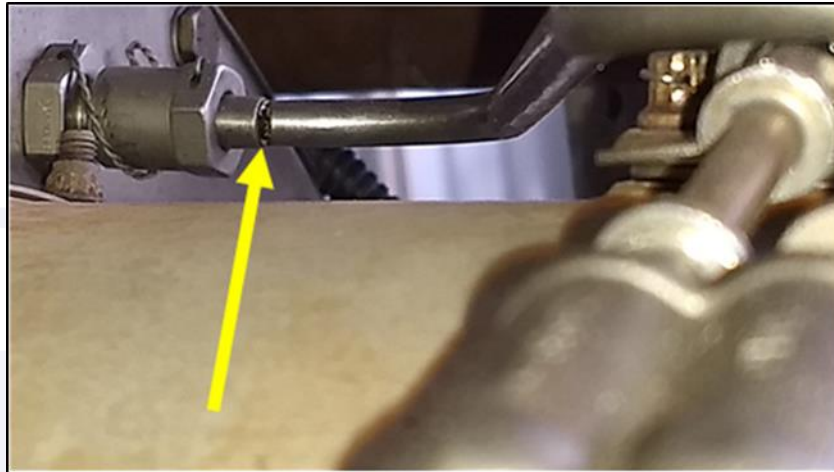
During the visual inspection of the external parts of the engine, one observed damage to the Py piping terminal (Figure 11).

Figure 11 - Image of the Py pipe. The yellow arrow indicates the damaged part.

The said piping was fixed to the structure of the engine, at the point of separation between the *Gas Generator Case* and the *Exhaust Duct*.

The function of the PY pressure, is to modulate the fuel flow in accordance with the requested power. A loss of Py pressure, (i.e., a leak in the Py tube), will result in a fuel flow reduction leading to a loss of engine power. Without Py pressure the only way to modulate the fuel flow would be via the emergency power lever (EPL).

With respect to the failure identified in the Py piping, given that the said component was fixed to the engine structure at the point of separation between the Gas Generator Case

and the Exhaust Duct, it is possible that the vibration resulting from the loss of material from the exhaust system structure caused the rupture of the pipe. Such failure was facilitated by the weakening of the material due to the presence of intergranular corrosion and pitting in the fracture region, and was responsible for the loss of engine power.

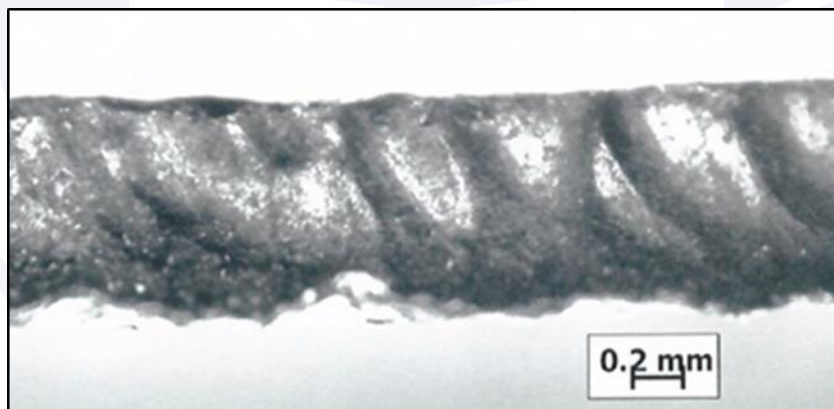
Visual and stereoscopy analyses of the Exhaust Duct indicated that erosion had occurred on the fracture surface as a result of the flow of hot air originating from the engine's internal combustion process (Figure 12).

Figure 12 - Wavy Exhaust Duct fracture surface, indicating erosion by hot gases.

With respect to the Exhaust Duct, the laboratory exam concluded that the fracture was facilitated by the presence of hot corrosion. It was not possible to determine the failure mechanism due to erosion of the fracture surface caused by the flow of hot gases from the engine's internal combustion process.

Relatively to the Exhaust Duct, although the analyses in the laboratory led to the conclusion that it was not possible to determine the failure mechanism due to the erosion of the fracture surface caused by the flow of hot gases originating from the engine's internal combustion process, the presence of the corrosion surface in the region of the fractures suggested the possibility that the degradation of the material of this component was already under way on the date of the 450 flight-hour inspection (12 April 2019), and that the referred process culminated in the fracture of the equipment.

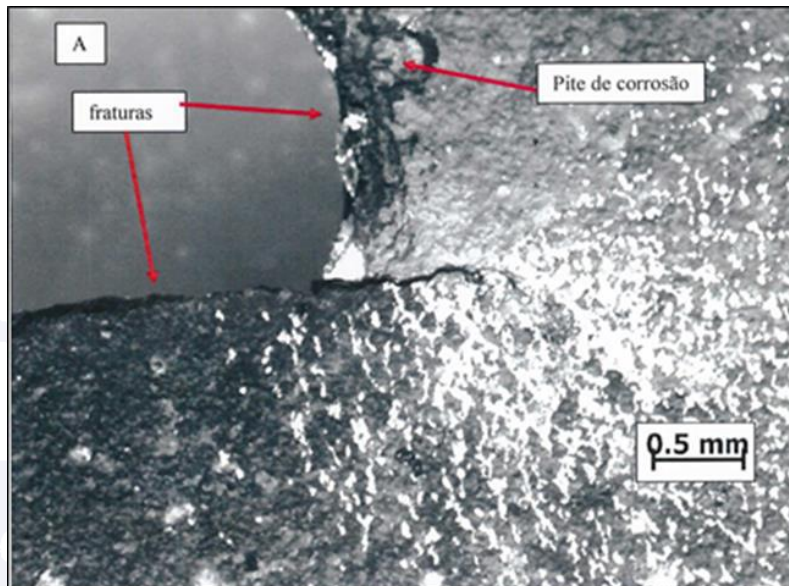
The Metallographic exam of the internal and external surfaces of the fracture region also showed the presence of corrosion pits. (Figure 13).

Figure 13 - Photostereoscopy of the fracture region showing the existence of corrosion pits.

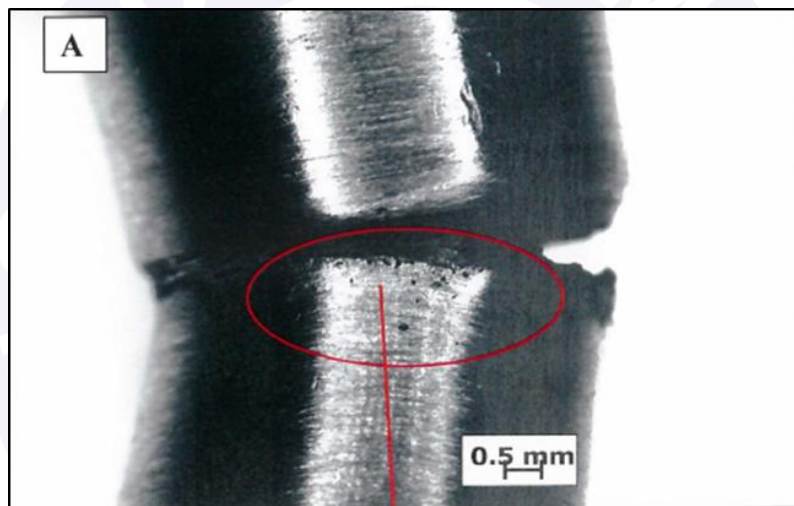
The analysis of the Py piping showed widespread corrosion on its internal surface, close to the fracture, in addition to intergranular corrosion and pitting in the fracture region (Figures 14, 15, and 16).

Figure 14 - Image of the Py Tube fracture showing the corrosion pits.

Based on the results of the analyses, one concluded that the Py tube presented a fracture that had started in corrosion pits.

With regard to the failure of the Py tube, in view of the laboratory analysis' conclusion that the fracture began in corrosion pits, one concluded that such process weakened the material and facilitated its rupture due to the abnormal vibration that occurred after the failure of the Exhaust Duct.

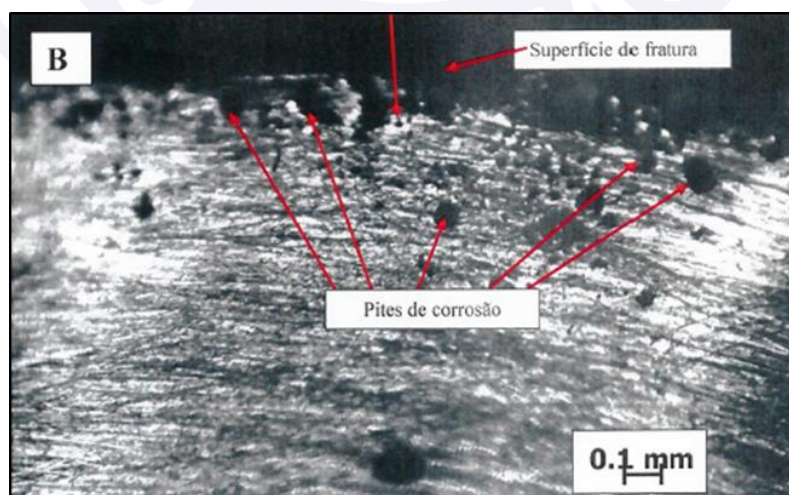
Figure 15 - Close-up image of the Py Tube fracture showing the pits of corrosion.

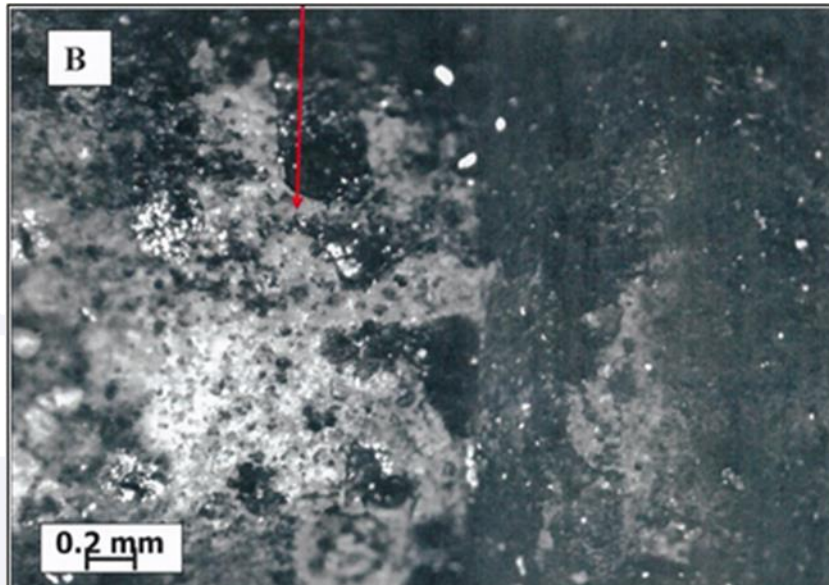
Figure 16 - Image of the internal part of the Py Tube showing widespread corrosion.

Still, considering the widespread corrosion observed, it is possible that the degradation of the material was already under way on the date of the last engine inspections (07 October 2019), eleven days before the incident in question.

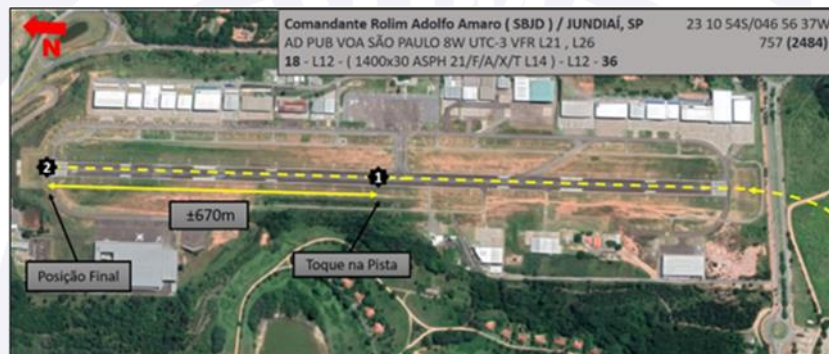
The aircraft touched down approximately at the midpoint of the runway. During the braking, the main landing gear tires burst (Figures 18 and 19).

Figure 18 – Croquis of the occurrence.

After traveling for about 700 m, the aircraft stopped 10 m past the end of the runway.

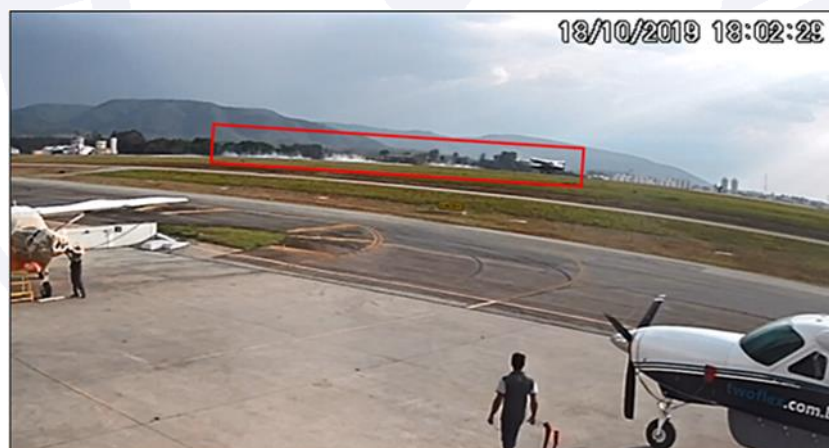
Figure 19 - Image showing the smoke produced by the locking of the main landing gear wheels.
