**FINAL REPORT**  
**IG-127/CENIPA/2020**

**SERIOUS INCIDENT**

**PR-MYW/PT-OLF**

**A320-214/PA-31T1**

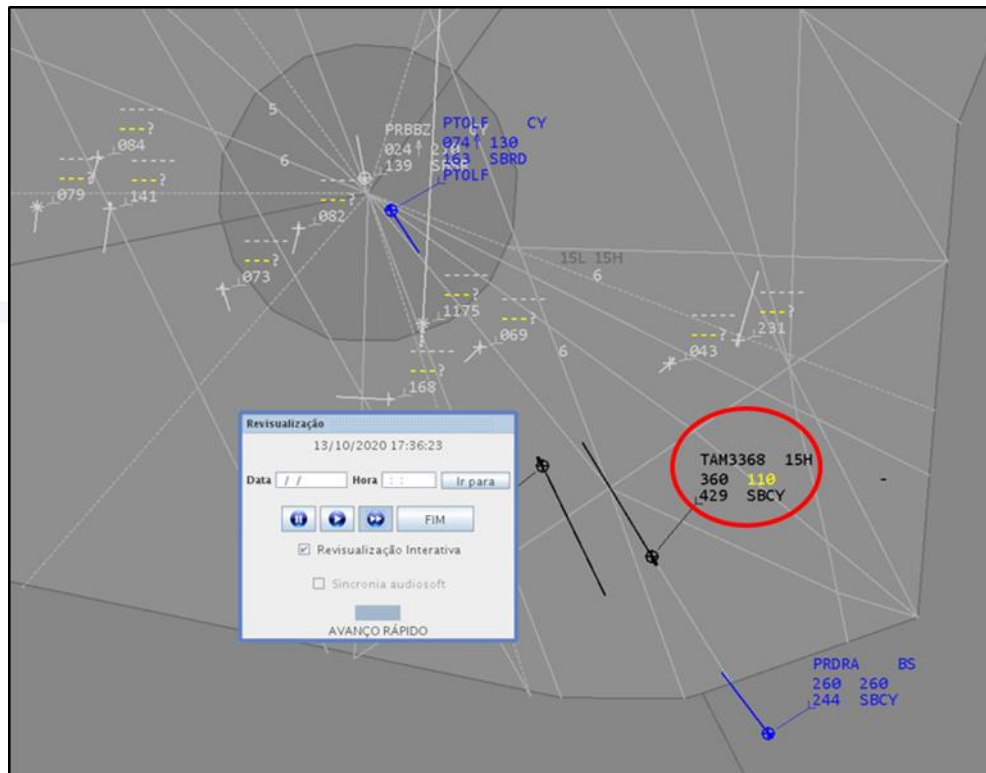
At 17:35:50 UTC, PR-MYW (TAM 3368) requested descent clearance from ACC-AZ and was cleared to descend to FL110 (Figure 2).

Figure 2 – PR-MYW (TAM 3368) highlighted at FL360, with cleared descent to level FL110 (in yellow).

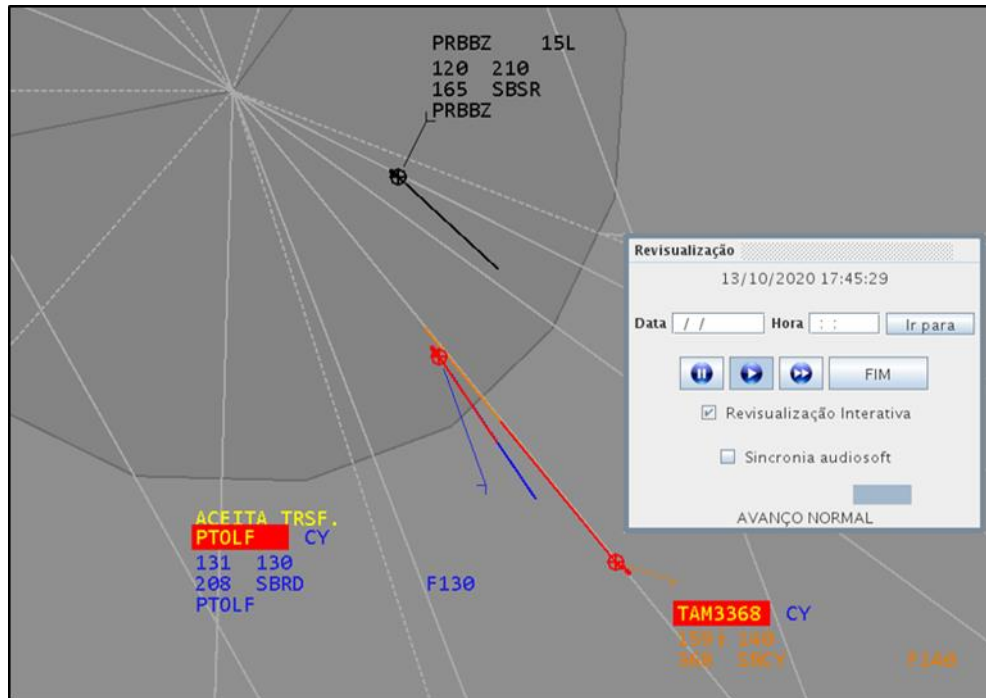
At 17:46:06 UTC, PR-MYW (TAM 3368) squawked IDENT at the request of APP-CY while descending through FL150, proceeding direct to position CY001 of the ILS X RWY35 approach procedure, on a converging course with PT-OLF (Figure 3).

Figure 3 – Aircraft on converging courses, approximately 26 NM apart.

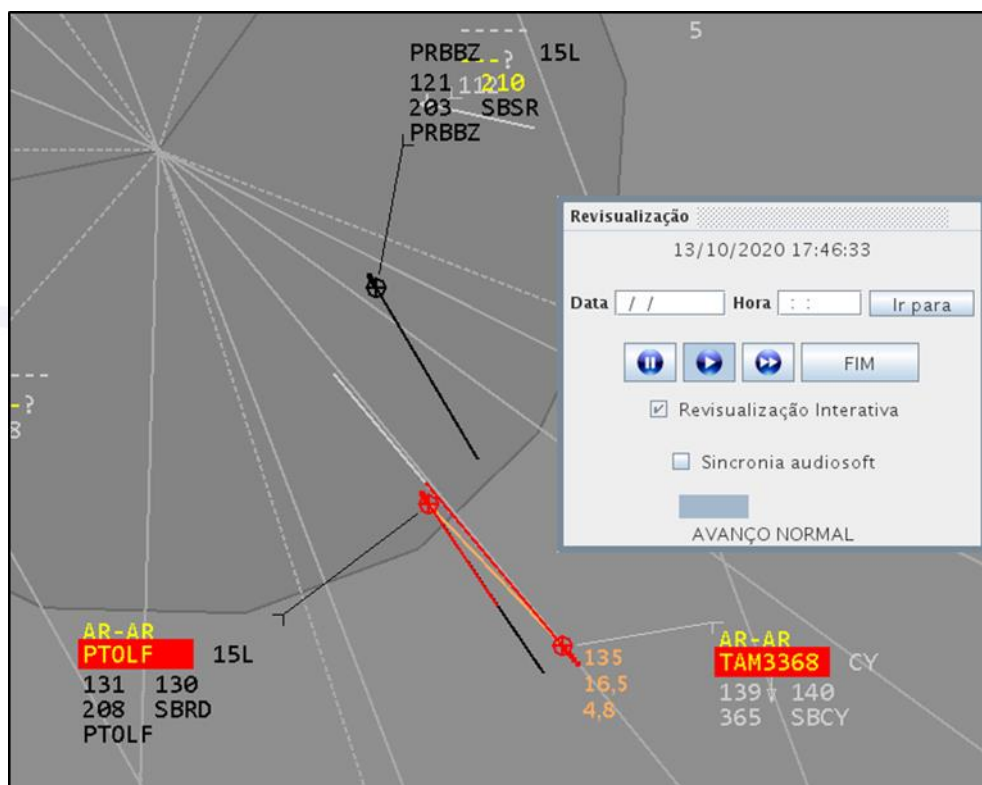
At 17:46:33 UTC, PR-MYW (TAM 3368) passed FL140 while descending, 16 NM from PT-OLF (Figure 4).

Figure 4 – PR-MYW (TAM 3368) passing FL140 during descent.

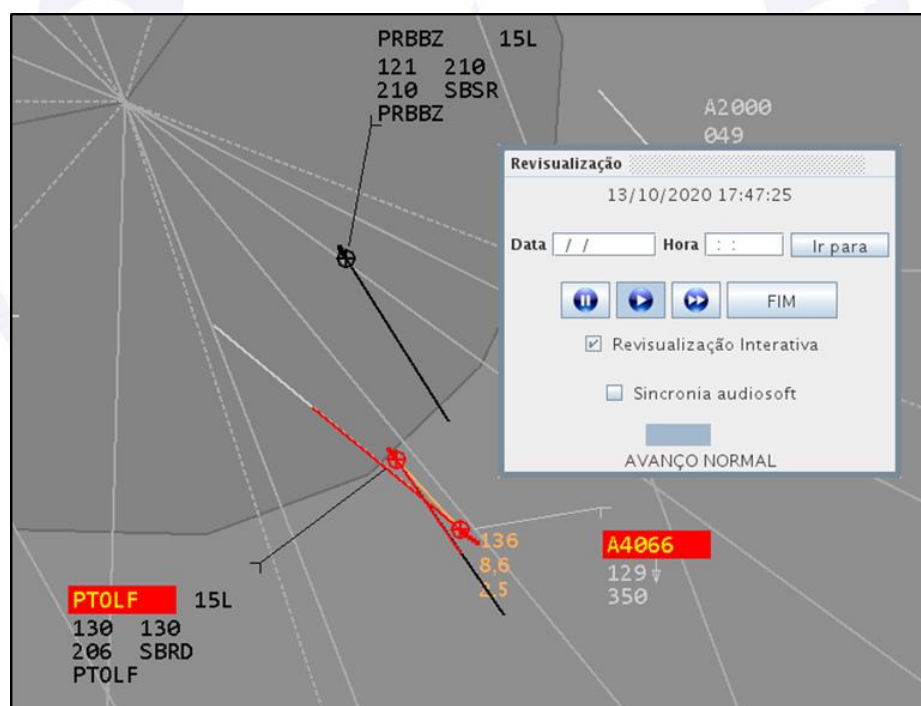
At 17:47:22 UTC, during the descent of PR-MYW, which was approximately 2 NM from PT-OLF, on an opposite course, the ASST APP-CY identified that the traffic had been cleared to FL060 and requested the ATCO APP-CY to restrict PR-MYW to FL130, while informing that PR-BBZ was maintaining FL120 (Figure 5).

Figure 5 – PR-MYW (TAM 3368) passing FL130, approximately 2 NM away, on an opposite course to PT-OLF.

The ATCO APP-CY immediately issued the restriction. However, as PR-MYW was approaching FL130, it briefly descended below the assigned level, reaching FL128 before returning to FL130. At that moment, APP-CY identified the conflict between PR-MYW and PT-OLF.

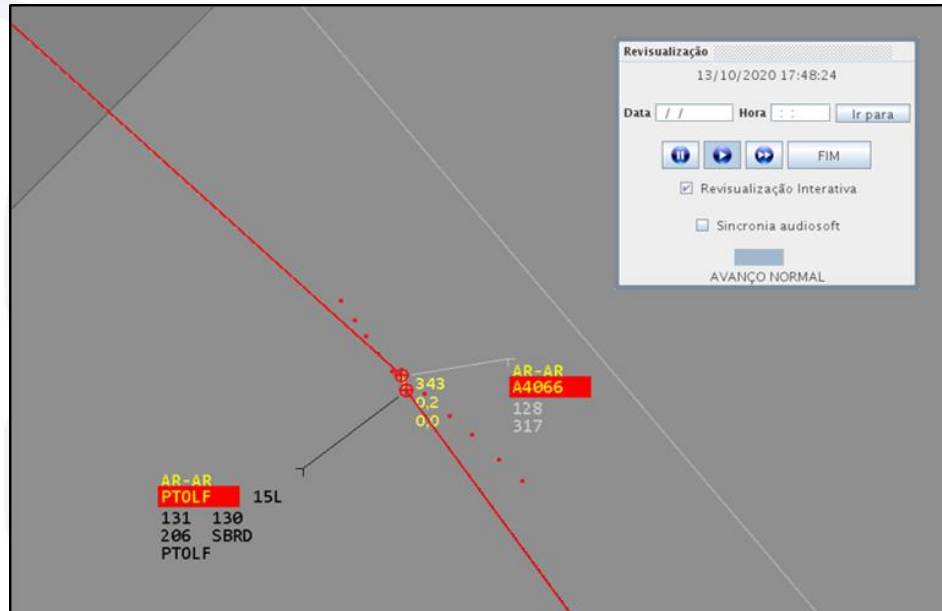
The crossing of paths below the minimum required separation occurred at 17:48:24 UTC. Radar data indicated a crossing with a vertical separation of 100 ft. and a lateral separation of 0.2 NM, within Class G ATS Airspace under ACC-AZ jurisdiction, approximately 0.8 NM from the *Cuiabá* Terminal Area boundary (Figure 6).

Figure 6 – Air-to-Air Conflict Alert on the SAGITÁRIO system showing separation of 100 ft. and 0.2 NM between PT-OLF and PR-MYW (TAM 3368) at 17:48:24 UTC.

During the investigation, it was found that the Air-to-Air Conflict Alert issued by the *SAGITÁRIO* system was not given due attention by the ACC-AZ team, as those involved believed the aircraft would remain vertically separated until horizontal separation was ensured – something which did not occur.
