**COMANDO DA AERONÁUTICA**  
**CENTRO DE INVESTIGAÇÃO E PREVENÇÃO DE**  
**ACIDENTES AERONÁUTICOS**

**FINAL REPORT**  
**A-063/CENIPA/2022**

| <b>AIRCRAFT:</b> | <b>PT-OQR</b> |
| <b>MODEL:</b> | <b>208</b> |

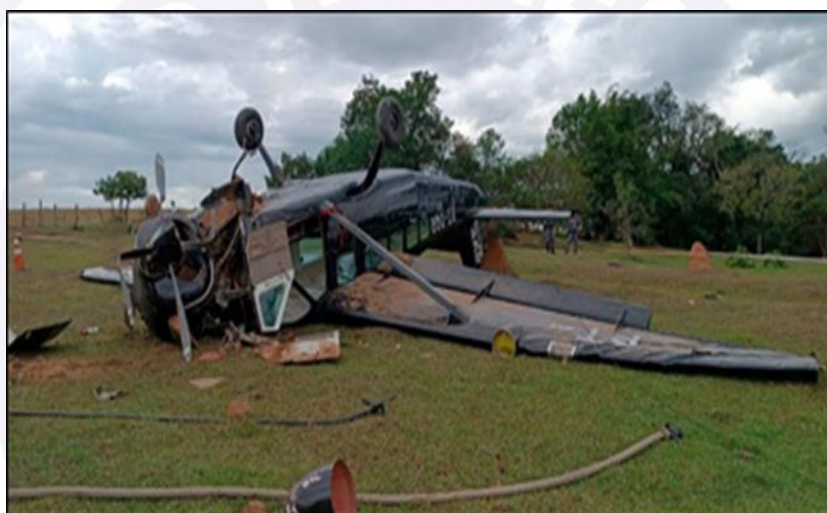
Upon landing, the aircraft collided with an embankment and a fence, and eventually overturned.

Figure 1 – Aircraft shortly after the occurrence.

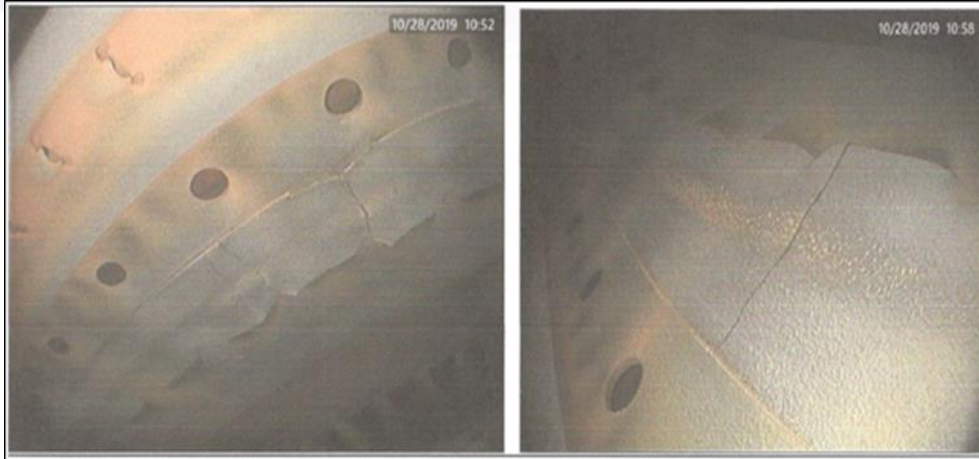
Figure 2 – Borescopic image of the outer liner of the engine's combustion chamber on October 28, 2019.

- On December 17, 2019, with a TSN of 3,017 hours and 36 minutes, the inner liner and outer liner of the engine's combustion chamber were replaced;
- On March 23, 2020, with a TSN of 3,092 hours and 18 minutes, the aircraft engine was removed and sent to *Pratt & Whitney Canada do Brasil* for inspection, during which repairs were performed on the compressor stator and an engine test bench run was conducted;
- On June 18, 2021, with a TSN of 3,218 hours and 36 minutes, a borescope inspection was performed on the engine by *CONAL AVIONICS*, during which the presence of cracks in the combustion chamber was identified, along with burn marks, erosion, and material loss in some stator blades (Figure 4). The investigation team was not provided with the corresponding inspection report, and it was not entered into the aircraft's logbooks;

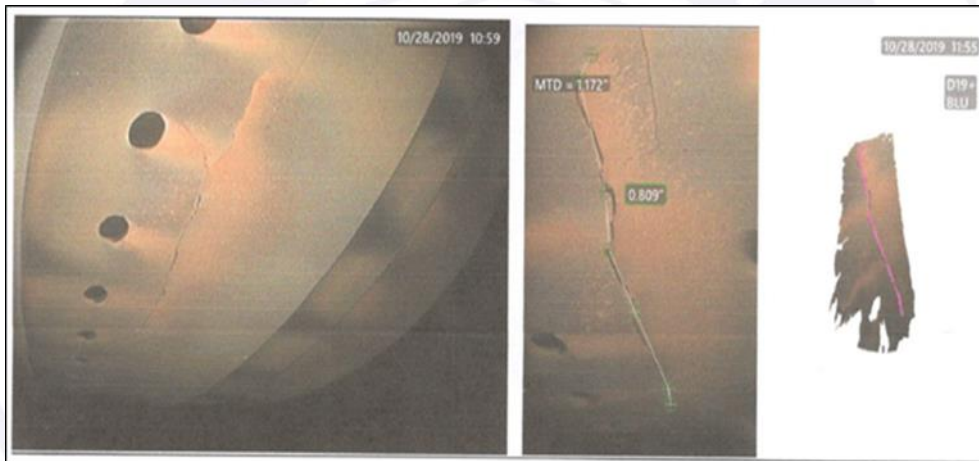
Figura 3 - Borescopic image of the inner liner of the engine's combustion chamber on October 28, 2019.

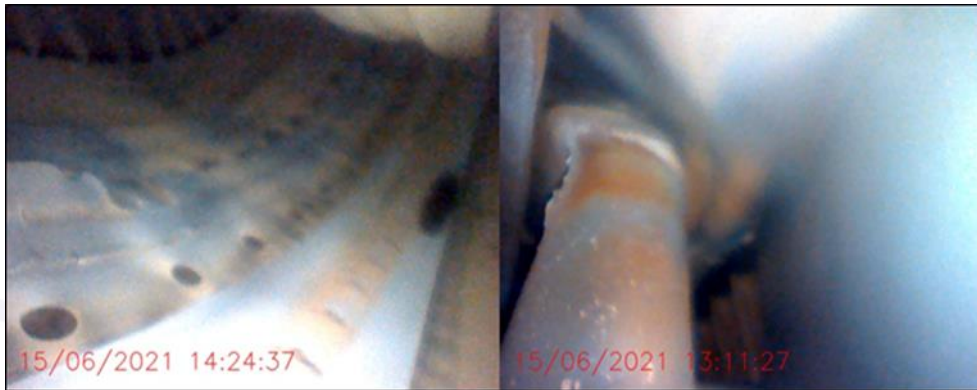
Figure 4 – Cracks in the combustion chamber and burn marks, erosion, and material loss in a compressor stator blade.

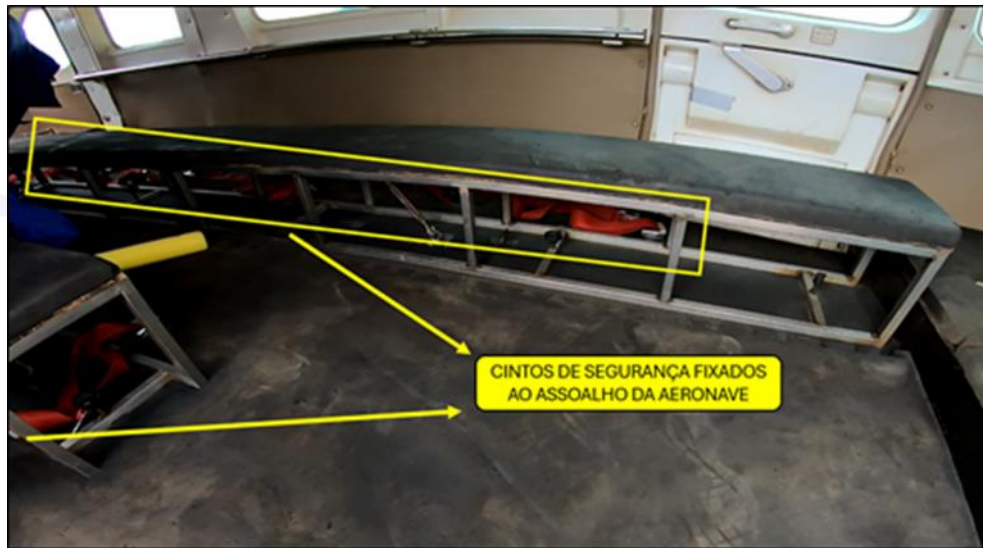
Furthermore, it was observed that the parachutists' seat belts were attached to the aircraft floor on only one side of the benches, as shown in Figure 9.

Figure 9 – Highlight showing the positioning of the seat belts attached to the floor on only one side of the benches (outer sides of the cargo cabin).

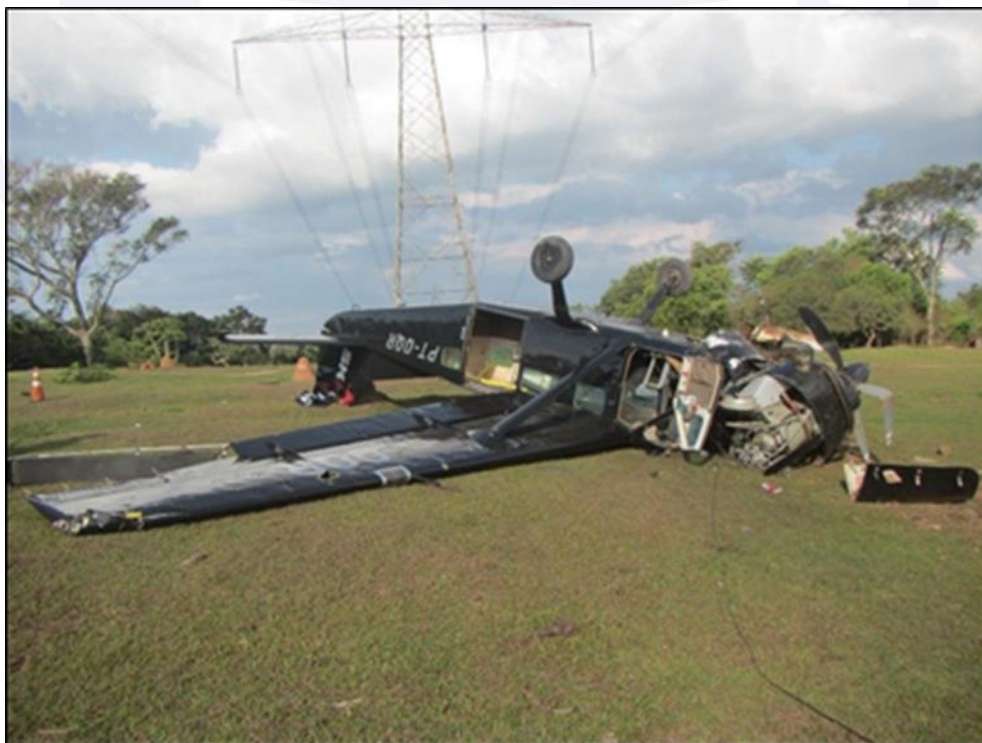
The nose landing gear separated at the final impact, and the left main landing gear struck the slope before the right main gear, generating a yawing moment to the left and causing the aircraft to overturn.

Figure 19 – Final resting position of the aircraft.

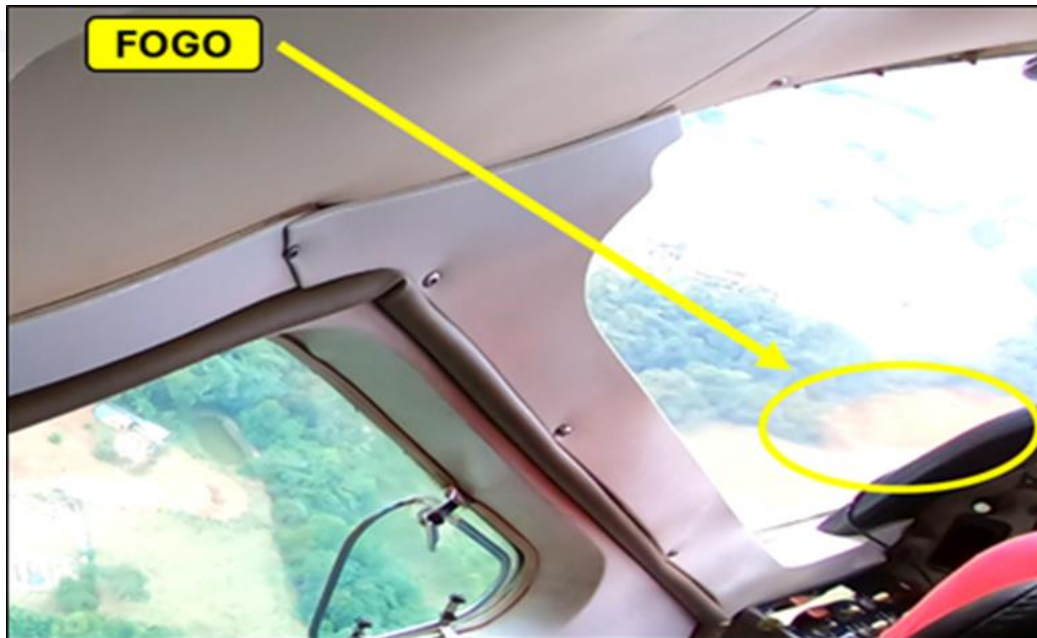
Footage from one of the parachutists' cameras showed flames emerging from the engine exhaust moments before the emergency landing, as illustrated in Figure 25.

Figure 25 – Flames visible from the left exhaust moments before the emergency landing.

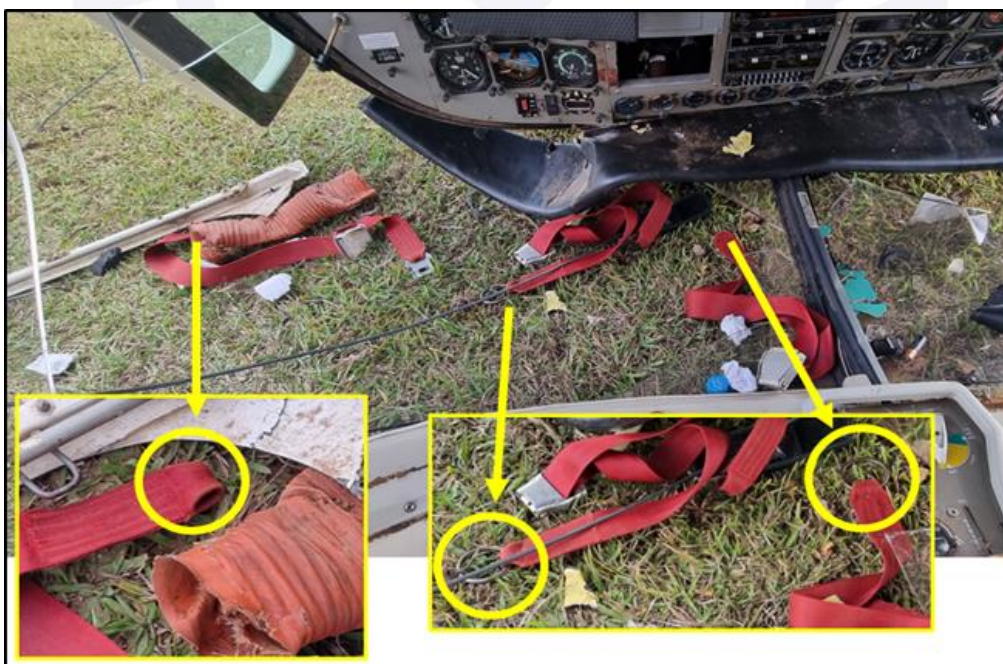
Following the impact, the aircraft occupants were thrown forward, compressing the pilot's seat and those located toward the front of the cabin. Most of the passenger seat belts were torn due to the impact, as illustrated in Figures 26 through 30.

Figure 26 – Seat belts found at the front of the aircraft: missing anchor ring (highlighted on the left) and with intact anchor rings (highlighted on the right).

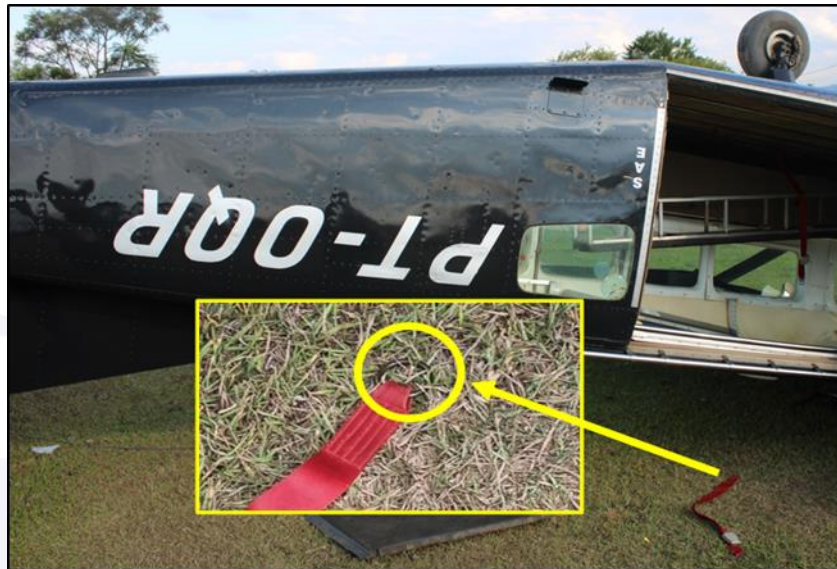
Figure 27 – Seat belt found next to the aircraft, with intact anchor ring.

Some of the attachment fittings were sheared, and some of the anchor rings were broken. In addition, some of the seat belts were torn. Rust marks were also observed on the sheared fittings, as shown in Figures 27 to 30.

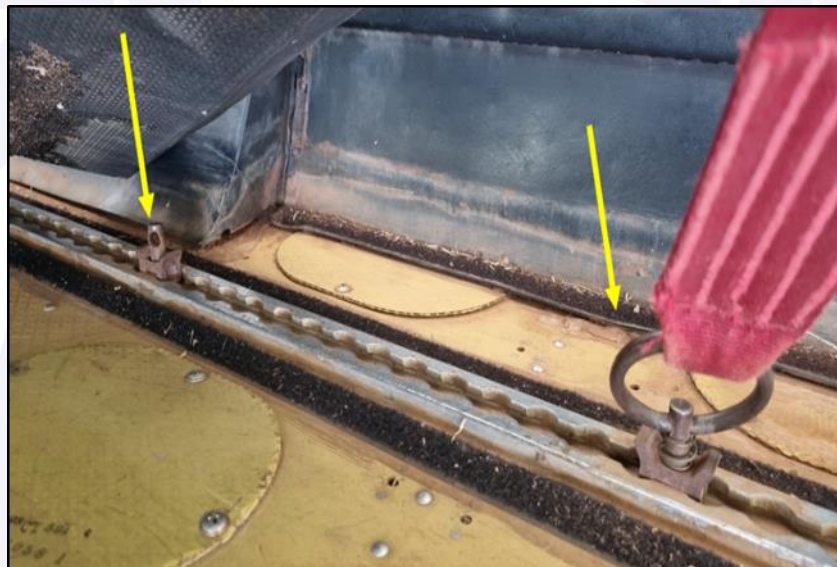
Figure 28 – Belt attachment fittings on the aircraft floor rails showing signs of corrosion (highlighted in yellow).

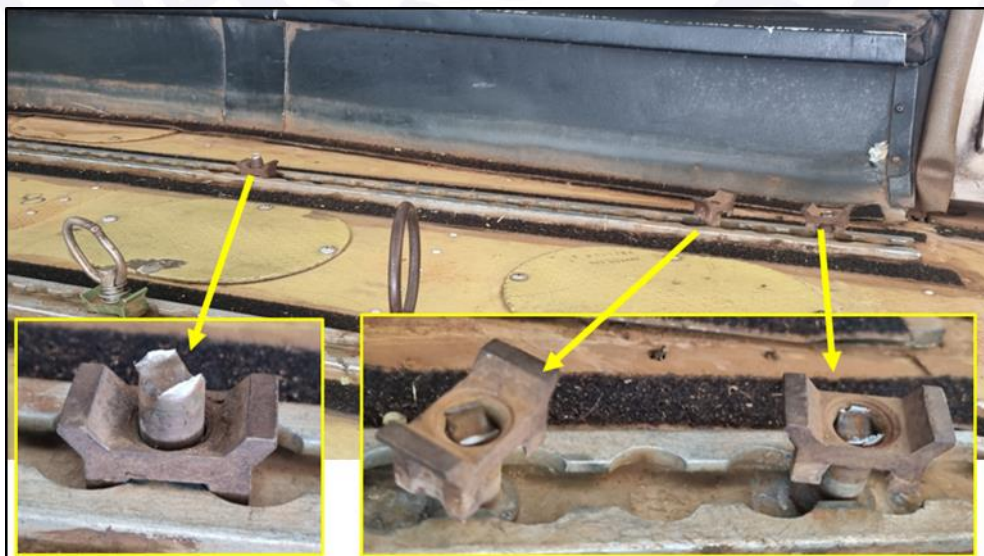
Figure 29 – Sheared belt attachment fittings on the aircraft floor rails (highlighted in yellow).

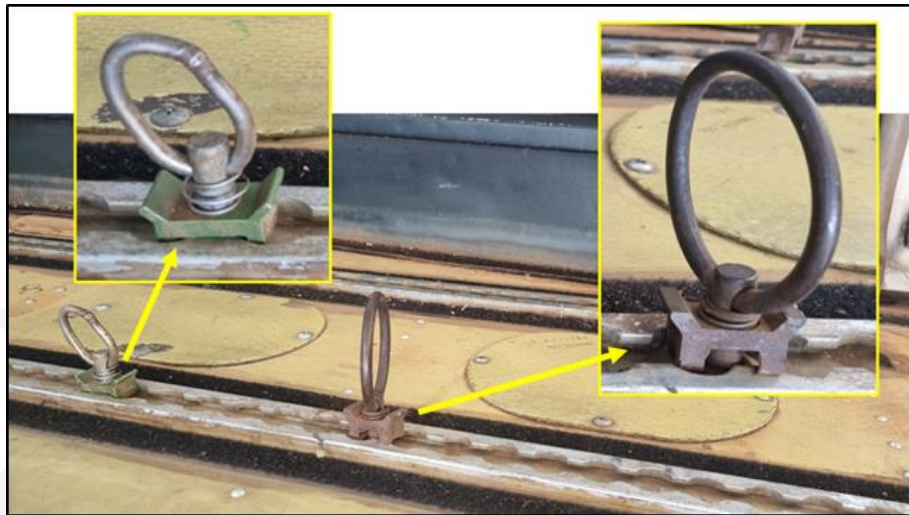
Figure 30 – Belt attachment fittings on the aircraft floor rails found in the unlocked position (highlighted in yellow).

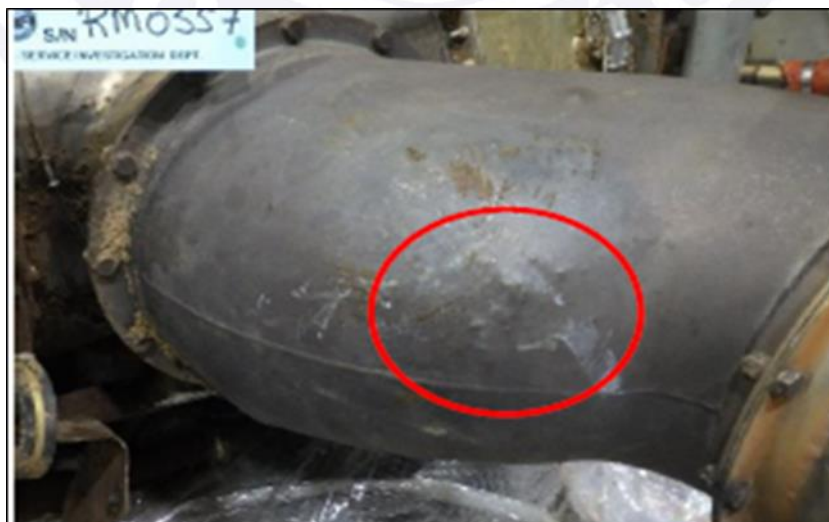
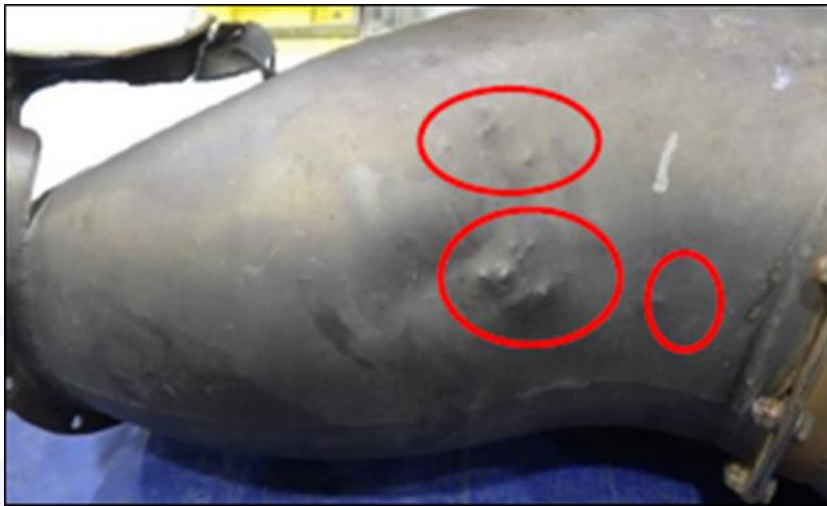
During the investigation, an analysis was conducted on the Pratt & Whitney engine, model PT6A-42A, SN PCE - RM0557. It was observed that, externally, the engine did not suffer significant damage. However, the FCU sustained damage that prevented it from being tested on a test bench. Impact marks were observed on the left exhaust duct, from the inside out, as shown in Figures 31 and 32.

Figure 31 – Damage observed on the aircraft's left exhaust duct.

Figure 32 – Damage observed on the aircraft's left exhaust duct.

The remaining portion of this material was carried by the flow of overheated gases, and the impact of these particles on the stages of the power turbine caused damage to the stator vanes and blades. As a result, fragments from these blades collided with the exhaust ducts, leaving visible marks on the left duct.

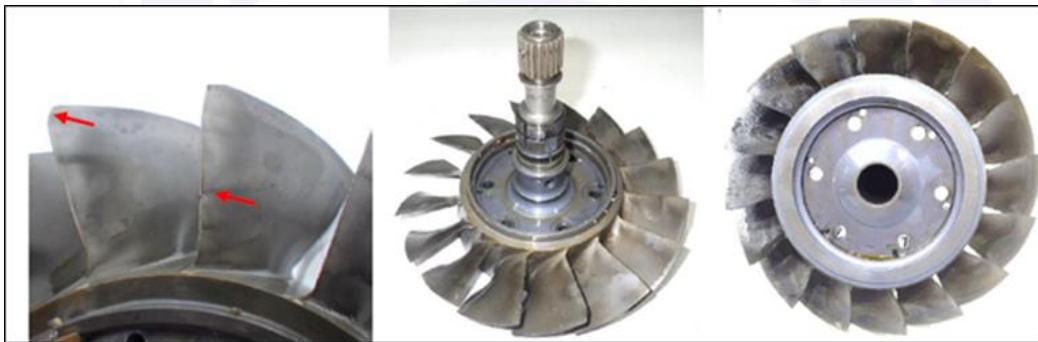
In the axial compressor, minor damage was observed on the first-stage blades caused by Foreign Objects (FO), along with erosion on their respective leading edges (Figure 35).

Figure 35 – First stage of the axial compressor; red arrows point to FO-induced damage.

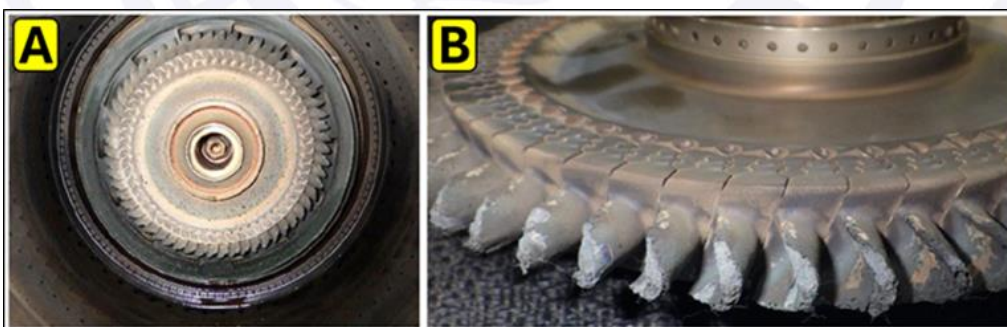
Subsequently, during the analysis, it was verified that the compressor turbine blades exhibited heat damage, with approximately half of their length burned/melted. Delamination of the protective coating on the blades was also observed (Figure 36).

Figure 36 – (A) – Heat damage on the compressor turbine blades.  
(B) – Delamination of the protective coating on the blades.

Regarding the conditions found in the engine, it was possible to observe that its temperature, during operation, reached high levels, exceeding the material resistance limit of the turbine blades. This caused a change in the physical state of the material (melting), leading to its deterioration, with part of the melted material being deposited on the shroud due to centrifugal force.

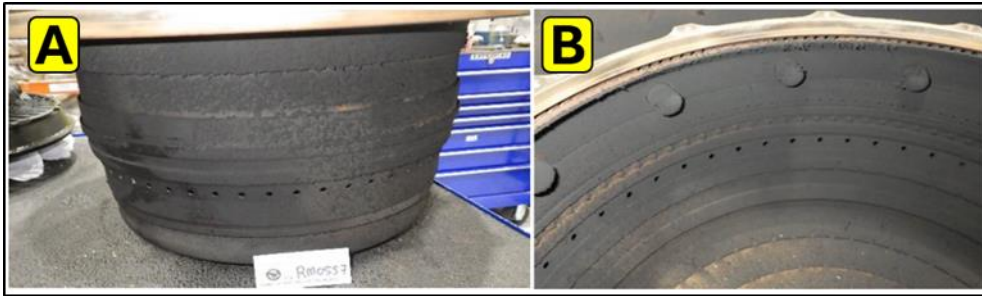
A large amount of soot was observed deposited inside the combustion chamber and on the fuel nozzles, indicating that the engine operated with a rich air/fuel mixture—meaning there was more fuel than necessary for the proper combustion of the air supplied by the compressor (Figure 37).

Figure 37 – Internal and external lining of the combustion chamber showing soot deposits and carbon buildup on the walls and cooling ring.

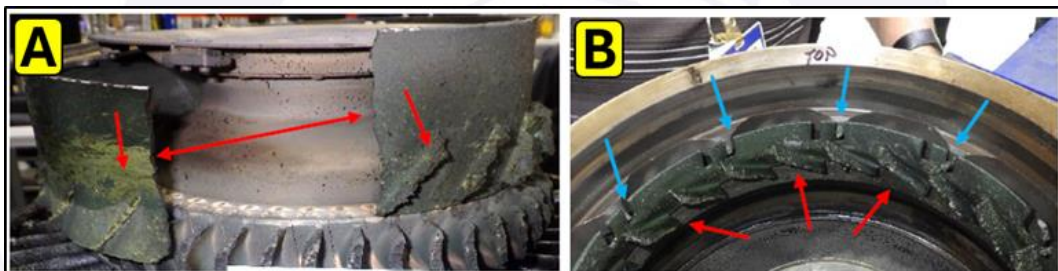
The entire stator of the first stage of the power turbine was melted, and its inner rim was fractured, as shown in Figure 38(A). Only a small portion of the vanes was observed on the inner and outer edges (red arrows). The T5 probes (Figure 38 B) were melted/fractured (blue arrows).

Figure 38 – Close-up: stators indicated with red arrows and T5 probes with blue arrows.

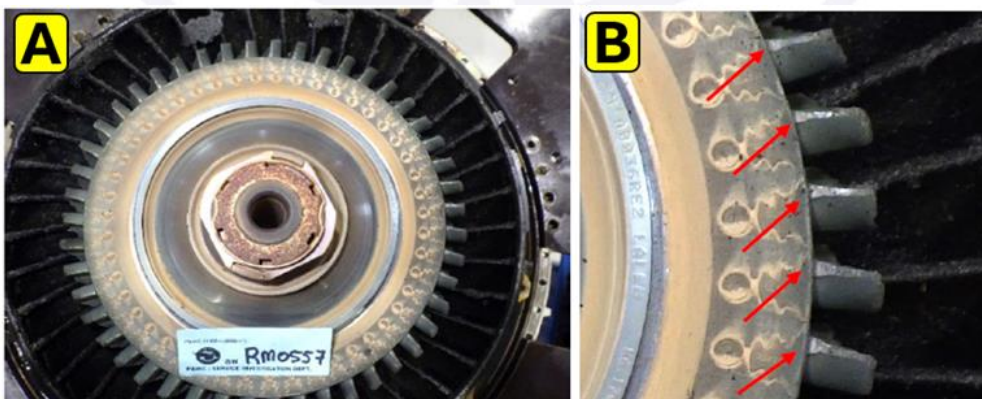
The blades of the first stage of the power turbine were fractured approximately 0.63 cm from their roots, as shown in Figure 39(A). In addition, signs of rubbing were observed on the remaining portion of the leading edge of the blades, extending from the root to the fractured area (Figure 39 B). The fracture surface of the blades displayed an irregular pattern, characteristic of overload, as shown in Figure 40.

Figure 39 – (A) First stage of the power turbine with fractured blades; detail of rubbing on the blades indicated with red arrows (B).

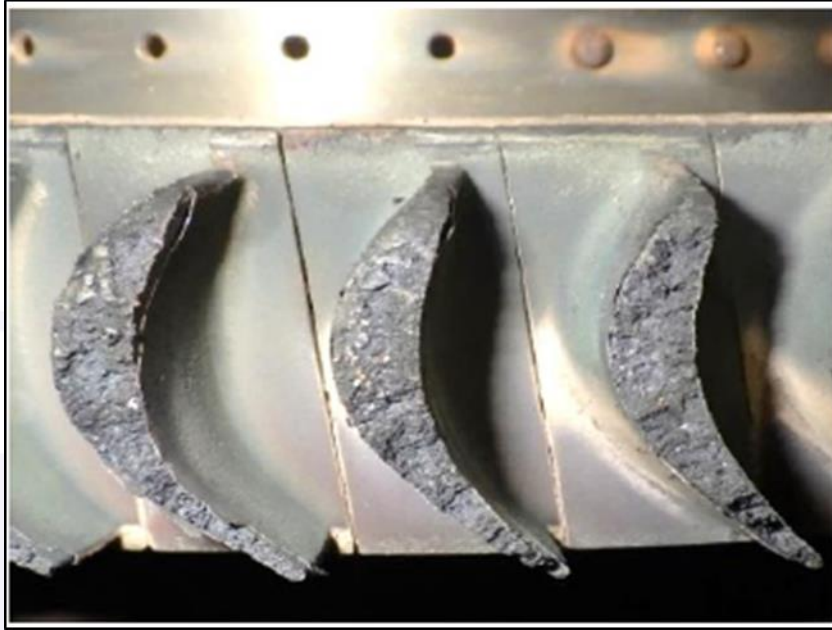
Figure 40 – Frontal view of the blades from the first stage of the power turbine.

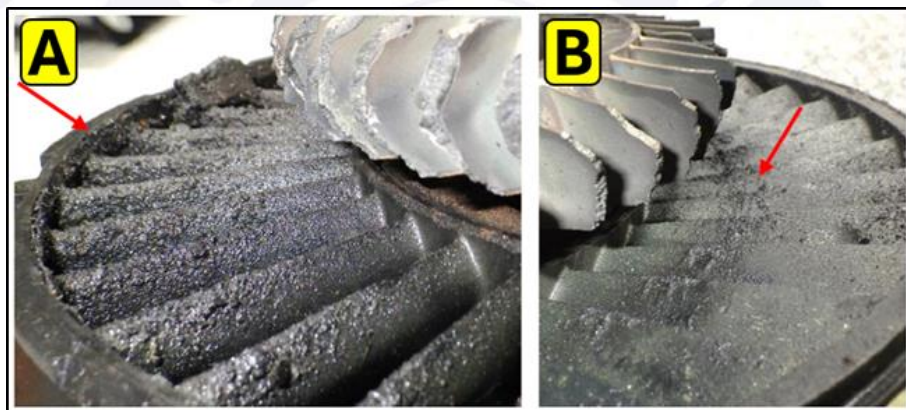
Figure 41 shows the stators of the second stage of the power turbine with impact damage and splashes of material on the airfoil surfaces. Additionally, debris from the ring and blades of the first stage of the power turbine was found lodged between the airfoils.

Figure 41 – Leading edge of the second-stage power turbine stator (A) and trailing edge on the right (B).

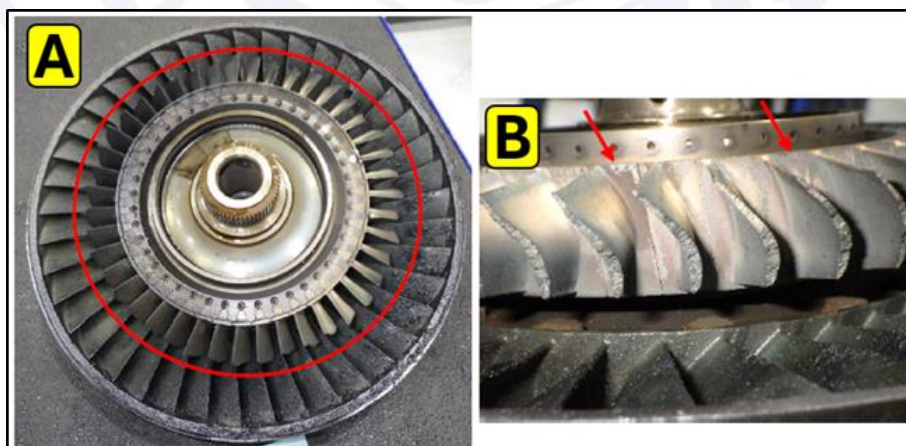
Figure 42 – Second stage of the power turbine (A) and presence of corrosion highlighted with red arrows (B).

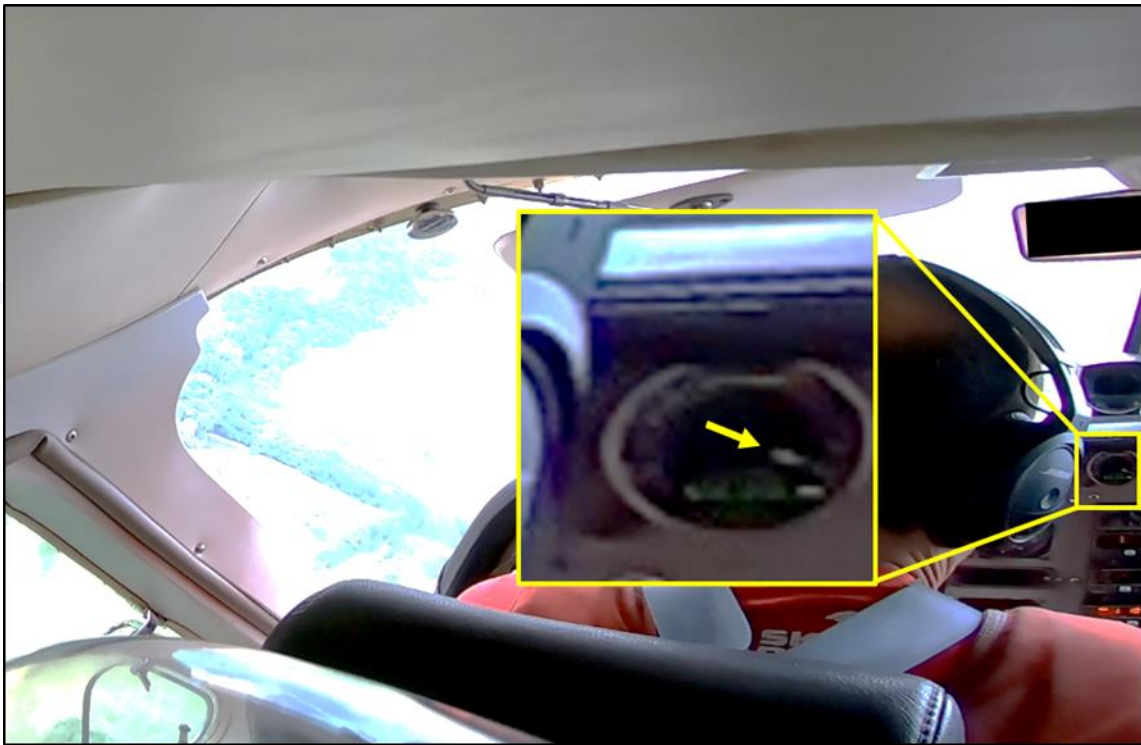
Footage from a helmet-mounted camera worn by one of the parachutists showed that the Interstage Turbine Temperature (ITT) indication was near the upper limit of the instrument's range, as shown in Figure 43.

Figure 43 – ITT indication near the instrument's upper limit.
