**COMANDO DA AERONÁUTICA**  
**CENTRO DE INVESTIGAÇÃO E PREVENÇÃO DE**  
**ACIDENTES AERONÁUTICOS**

**FINAL REPORT**  
**A-061/CENIPA/2022**

<b>OCCURRENCE:</b>	<b>ACCIDENT</b>
<b>AIRCRAFT:</b>	<b>PT-OUB</b>
<b>MODEL:</b>	<b>PA-25-235</b>
<b>DATE:</b>	<b>03MAI2022</b>

This is Final Report of the 3<sup>rd</sup> May 2022 accident involving the model PA-25-235 aircraft, registration marks PT-OUB. The accident was typified as “[LOC-I] Loss of Control in Flight and [LALT] Low Altitude Operation”.

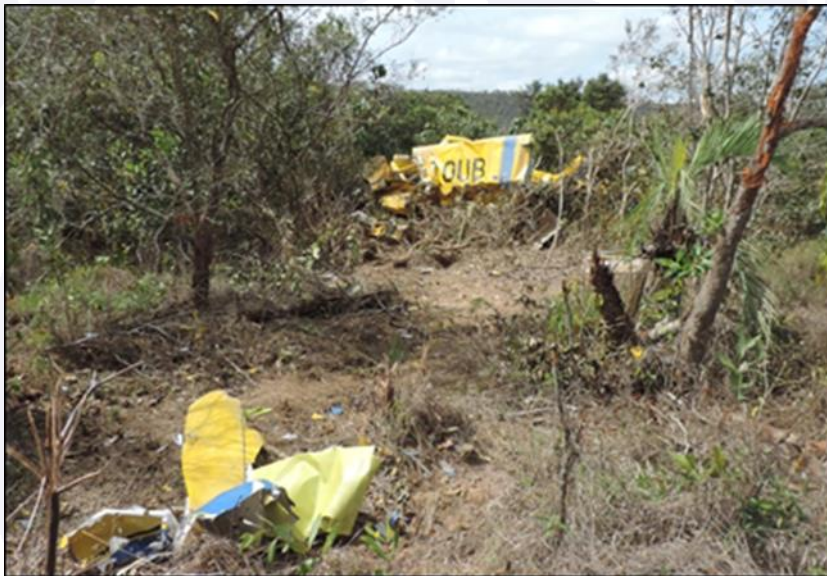
The aircraft was about to perform a repositioning turn when there was loss of control in flight, causing the airplane to collide with the ground.

Figure 1 - Final position of the aircraft.

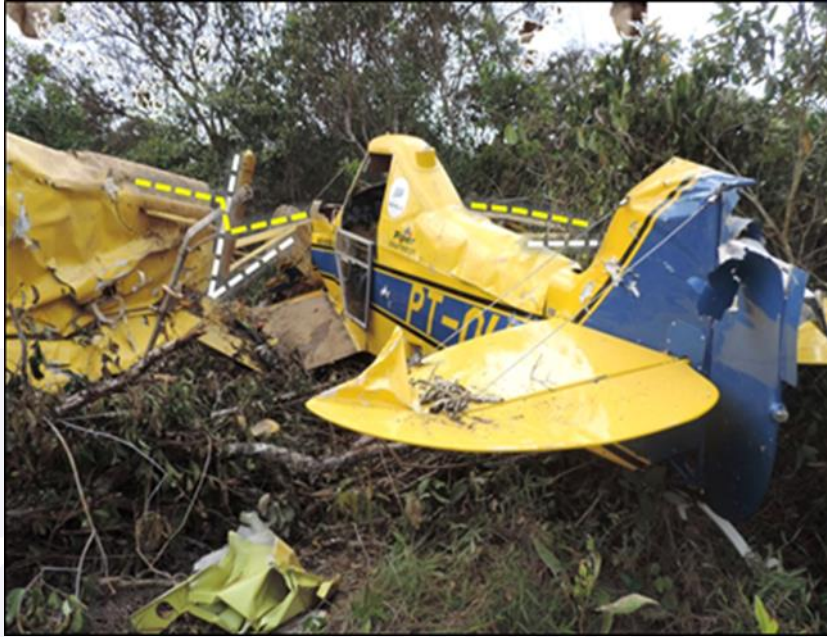
The aircraft sustained substantial damage. The main landing gear was *crumpled*, the engine mount was broken, the propeller assembly separated from the engine shaft, the wing struts were deformed, and the left wing was partially separated upwards and backwards (position closest to the root, approximately one-third of its length).

The left strut displayed a “V”-shaped bend, in addition to dents. The right-hand strut had several dents, but retained its original shape.

The cockpit remained preserved, as did the rear section of the fuselage, except for the vertical stabilizer, which showed damage to its upper part (Figure 2).

Figure 2 - Detail of the wing struts and cockpit preservation.

With regard to the deformation of the wing struts, the left-hand wing strut was bent in a "V" shape, in addition to being dented, and the right-hand wing strut sustained several dents, but maintained its original shape, which suggests that the aircraft touched the ground with the left wing lower in relation to the right-hand wing (rolling or turning to the left), consistent with what was observed on the ground.

The partial separation of the left wing upwards and backwards at the position closest to its root, but at approximately one-third of its length, and the damage observed on the right-hand side, corroborate that the aircraft touched the ground while rolling to the left.

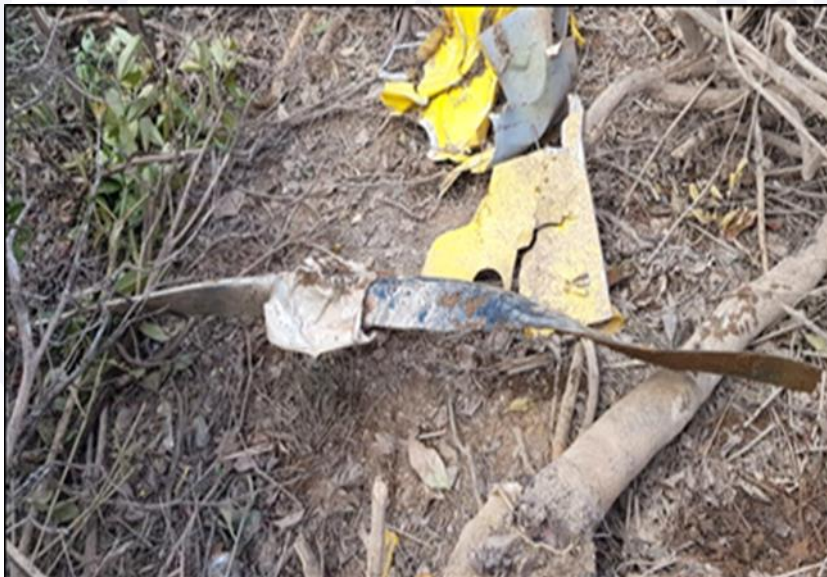
The tip of the left-hand wing was found approximately 10 m from the site, in the direction of the crash. The propeller assembly was torn from the engine shaft and was found in an intermediate position between the tip of the left wing and the wreckage concentration.

Figure 3, below, shows an overview of the curvature of the propeller blades, both of which had transverse scratches caused by the collision with the ground.

Figure 3 - View of the propeller blades.

Since the collision with the ground occurred at a relatively low angle for a loss of control in flight, less than 45° and in the direction of travel, but in a left turn, one inferred that these parts had detached from the aircraft while it was still in flight. However, it was not possible to verify to what extent this detachment of components with the aircraft flying influenced its controllability and led to the loss of control in flight. The damage observed on the aircraft's propeller blades suggested that there had been no loss of engine power that could have affected the aircraft's performance. The transverse scratches on both blades indicated that propeller was rotating at the time of impact.

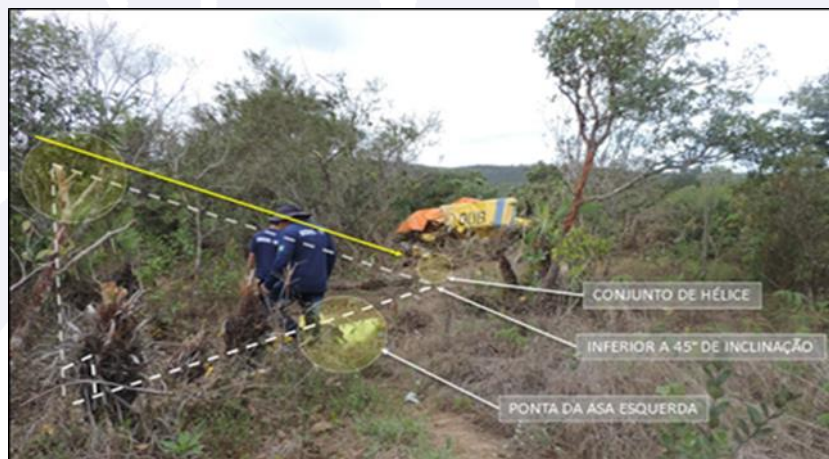
According to physical evidence found in the crash site, the aircraft was making a left-hand turn when it hit the ground (left-hand wing lower than the right-hand wing). The marks on the vegetation suggest that the aircraft was at a maximum vertical angle of about 45° during the descending trajectory, having slid about 30 m on the terrain, from the point of first impact until coming to a complete stop (Figure 4).

Figure 4 - Location of the wreckage.

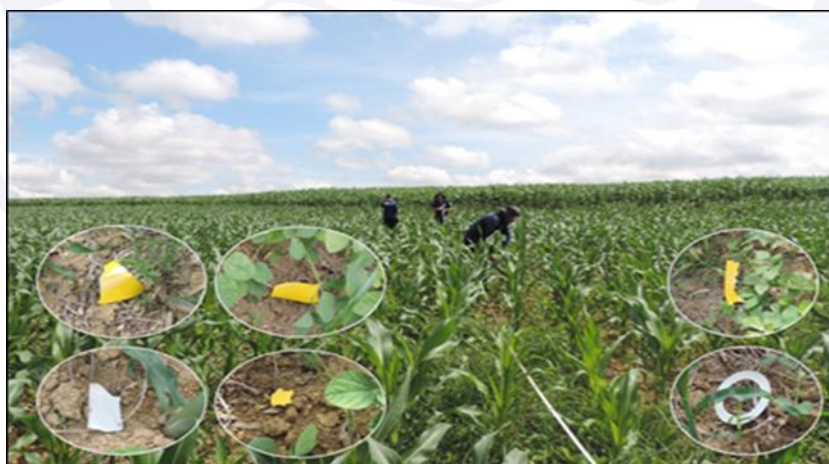
Parts of the aircraft detached before it came to a stop in the location of concentration of the wreckage. Such parts were found approximately 200 m short of the final position of the aircraft, and were mainly from the painting of the wings, which were canvas (non-metallic). All the parts were arranged on the ground in a direction compatible with the trajectory traveled by the aircraft (Figure 5).

Figure 5 - Parts detached from the aircraft and were found approximately 200 m from the final position of the aircraft.

Excluding the small pieces of the wing tip, some paint chips from the wing and from the wing strut fairing, all the other parts of the aircraft remained concentrated.

From that moment on, the aircraft entered a left-hand turn, and there was a loss of control in flight, causing the plane to collide with the ground. Small parts of the wingtip, some paint chips from the wing and from the wing strut fairing were identified, which detached from the aircraft in a position short of the concentration of the wreckage, and were found approximately 200 m from the final position of the plane.

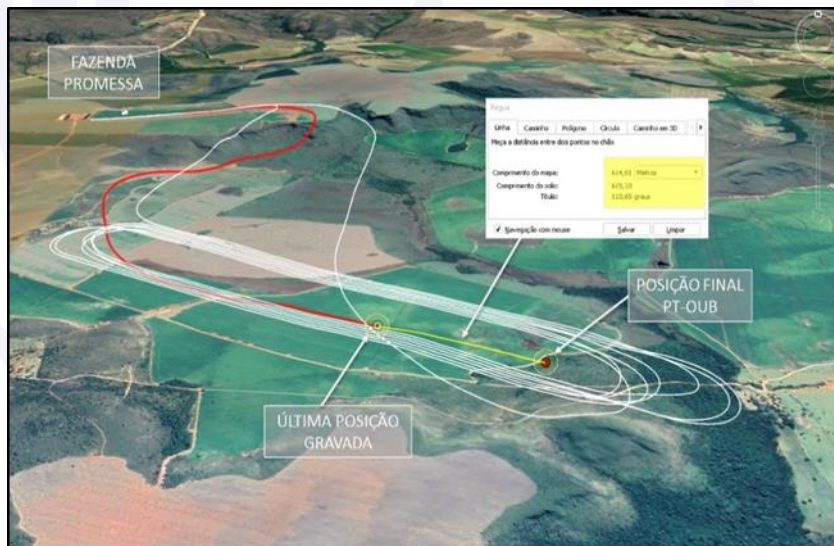
The said device was in operation during the accident flight, however, due to the characteristics of the system, it did not record the seconds prior to the impact. The recorded data was limited to the 600 m distance measured from the aircraft's final position.

Although the DGPS data corroborated the pilot's report regarding the horizontal trajectory on the ground, by comparing the flights prior to the accident flight, one was not able to obtain the vertical data (altitude/height) (Figure 6).

Figure 6 - In white, the flight trajectory prior to the accident and, in red, the trajectory of the occurrence. Source: adapted from Google Earth / DGPS.

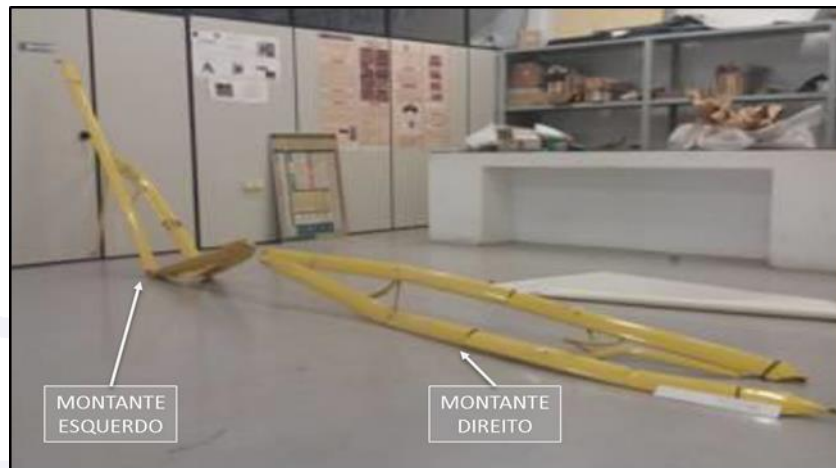
The two struts of the right-hand and left-hand wings were sent to a laboratory for analysis of a possible structural failure (corrosion and/or overload) (Figure 7).

Figure 7 - Wing struts sent for analysis.

The analysis indicated that the fractures and dents affecting the wing struts of the PT-OUB aircraft were caused by an “overload mechanism” (*stress above the material’s resistance limit*) due to impacts against obstacles on the ground. No signs of corrosion at the wing/fuselage connection points were found, only signs of overload.

The analysis of the wing struts indicated that the fractures and dents were caused by an "overload mechanism" (*stress above the material's resistance limit*), due to impacts against obstacles on the ground, and it was not possible to state whether the fractures and dents occurred in flight. The possibility of rupture due to corrosion at the strut/wing junction was ruled out.
