COMANDO DA AERONÁUTICA
CENTRO DE INVESTIGAÇÃO E PREVENÇÃO DE
ACIDENTES AERONÁUTICOS

FINAL REPORT
A - 116/CENIPA/2020

OCCURRENCE:	ACCIDENT
AIRCRAFT:	PT-POH
MODEL:	SZD-48-3
DATE:	20SEPT2020

This is the Final Report of the 20SEPT2020 accident with the SZD-48-3 aircraft model, registration PT-POH. The accident was classified as “[SCF-NP] System/Component Failure or Malfunction Non-Powerplant and [LOC-I] – Loss of Control in Flight”.

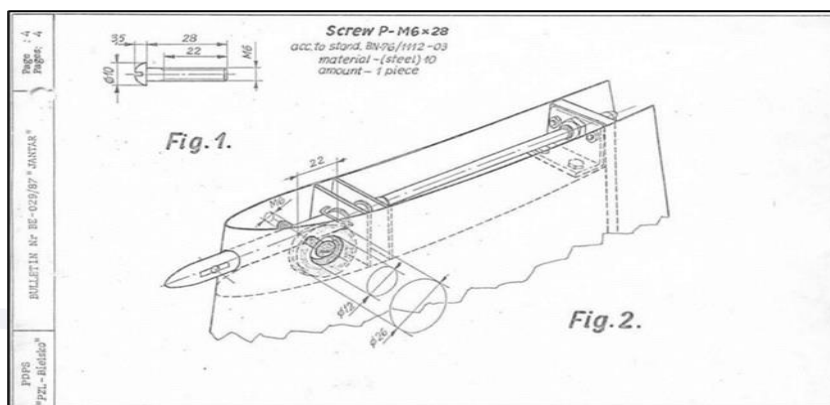
A manufacturer's document, called Bulletin Nº BE-029/87, stated that, due to reported doubts about the reliability of the tail bolt attachment in relation to a possible accidental disconnection, an additional way for its attachment was developed. It also said that each user could decide whether to adopt it or not.

The change consisted in making a hole through the head of the bolt and adapting the vertical stabilizer to receive a screw. This bulletin was not implemented on the crashed aircraft.

Figure 1 - Schematic drawing of the adaptation suggested in Bulletin N° BE-029/87.

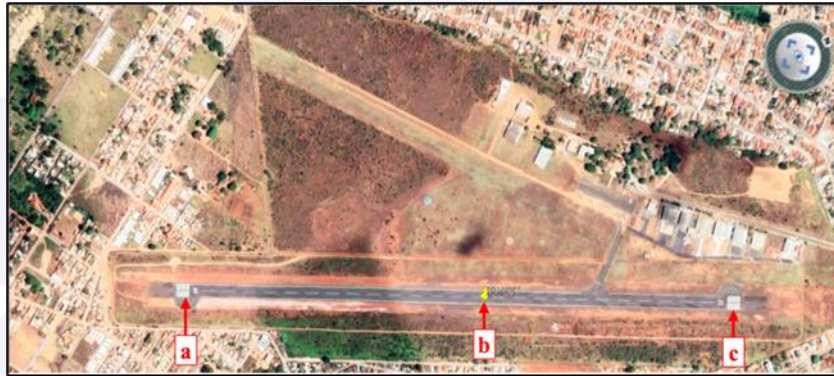
Figure 6 - Location of the aircraft wreckage in relation to the runway. Point “a” indicates threshold 05, “b” the place of impact and “c” threshold 23.

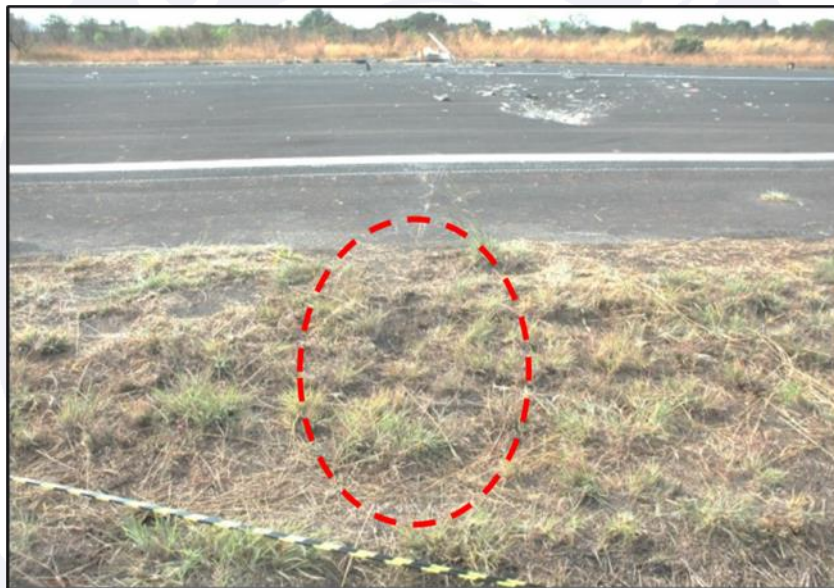
The first impact occurred in a pitch up attitude and tilted to the left, causing the left-wing tip to collide with the ground. Subsequently, the collision of the cabin, tail cone and stabilizers occurred.

Figure 7 – Left-wing impact point.

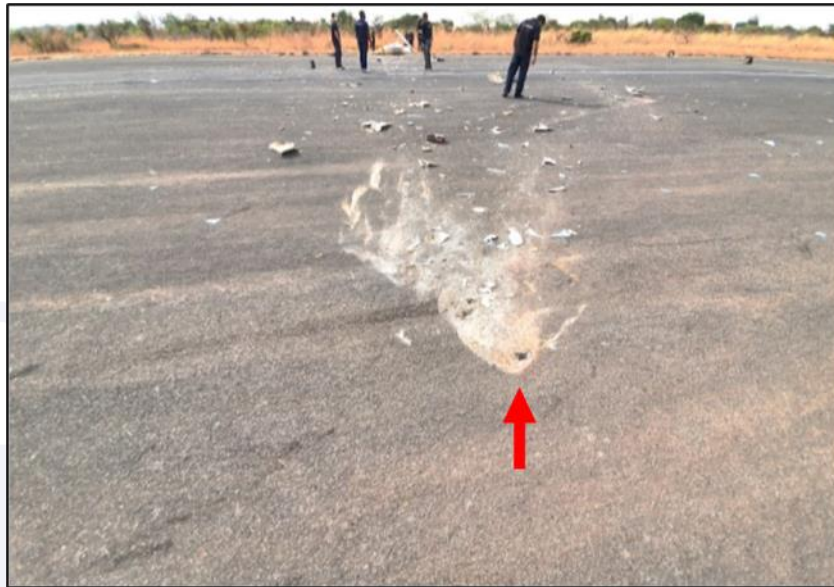
Figure 8 - Point of impact of the aircraft's nose.

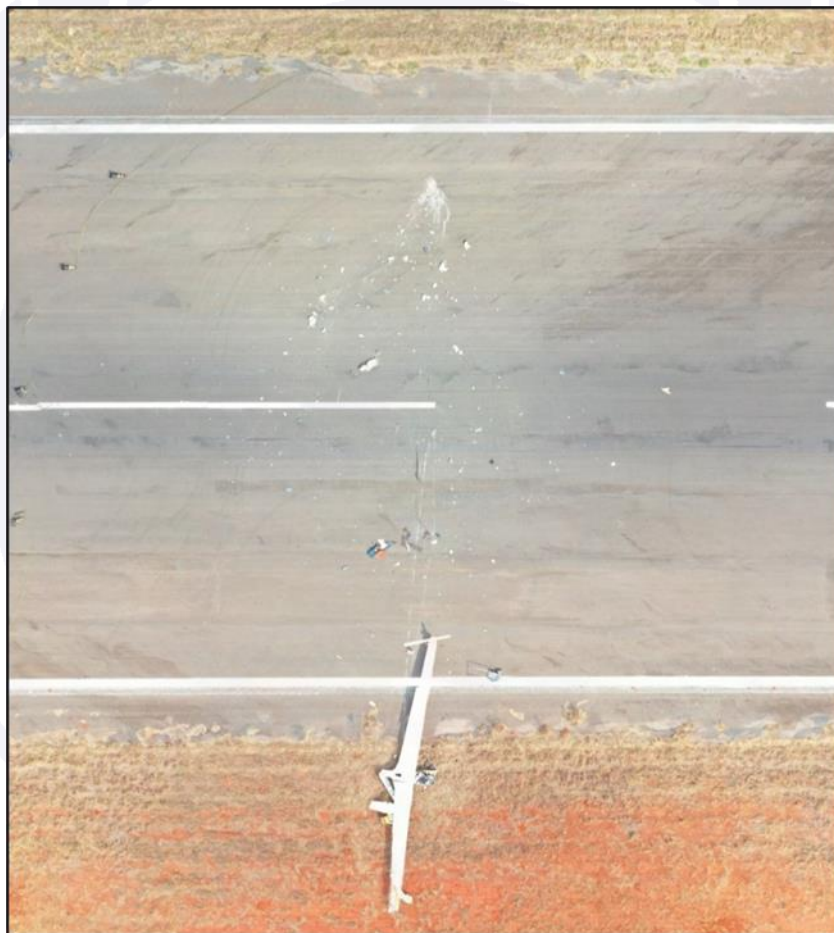
The aircraft had substantial damage. There was a breakage of the tail cone, canopy and wings.

Figure 9 - Final position of the aircraft and its wreckage.

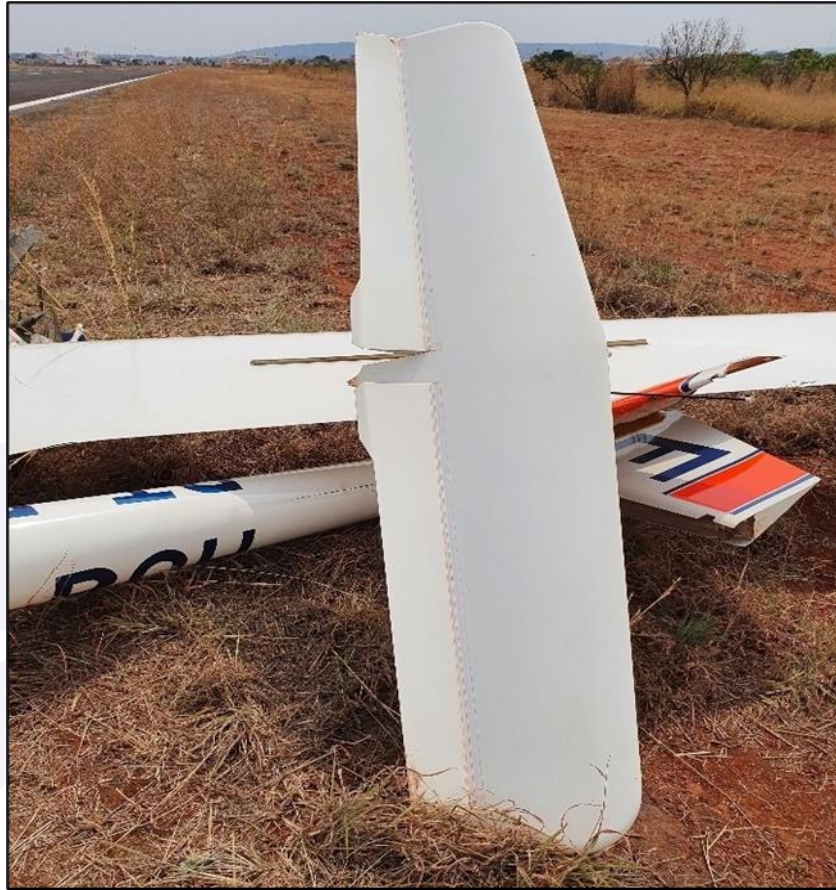
Figure 10 - Position of the aircraft elevator.

During the Field Action, it was verified that the elevator was locked in the pitch up position. In addition, it was identified that the fixation bolt had its final segmentation of the fitting disengaged from the lock that connected it to the horizontal stabilizer (Figure 11), although the bolt was still next to the rear lock, as shown in Figure 12.

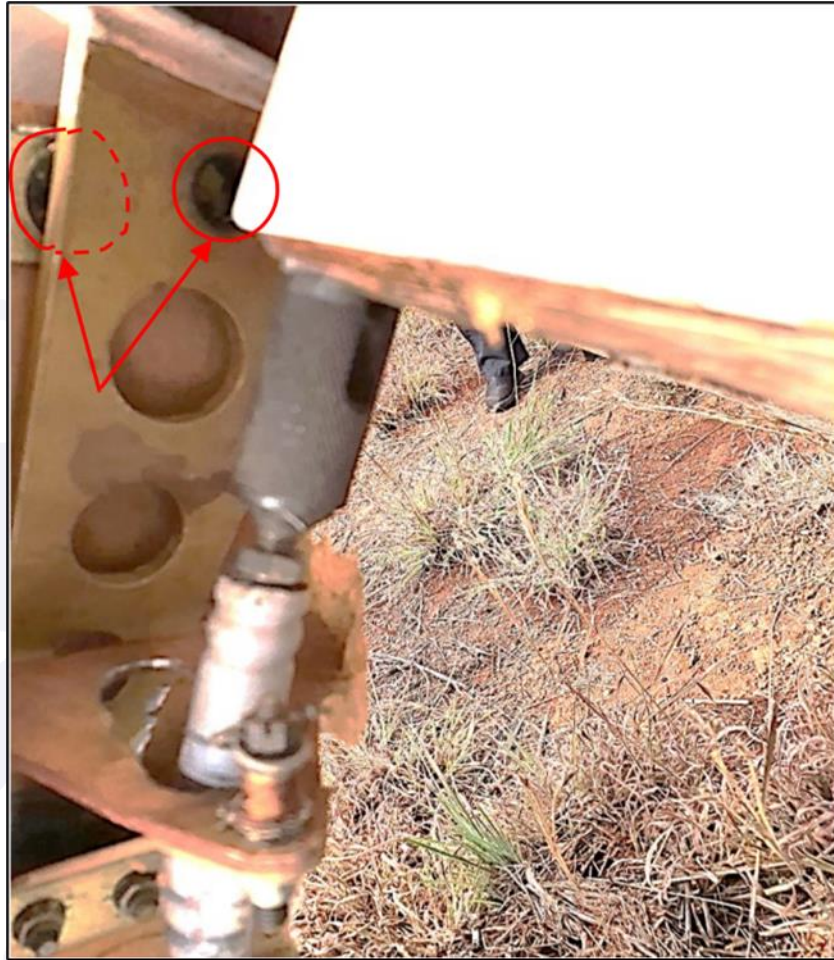
Figure 11 - Misalignment between the bolt housing and the horizontal stabilizer rear lock.

In the analyzes performed, it was observed that the housing fixing bolt located in the rear lock of the horizontal stabilizer was disengaged. The bolt disengagement may have occurred due to a possible horizontal stabilizer assembly failure, which was evidenced by the non-locking of the bolt grooves in the spring. There is also the hypothesis that structural efforts resulting from the overspeed of the aircraft, in a region of turbulent air, have contributed to the total disconnection of the unlocked bolt.

Disclose the lessons learned in this investigation to the operators of model SZD-48 gliders, alerting them to the need of paying special attention to the assembly of the bolt next to the elevator stabilizer since the non-locking can cause its displacement along the connecting surface and, consequently, the loss of control of the aircraft.

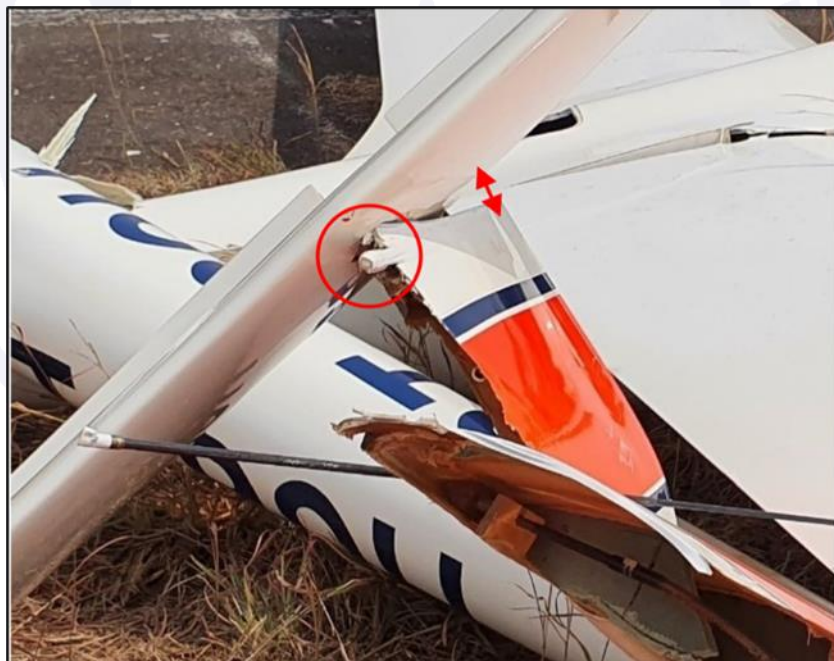
Figure 12 - Fixing bolt and the displacement between the rear parts of the horizontal and vertical stabilizers.

When the bolt was disengaged, the horizontal stabilizer remained connected to the vertical stabilizer only by the front lock (through which the bolt passed) and by the elevator control rod.

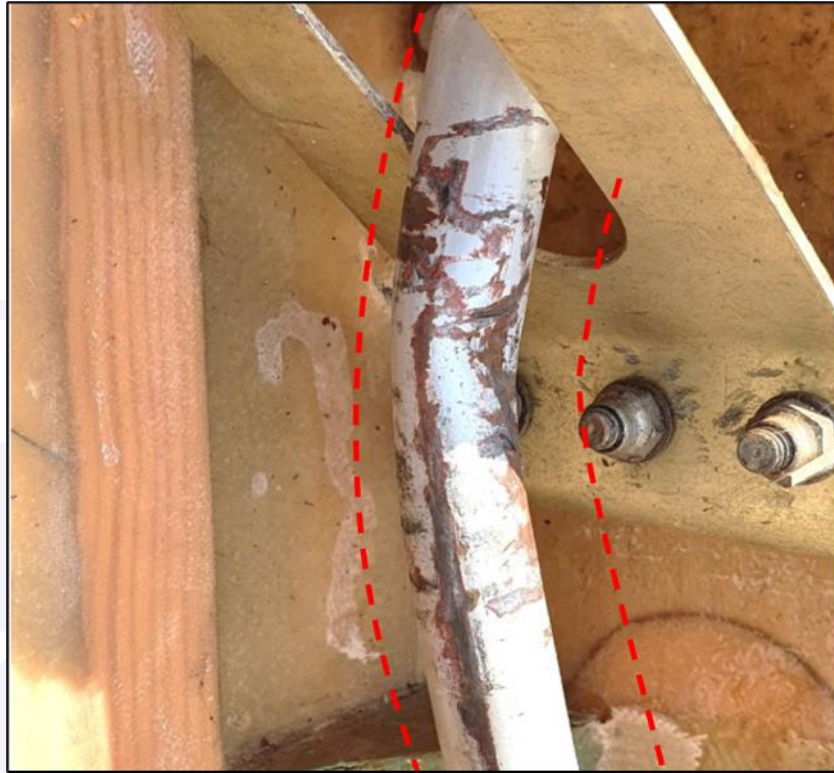
In addition, as can be seen in Figure 13, the elevator control rod showed friction marks with the structures around it, which contributes to the thesis of irregular movement.

Figure 13 - Elevator control rod. The marks of friction with the surrounding structures (dark brown) are highlighted.

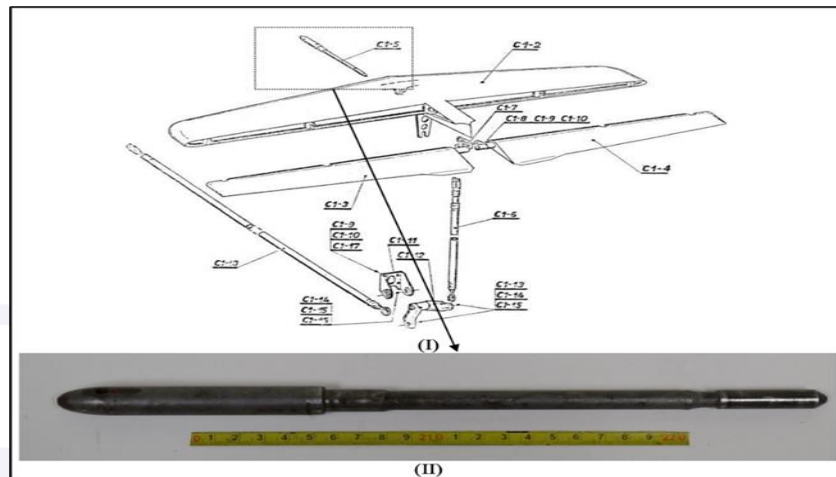
Figure 15, item (I), shows the assembly scheme of the bolt next to the elevator stabilizer according to the spare parts catalog of the SZD-48-3 aircraft and in (II) the bolt of the crashed aircraft.

Figure 15 - In (I) scheme of the bolt assembly next to the elevator stabilizer and in (II) the bolt of the crashed aircraft.

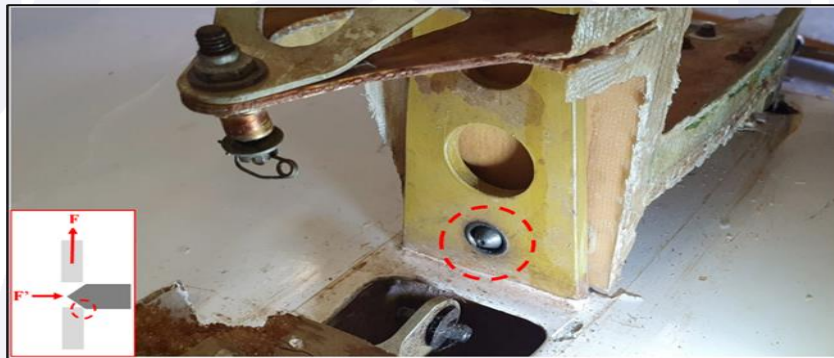
Figure 16 shows the condition in which the head/body of the bolt reaches the spring, but not the stop, with the system unlocked.

Figure 16 - View of (upside-down) of the pin could be in an inappropriate position, unlocked (i.e. rotated or not fully engaged to its stop), and still be the horizontal stabilizer rear lock fitting in the vertical stabilizer structure.

During the analysis, it was observed that the conical part of the pin was close to the hole, in such a way that an inappropriate placement, such as not locking it in the slot region, could lead to its displacement and, thus, to the loss of its function. This displacement could still be facilitated by the final conical shape of the pin.

According to the analysis made, the pin could be in an inappropriate position, unlocked, and still be providing elevator control, until its total release and loss of control occurred.

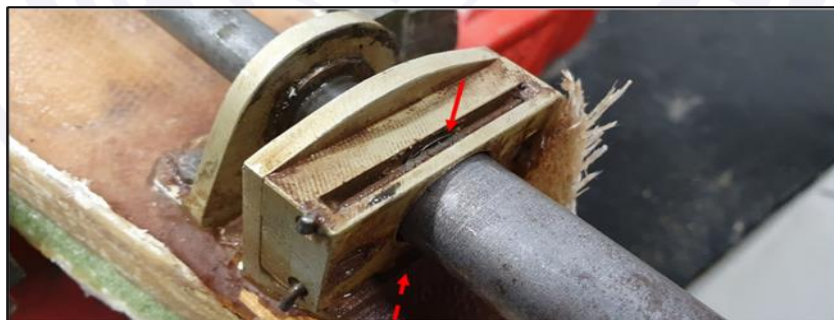
In Figure 17, the head/body of the bolt reaches the stop, and the system is locked. The bolt head slots fitted into the spring stand out.

Figure 17 - Fitting the bolt in the vertical stabilizer structure.

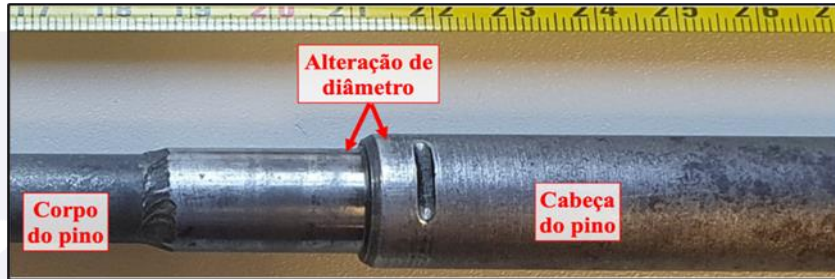
Figure 19 - Change in the head/body diameter of the bolt (scale in millimeters).

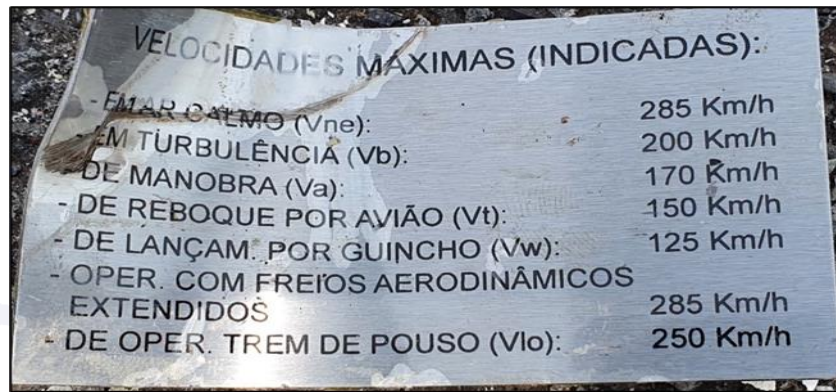
- in calm air (Vne - Velocity Never Exceed) - 285 km/h;
- in turbulence (Vb) 200 km/h; and
- maneuvering 170 km/h.

Figure 20 - Plate with the maximum speed limitations indicated.

Analyzing the existing recorders on the aircraft, there were speed records between 308 and 321 km/h, before the beginning of the loop, which indicates that, at that moment, the aircraft operation was performed with an indicated speed above the limits established for the operation.
