FINAL REPORT
A - 084/CENIPA/2020

| OCCURRENCE: | ACCIDENT |
| AIRCRAFT: | PT-TMO |
| MODEL: | A319-132 |

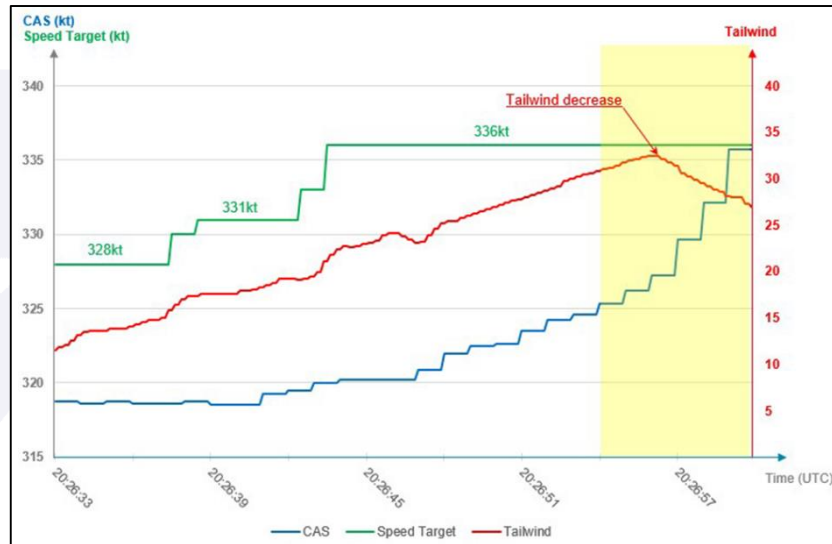
- at 20:26:55, the aircraft was crossing 18,800ft and the tailwind started to decrease from 33kt;
- the selected speed was 336kt and the Calibrated Speed (CAS) was increasing from 326kt;
- As the CAS was approaching its target, the autopilot commanded a pitch-up order to slow the speed increase. Consequently a nose-up movement occurred, and the rate of descent was approximately 6,250ft/min.

Figure 1 - Graphical information of the CAS, selected speed and tailwind recorded through the FDR between 20:26:55 and 20:26:59.

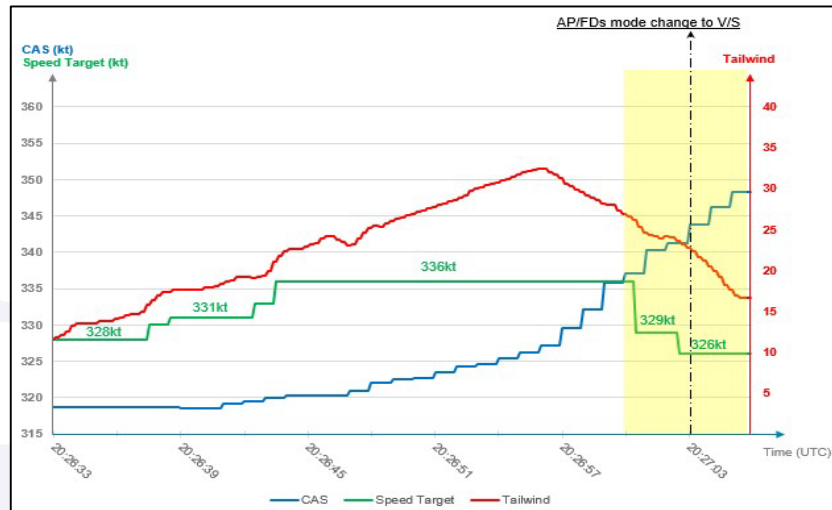
- at 20:27:00, the aircraft was crossing 18,300ft and the tailwind was still decreasing;
- at 20:27:03, the autopilot was changed to Vertical Speed mode and the auto thrust (A/THR) was changed to Speed mode;
- the CAS was still increasing and the speed was selected for 329kts and after 2 seconds for 326kts this value remained for about 40 seconds;
- the pitch angle was still increasing; and
- the rate of descent was going from 5,200ft/min to the selected rate of descent (4,400ft/min).

Figure 2 - Graphical information of the CAS, selected speed, and tailwind recorded through the FDR between 20:27:00 and 20:27:05.

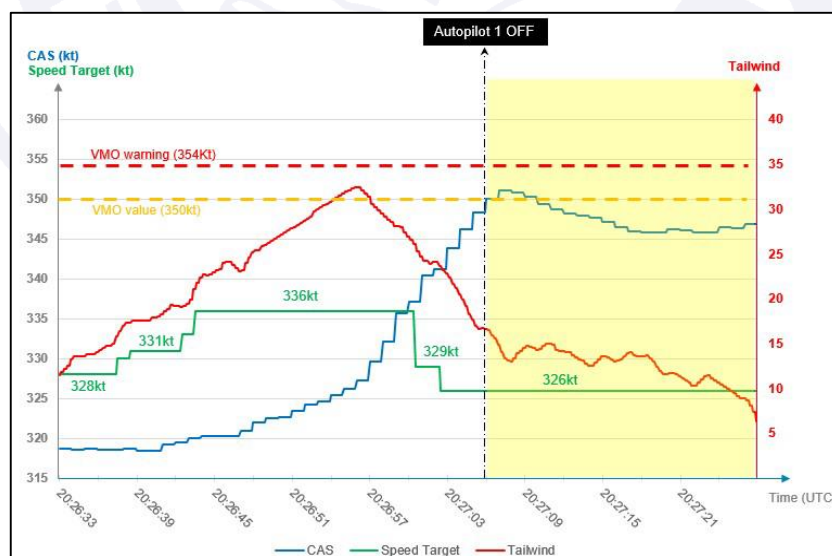
- at 20:27:06, the aircraft was crossing 17,800ft with the tailwind decreasing, when the CAS reached the VMO value (350kts). The maximum registered value of the CAS was 351kts;
- the autopilot was disconnected and the use of the sidestick in its entirety was recorded for the “full back-stick” position;
- the load factor increased to the maximum of +2.23G.
- immediately after entering the sidestick, the use of the rudder was also recorded;
- the application of the commands lasted approximately 20 seconds;
- the load factor decreased from +2.23G to about +0.82G;
- CAS stabilized around 346kts; and
- around 20:27:06 and for the 40 seconds that followed, the use of the rudder was recorded. The side load factor increased to +0.15G, then stabilized around +0.1G.

Figure 3 - Graphical information of the CAS, selected speed, and tailwind recorded through the FDR between 20:27:06 and 20:27:26.

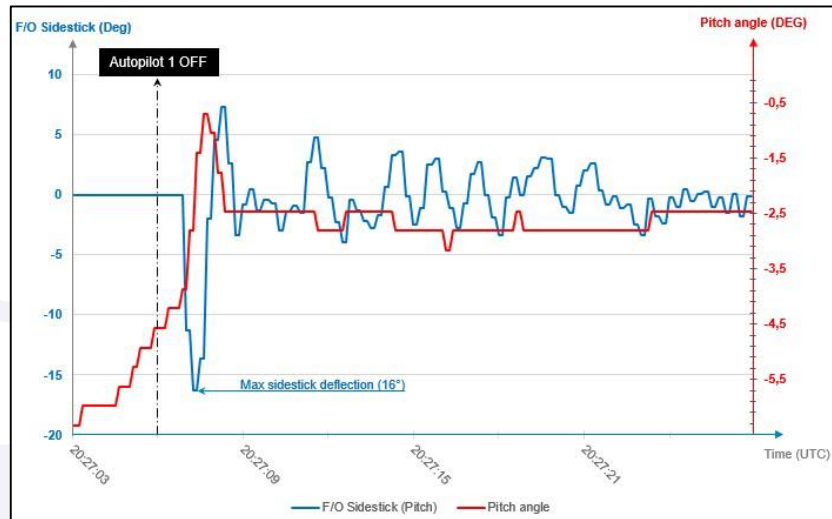
Figure 4 - Graphical information on the use of the sidestick and the aircraft's pitch angle.

The amplitude used caused a deflection of -16.1219 in the Stick Right, close to the VMO, suggesting little familiarization of the copilot with manual flight in this condition, which may have contributed to the Pilot-Induced Oscillation.

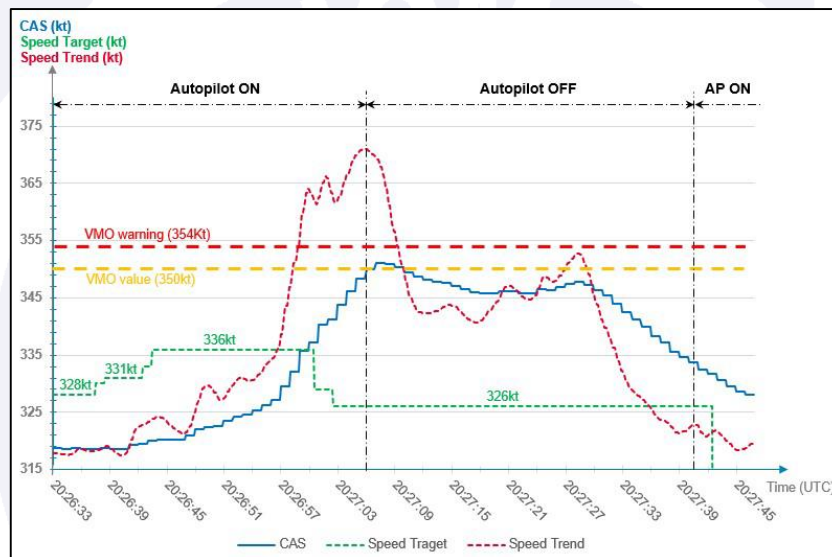
The recorded data allowed the joint analysis of the CAS parameters evolution, selected speed, and speed trend, as shown in Figure 5.

Figure 5 - Evolution of the CAS parameters, selected speed, and speed trend.

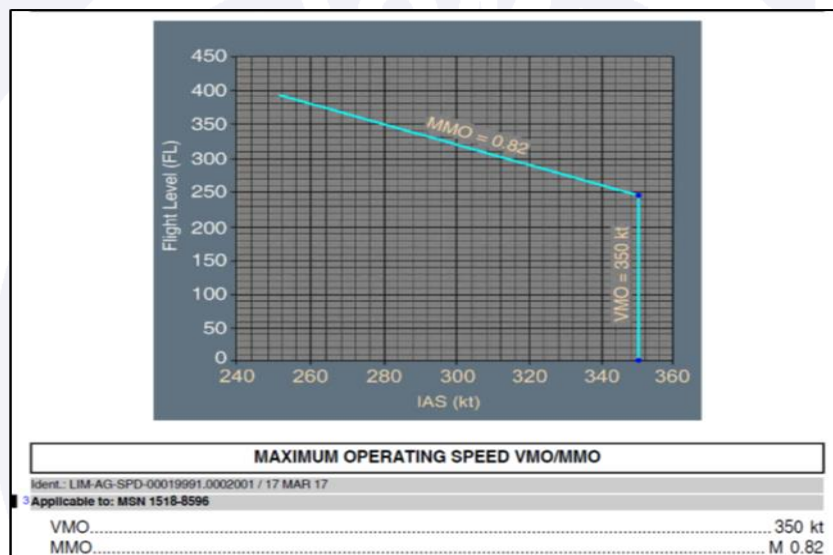
The aircraft's FCOM provided information that the "Maximum Operating Speed" was M 0.82 for MMO and 350kts for VMO, as shown in Figure 8.

Figure 8 - Presentation of MMO and VMO information on the aircraft's FCOM.

Even though the aircraft's VMO is 350kts, the Overspeed warning appears only when the airspeed reaches VMO+4kts (354kt). According to the recorded data, the Overspeed warning did not occur during the event, with 351kt being the maximum CAS recorded.
