COMANDO DA AERONÁUTICA
CENTRO DE INVESTIGAÇÃO E PREVENÇÃO DE
ACIDENTES AERONÁUTICOS

FINAL REPORT
A-088/CENIPA/2023

OCCURRENCE:	ACCIDENT
AIRCRAFT:	PT-UVC
MODEL:	EMB-202A
DATE:	23MAI2023

This is the Final Report of the 23 May 2023 accident involving the EMB-202A aircraft of registration marks PT-UVC. The occurrence was typified as “[FUEL] Combustion.”

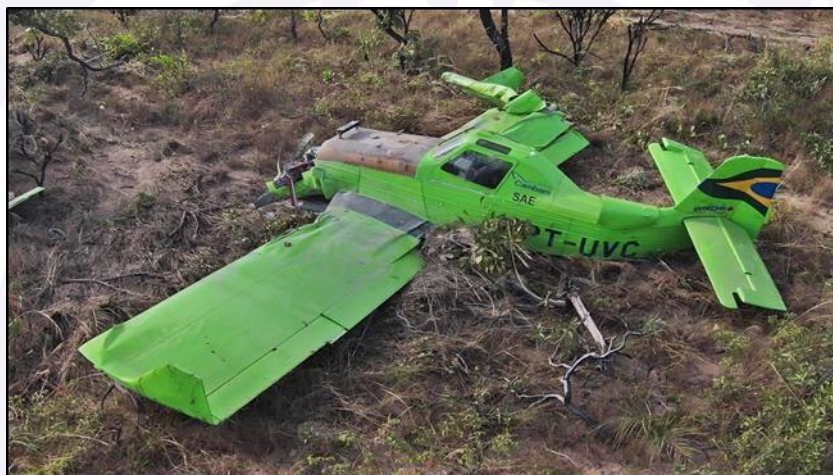
Figure 1 - View of the aircraft at the accident site.

The aircraft sustained substantial damage to the tail cone, main and auxiliary landing gear, wings, elevator, rudder, propeller assembly, engine mount, and fuel tanks.

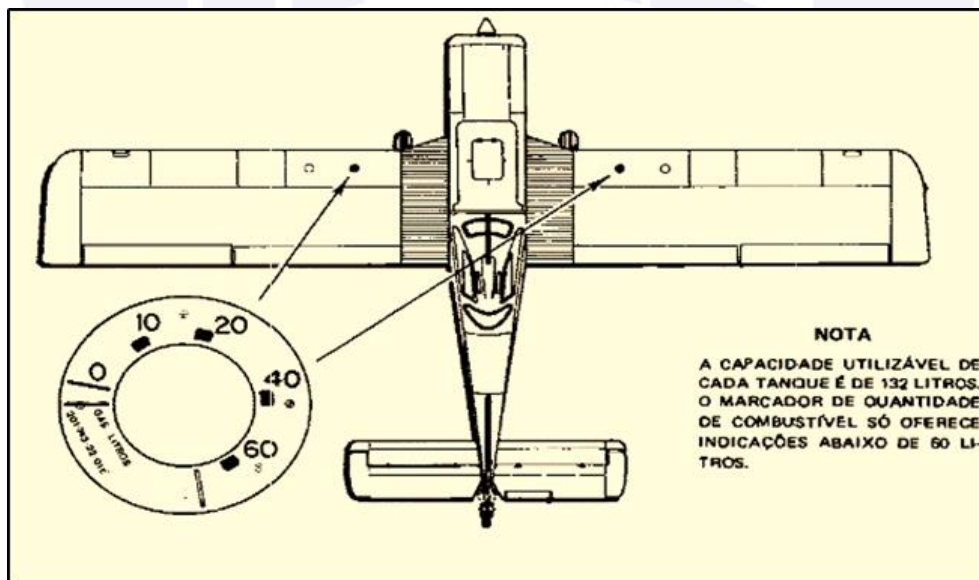
The aircraft's fuel quantity was measured using two mechanical liquid level gauges located on the upper wing surface, calibrated to display readings between 0 liters and 60 liters. A "zero" reading corresponded to 14 liters of unusable fuel (Figure 2).

Notably, there was no fuel quantity indicator in the aircraft's cockpit.

Figure 2 - Location of the fuel liquid level gauges.
Source: Adapted from the EMB-202A operations manual.

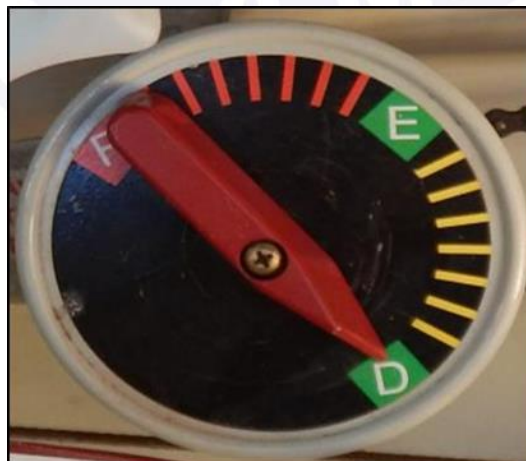
The fuel tank selector mechanism was operated via a selector located on the left side of the cockpit, near the pilot's seat. It had three positions: left tank (E), right tank (D), and closed (F), allowing the pilot to select which tank would supply fuel to the engine ("E" or "D") or to stop fuel flow to the engine ("F") (Figure 3).

Figure 3 - Positions "D," "E," and "F" of the EMB-202A fuel selector.

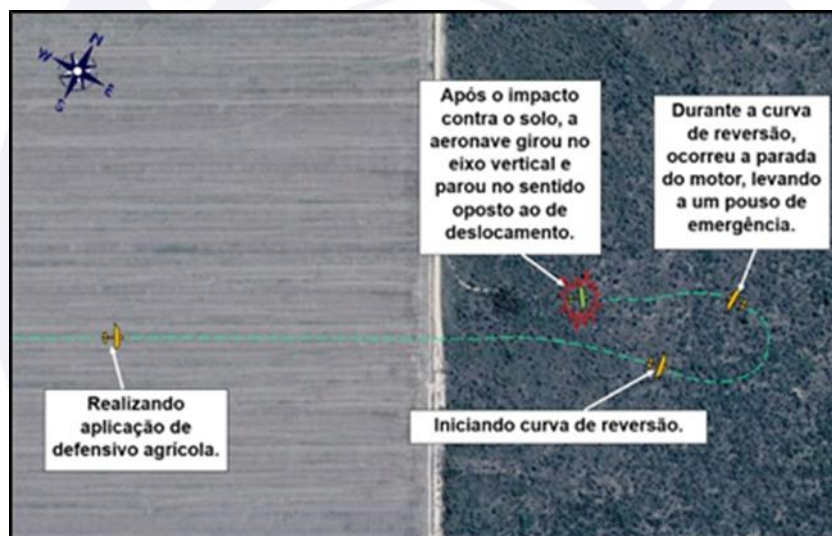
The first part of the aircraft to contact the vegetation and the ground was the right wing. Subsequently, the aircraft spun to the right around its vertical axis, and dragged for approximately 140 meters before coming to rest with its nose 180° offset from its direction of travel (Figure 4).

Figure 4 - Sketch of the accident site.

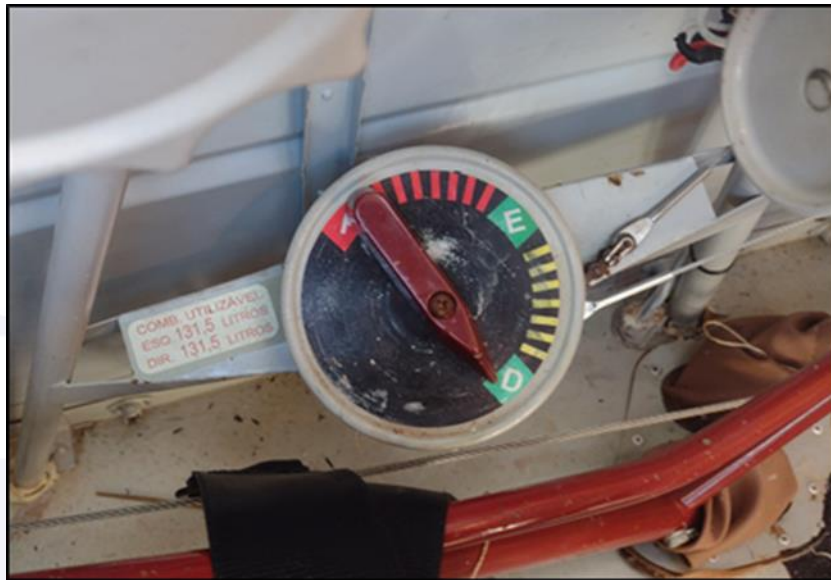
At the accident site, the fuel tank selector was found in the "D" position (Figure 5), and both tanks were found ruptured and empty.

Figure 5 - Fuel tank selector in the "D" position at the accident site.

In this context, one verified that the PIC maintained the fuel selector in the "E" position from takeoff until the moment at which the engine shut down. However, it remains unclear whether he skipped the checklist item to select the fullest tank, or whether he left the selector in the "E" position due to habitual use of that configuration, indicative of prior conditioning that led to inadequate performance.

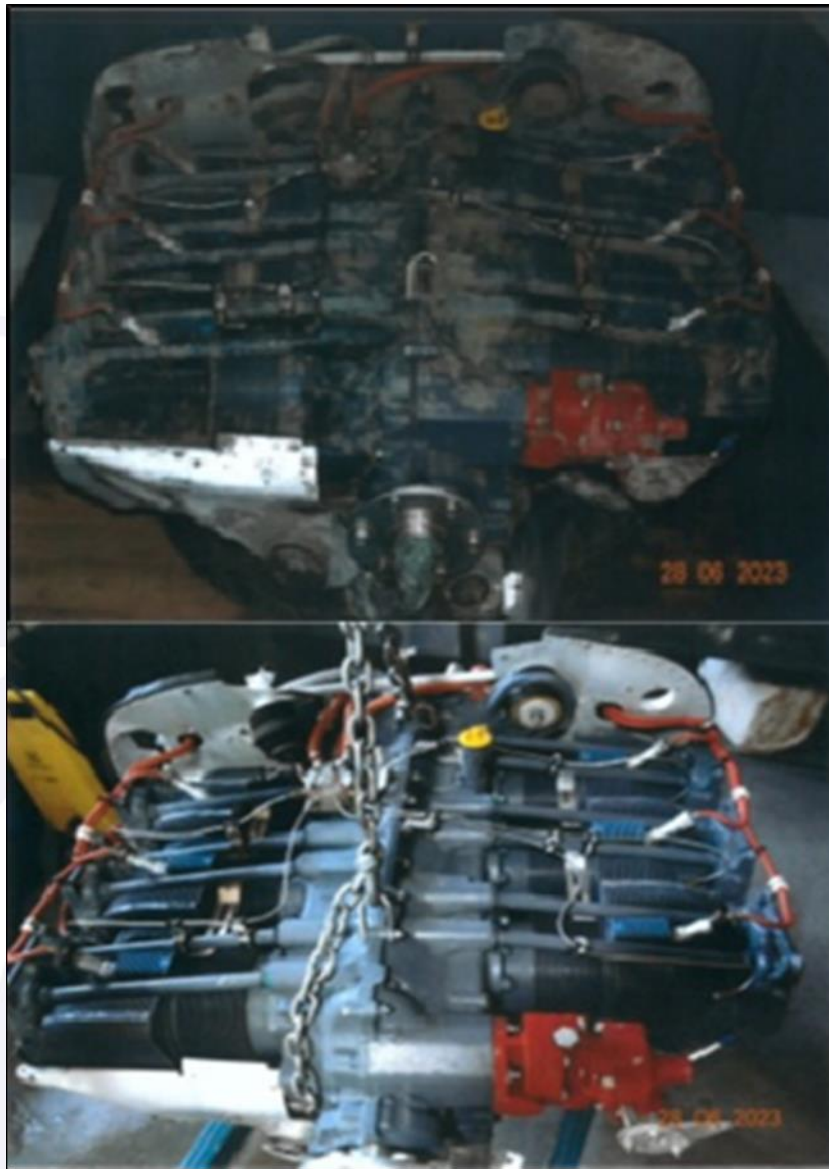
During the initial inspection, the engine was cleaned, revealing no severe damage caused by the emergency landing (Figure 6).

Figure 6 - View of the SN L-33052-48E engine before and after cleaning.

The aspect of the engine components inspected and analyzed was consistent with the 6 hours and 30 minutes of flight time following the overhaul.

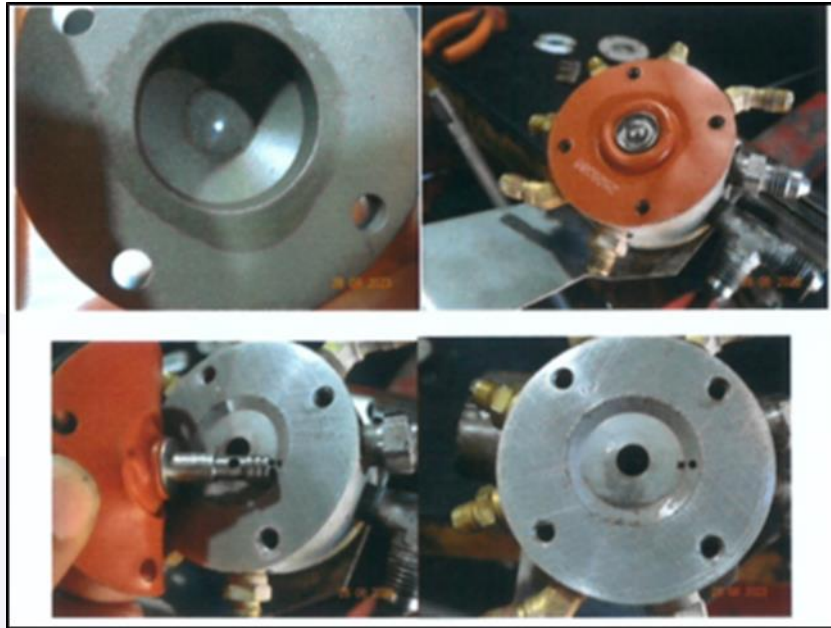
- The fuel distributor had no signs of corrosion or malfunction.
- The fuel pump was tested manually, and exhibited normal operation.
- The fuel inlet filter was clean, without any contaminating residues.
- The throttle's opening and closing movements were normal, without any abnormalities or discrepancies that could compromise fuel delivery to the engine.
- The fuel distributor showed no corrosion or other indications of malfunction (Figure 7).

Figure 7 - View of the fuel distributor.

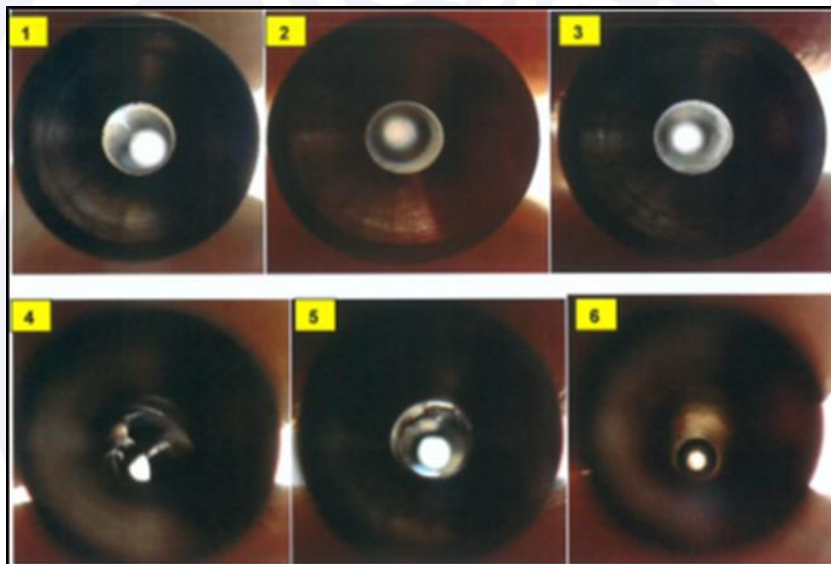
- The cylinder injectors were unobstructed (Figure 8).

Figure 8 - General view of the cylinder fuel injectors, free of obstructions.
