COMANDO DA AERONÁUTICA
CENTRO DE INVESTIGAÇÃO E PREVENÇÃO DE
ACIDENTES AERONÁUTICOS

FINAL REPORT
A - 149/CENIPA/2015

OCCURRENCE:	ACCIDENT
AIRCRAFT:	PT-WQH
MODEL:	650
DATE:	10NOV2015

This is the Final Report of the 10NOV2015 accident with the 650, Citation VII aircraft, registration PT-WQH. The accident was classified as “[SCF-NP] System/Component Failure or Malfunction Non-Powerplant”.

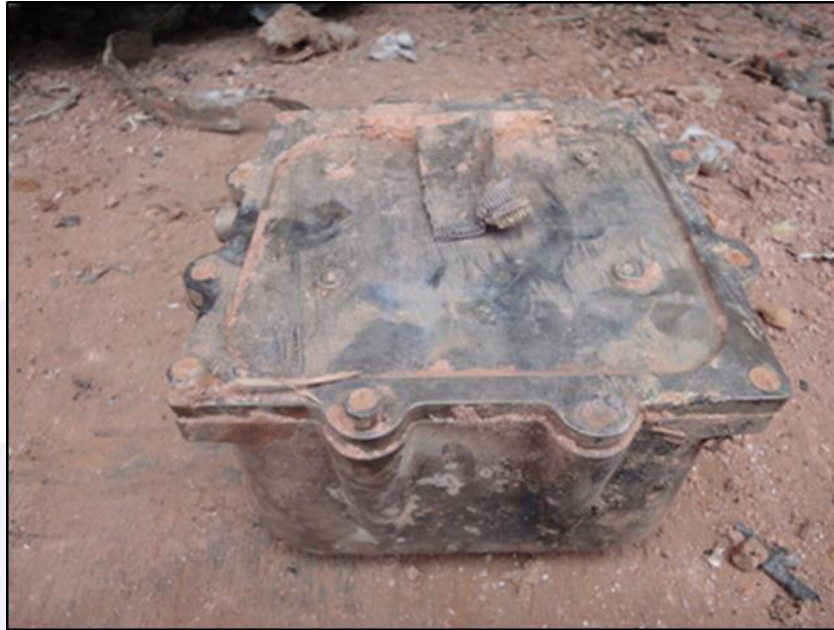
Data from this voice recorder model was stored in a unit called Crash Survivable Memory Unit (CSMU). The CSMU was found at the accident site with significant damage due to impact and fire (Figure 22).

Figure 22 - CSMU at the accident site.

With regard to high quality audio, a total of 31 minutes and 26 seconds of recording was extracted. However, it was identified that a memory chip was irrecoverably damaged.

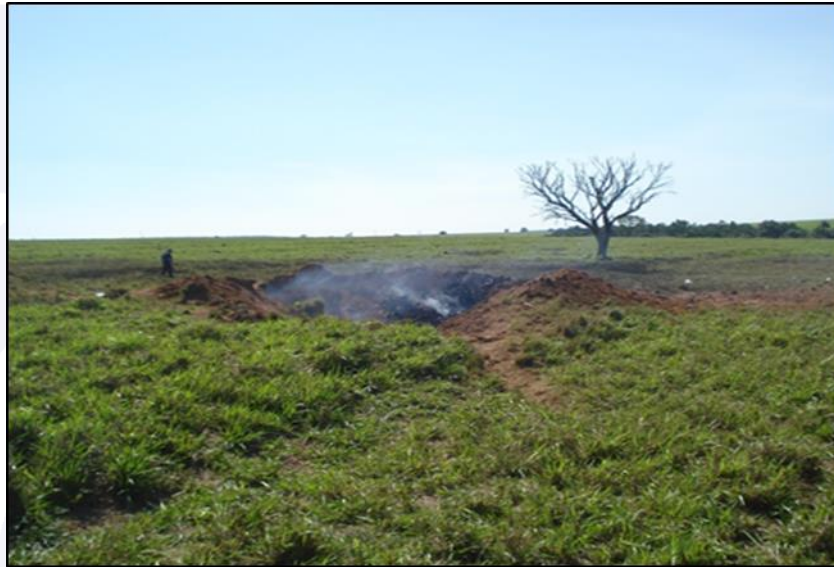
The aircraft crashed into the ground with high energy, in a farm located in the municipality of Guarda Mor - MG. The elevation of the terrain was of approximately 2,200ft.

The impact on the ground produced high fragmentation of the aircraft and a crater of approximately ten meters in diameter and seven meters deep.

Figure 23 - Place of impact of the aircraft against the ground.

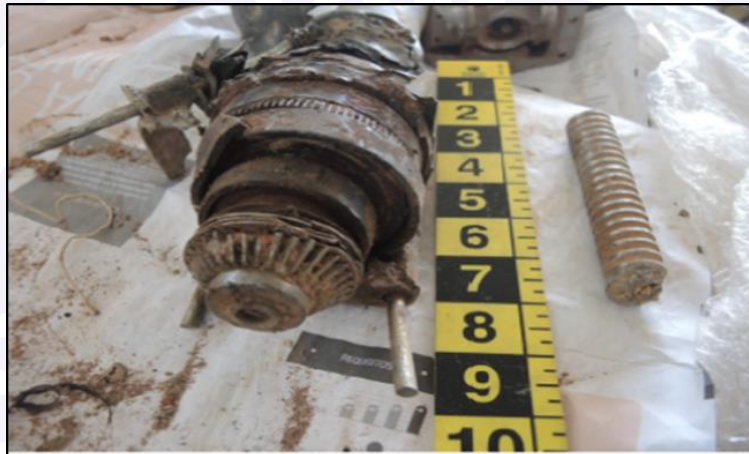
Regarding the pitch trim system, the actuator attachment assembly on the horizontal stabilizer surface, the horizontal stabilizer electric engine, and a section of approximately five inches of the jackscrew actuation (Figure 24) were recovered.

Figure 24 – Horizontal stabilizer electric engine and jackscrew section.

It was not possible to estimate the position of the horizontal stabilizer at the moment of impact.

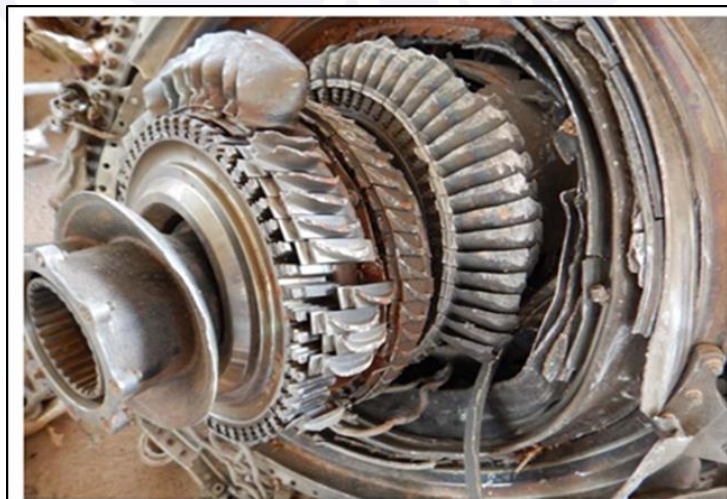
The left engine, model TFE731-4, PN 3073640-2, SN P-102269, presented damages with friction characteristics in the turbine disks. These damages indicated that the engine was rotating and was operating at the time of impact.

Figure 25 - Damaged blades of the left engine low-pressure turbine.

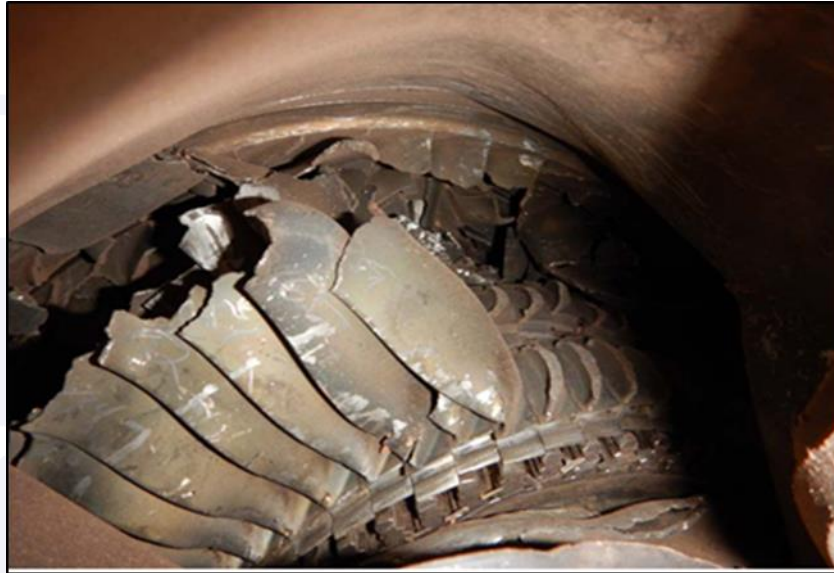
The right engine, model TFE731-4, PN 3073640-2, SN P-102278, presented damages with friction characteristics in turbine disks. These damages indicated that the engine was rotating and was operating at the time of impact.

Figure 26 - Damaged blades of the right low-engine turbine.

No preexisting conditions were observed indicating abnormal engine operating conditions.

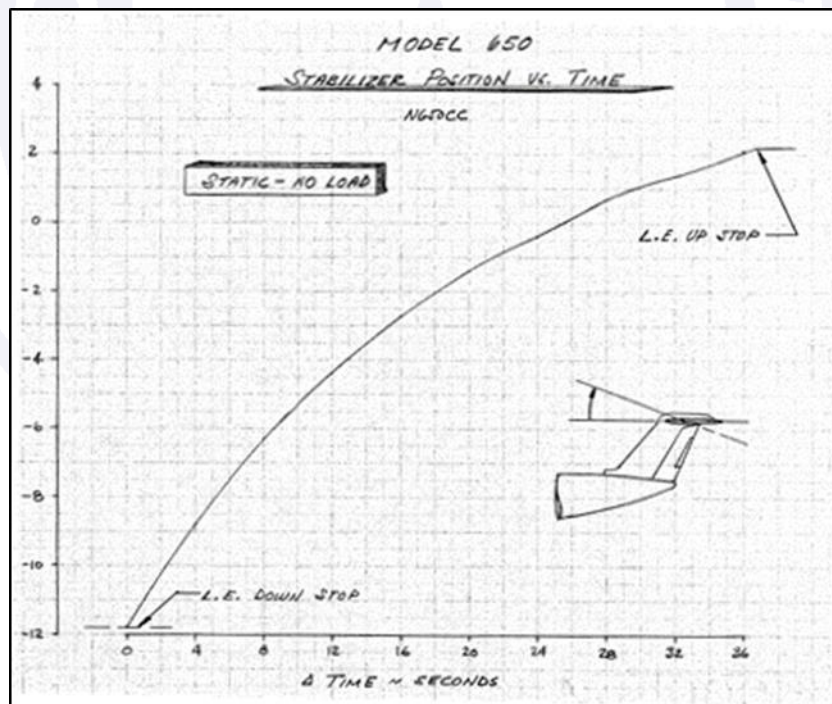
Figure 46 - Horizontal stabilizer angle plot by time. Property information of Textron Aviation®.

According to Figure 46, the time to move the horizontal stabilizer from the approximate positions of $+2.0^\circ$ to $+0.4^\circ$ would be about 9 seconds, this movement would be associated to the primary system, without aerodynamic loads.

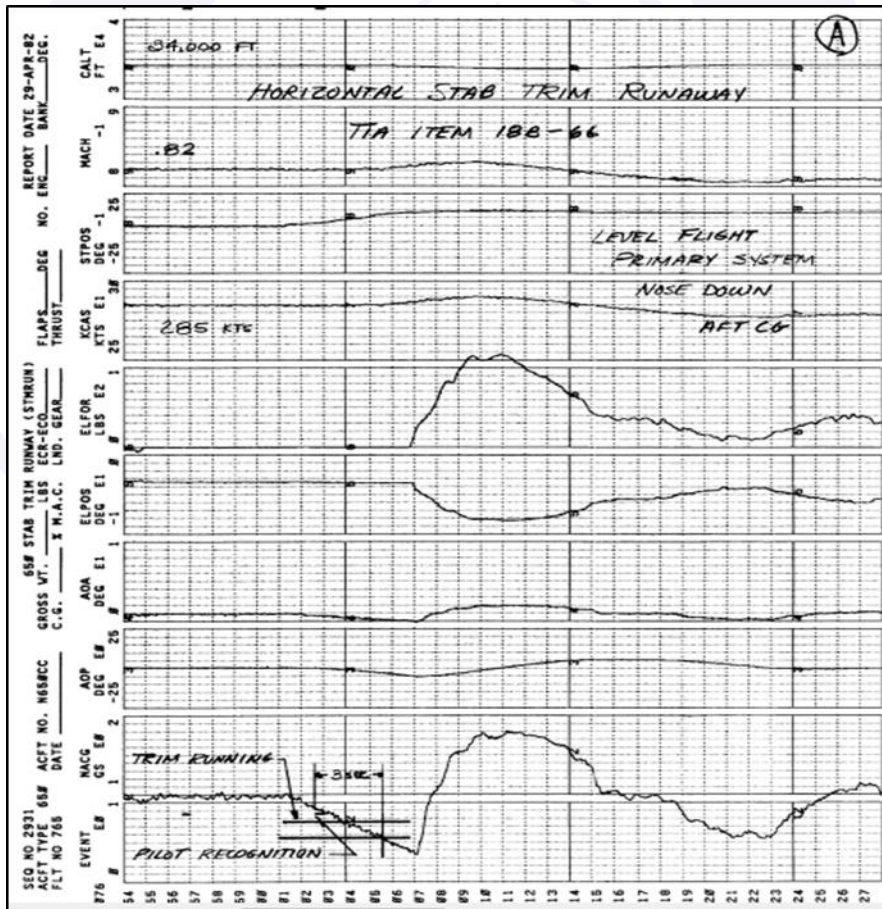
Figure 48 - In-flight test: Test "A" for the horizontal stabilizer trim runaway failure condition. Property information of Textron Aviation®.

In Test "A", it was possible to observe that the stabilizer moved for about 6 seconds, approximately 1.5 seconds without warning, 3 seconds with audible warning where the pilot already had indications for the recognition of the emergency situation and 1,5 additional seconds, where there would still be indication of movement for the pilots.

The force on the stick has reached values around 120 pounds, consistent with the elevator deflection values. The vertical acceleration reached values of approximately 0.2 G during the horizontal stabilizer movement and about 1.8 G during the recovery maneuver. The parameters of pitch angle and angle of attack were compatible with the maneuver executed.

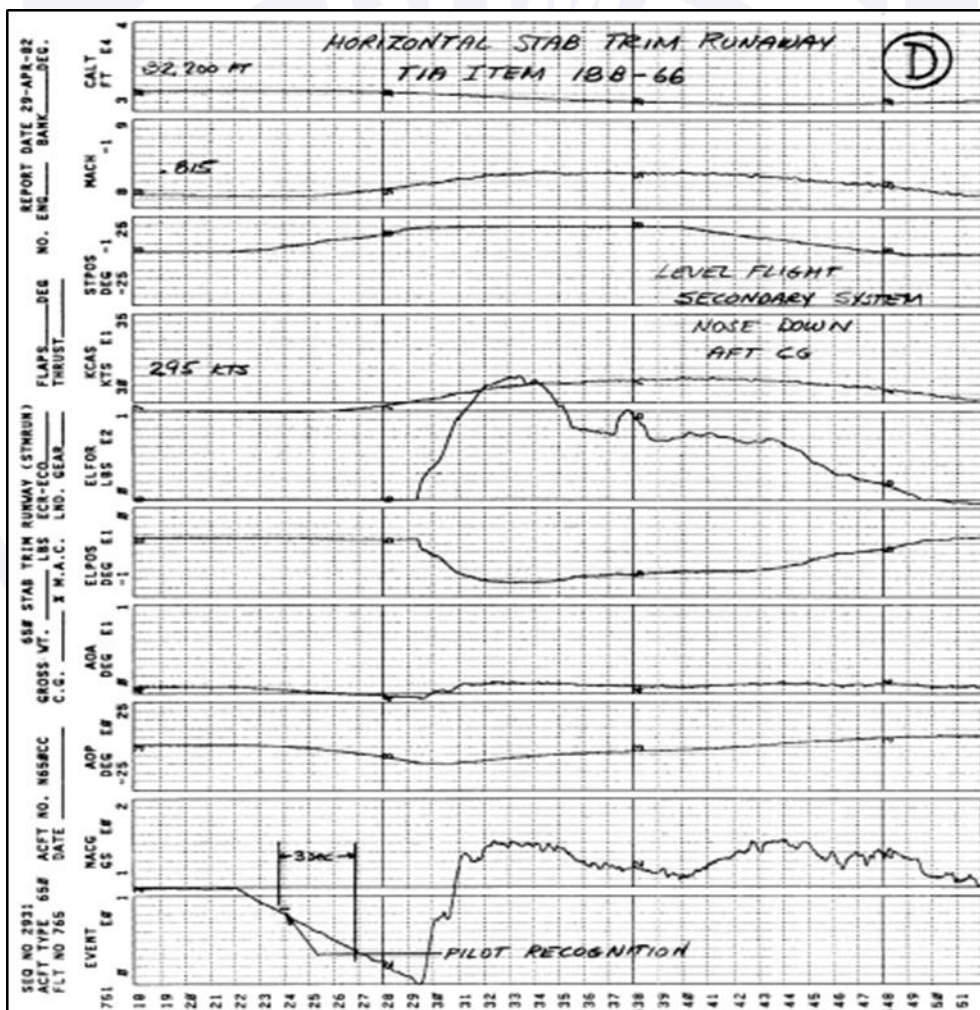
Figure 49 - In-flight test: "D" test for horizontal stabilizer trim runaway condition. Property information of Textron Aviation®.

In the "D" test, it was possible to observe that the stabilizer first moved for about 8 seconds (at about times 22 and 30), being approximately 2 seconds without aural warning, 3 seconds with aural warning, where the pilot already had indications for the recognition of

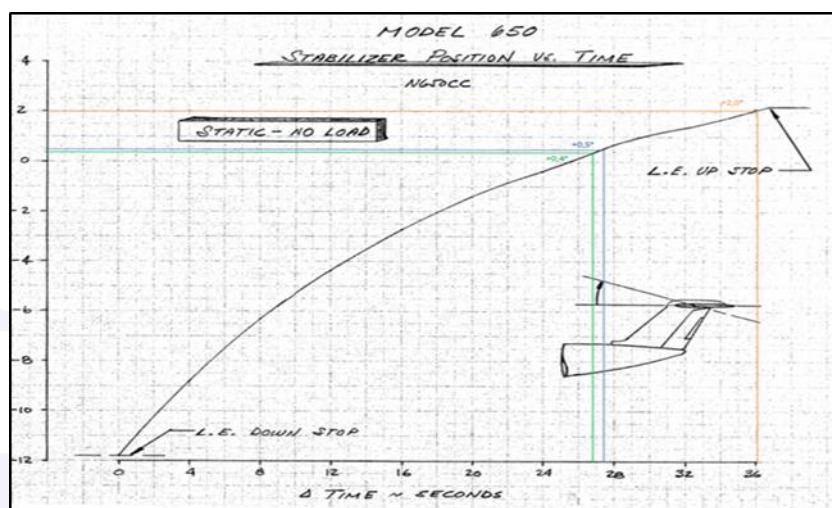
Figure 54 summarizes the observations described above illustrating the comparison of the horizontal stabilizer movements observed in the flight test "D" and the movement of that surface on the ground without aerodynamic loads, as shown in Figure 46.

Figure 54 - Positions observed in flight test "D". Adapted from reports belonging to Textron Aviation®.

Blue Line. Initial position of stabilizer in the "D" test (around $+0.5^\circ$).
