COMANDO DA AERONÁUTICA
CENTRO DE INVESTIGAÇÃO E PREVENÇÃO DE
ACIDENTES AERONÁUTICOS

FINAL REPORT
A - 014/CENIPA/2021

OCCURRENCE:	ACCIDENT
AIRCRAFT:	PT-WUU
MODEL:	T188C
DATE:	31JAN2021

This is the Final Report of the 31JAN2021 accident with the T188C aircraft model, registration PT-WUU. The accident was classified as “[LOC-I] Loss of Control in Flight”.

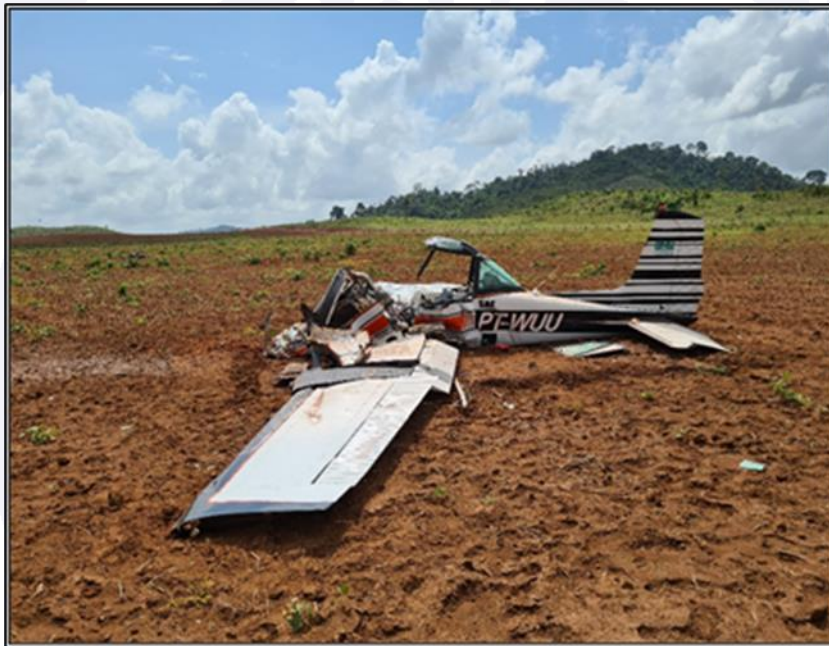
After the spraying, when performing a reverse turn, in order to reposition the aircraft for the last pass, the plane lost height and collided with the ground.

Figure 1 - Aircraft after the occurrence.

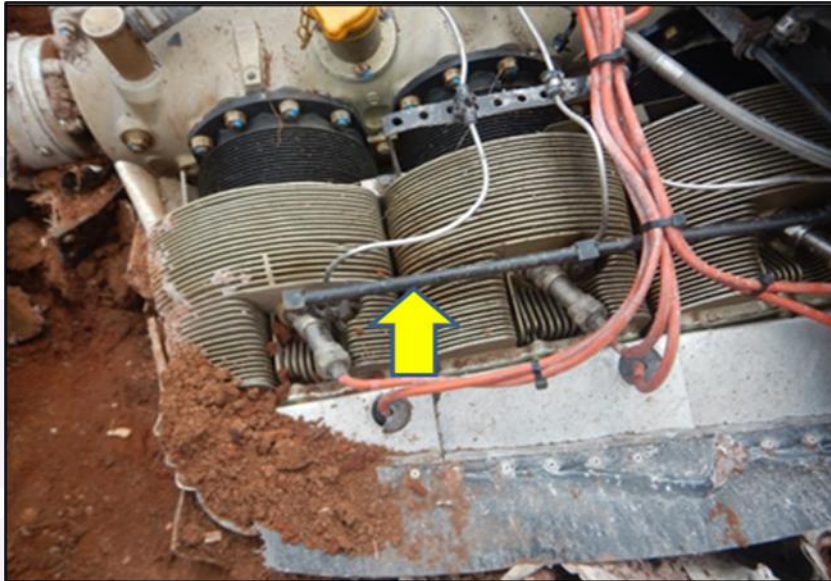
In the investigation field action, there was evidence that the aircraft operated with Ethanol fuel and that the engine had been modified to use this fuel without a CST process.

Although it was not presented any documentation proving that the engine could operate with Ethanol, evidence was found that the engine was adapted to use this fuel (Figure 2).

Figure 2 - Evidence that the aircraft engine was modified in the fuel supply system. Highlighted, the piping used to convert the engine to Ethanol.

It is noteworthy that, despite the evidence verified regarding the modification of the engine for operation with Ethanol, the OM Lima *Aeropeças* (COM 1905-31/ANAC) issued the CVA update, on 26OCT2020, indicating that the aircraft was inspected for airworthiness and documentation.

With the issuance of this CVA update, the technical manager of the maintenance company certified that, on that date (approximately 90 days before the accident), the aircraft engine (model: TSIO-520-T, SN: 515294) was not modified to Ethanol.

It should be noted that the certificates were not presented, which, according to the prescription of the IS No. 137.201-001, Revision C, Use of Ethanol in Agricultural Aircraft, prove the suitability of the engine to the aforementioned instruction.

In this context, at the time of the accident, the aircraft would not comply with what was established by the ANAC and could not be operating using Ethanol.

Work with Lima Aero peças (COM 1905-31/ANAC), so that OM observes the established requirements for issuing the CVA.

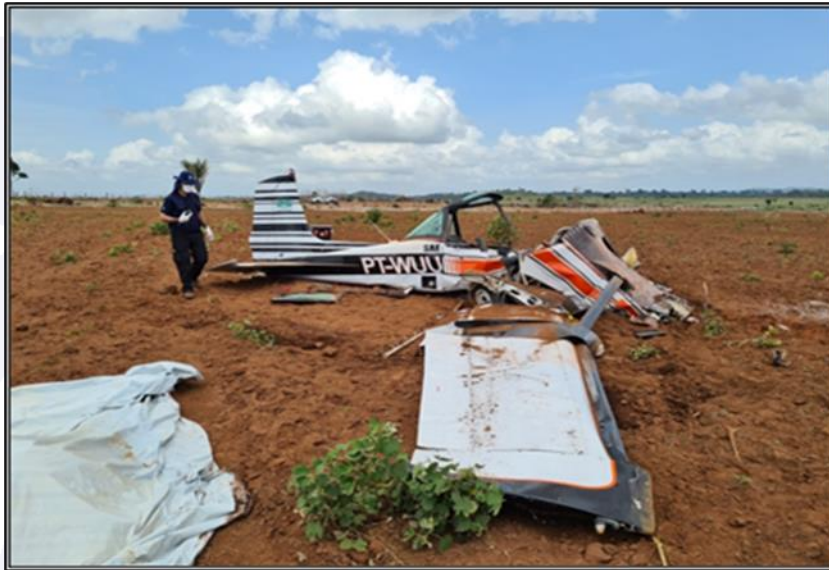
The aircraft impacted the ground in a pitched down attitude (between 70° and 80°) and without wing tilt. The impact was concentrated at a point without displacement on the ground (Figure 3).

Figure 3 – Situation of the PT-WUU wreckage.

The rear part of the aircraft was accommodated horizontally, breaking the fuselage in the region of the cockpit and in the station for fixing the engine mounts.

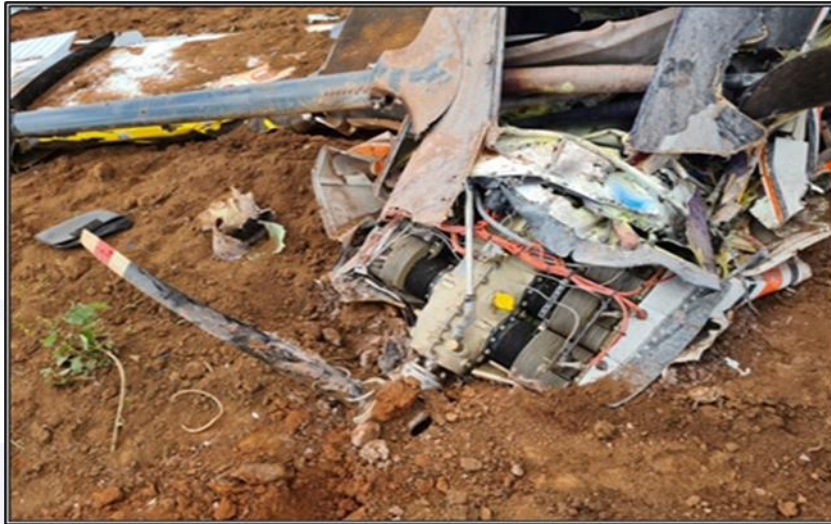
During the field action, it was observed that the land had been plowed for planting, and it was noticeable that the uncompacted soil contributed to the propeller and part of the engine penetrating the land (Figure 4).

Figure 4 - Engine partially buried, with two propeller blades torn from the fixing hub.

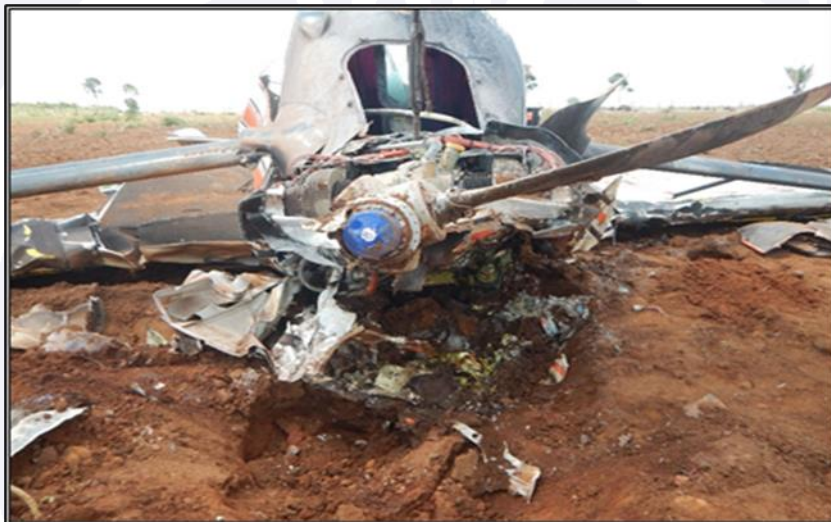
Two of the three propeller blades were torn off the hub. However, they were located just below the engine, buried in the ground (Figure 5).

Figure 5 - Propeller with two blades torn from the hub.

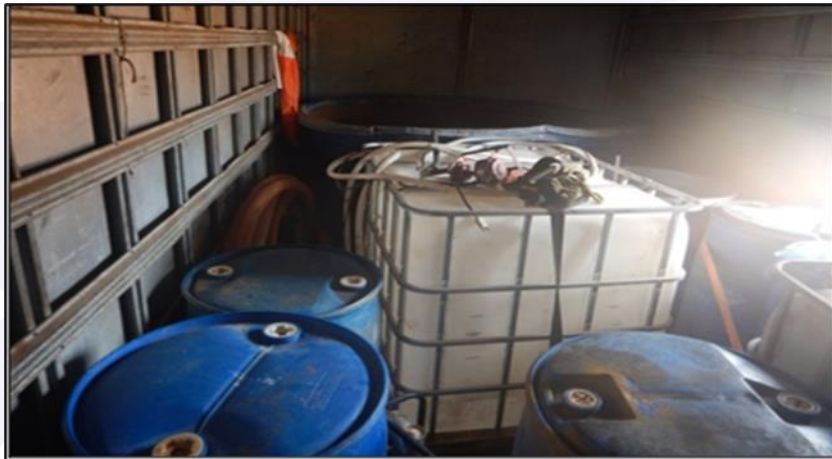
The existence of documents from the company for the acquisition of 10 thousand liters of Ethanol to operate its aircraft was reported. This fuel was stored in the supply tank maintained at the Ourilândia do Norte Aerodrome - PA as well as in the support truck at the Colorado Farm (Figure 6).

Figure 6 - Interior of the support trunk truck for supplying Ethanol on the farm.

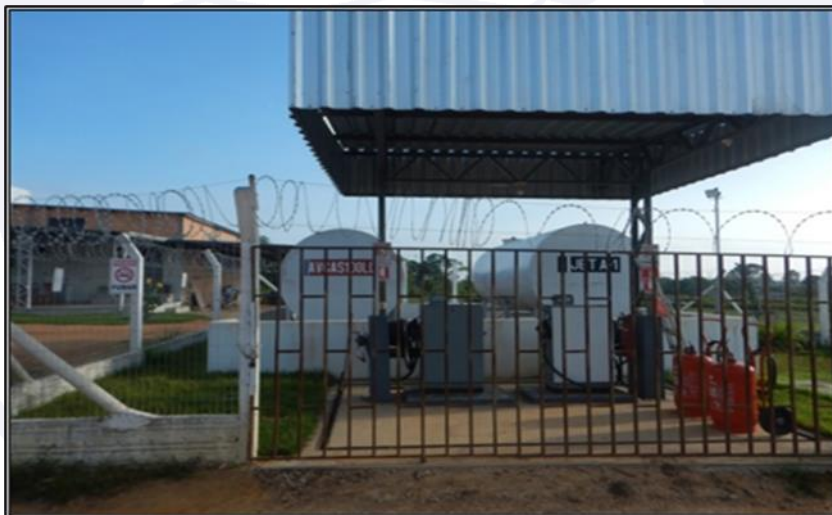
It is noteworthy that, at the aerodrome, the tank in which the Ethanol was stored, was stamped with the identification of aviation kerosene (JET-A1) (Figure 7).

Figure 7 - Ethanol storage station of the company with the inscription of aviation kerosene (JET-A1).
