COMANDO DA AERONÁUTICA
CENTRO DE INVESTIGAÇÃO E PREVENÇÃO DE
ACIDENTES AERONÁUTICOS

FINAL REPORT
A-021/CENIPA/2021

| AIRCRAFT: | PT-WVZ |
| MODEL: | AT-402A |

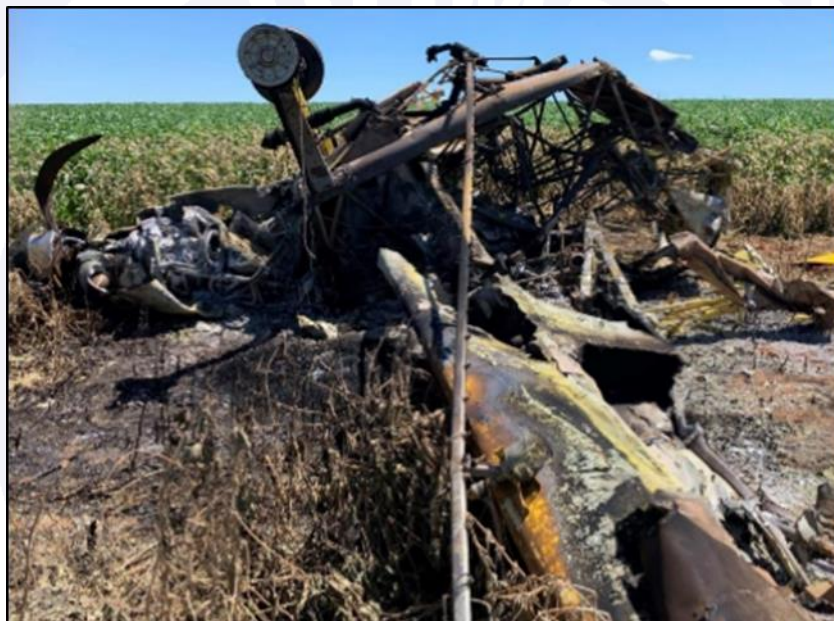
During the takeoff run, the aircraft did not reach the rotation speed, and overran the departure end of the airstrip. The airplane's right-hand wing collided with the ground, causing the aircraft to flip and catch fire.

Figure 1 - View of the PT-WVZ at the crash site.

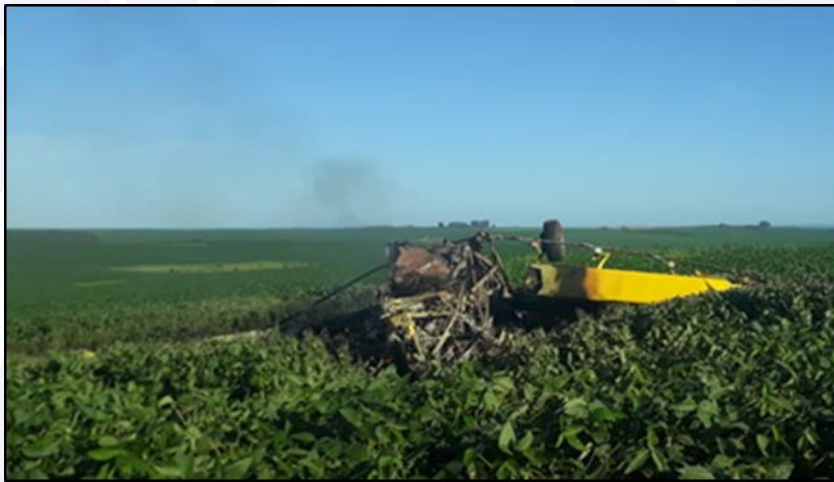
The PIC said that the meteorological conditions were consistent with the type of flight, being the temperature around 29°C, wind direction approximately 060° at 4 kt., devoid of cloud covers and without visibility restrictions, as shown in Figure 2.

Figure 2 - Image of the crash site moments after the occurrence.

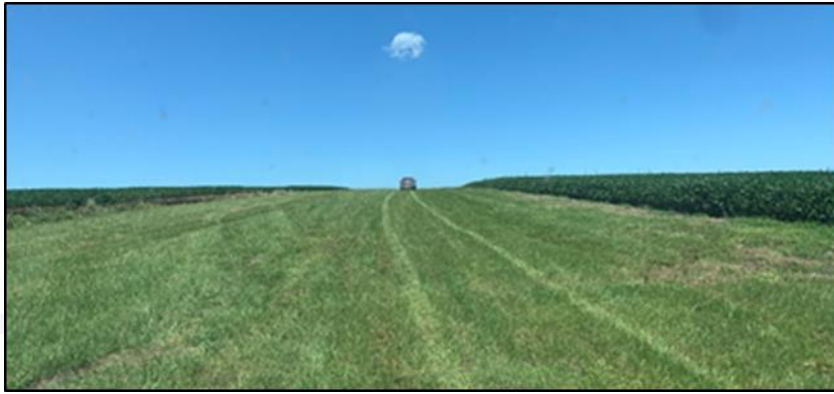
The accident happened in an airstrip for aeroagricultural use, whose surface was grassy, with thresholds 13/31, dimensions of 700 m x 16 m, at an elevation of 1,322 ft at the thresholds, and 1,360 ft in the middle of the airstrip, indicating a positive slope with a variation of 36 ft (11 m) between the thresholds and the highest point on the airstrip (Figure 3).

Figure 3 - View of the airstrip for aeroagricultural use from the threshold 13.

In the case in question, the recommendable conduction of risk analysis and risk management would be able to identify that the location did not have the appropriate dimensions for the operation of the PT-WVZ in the flight that culminated in the accident.

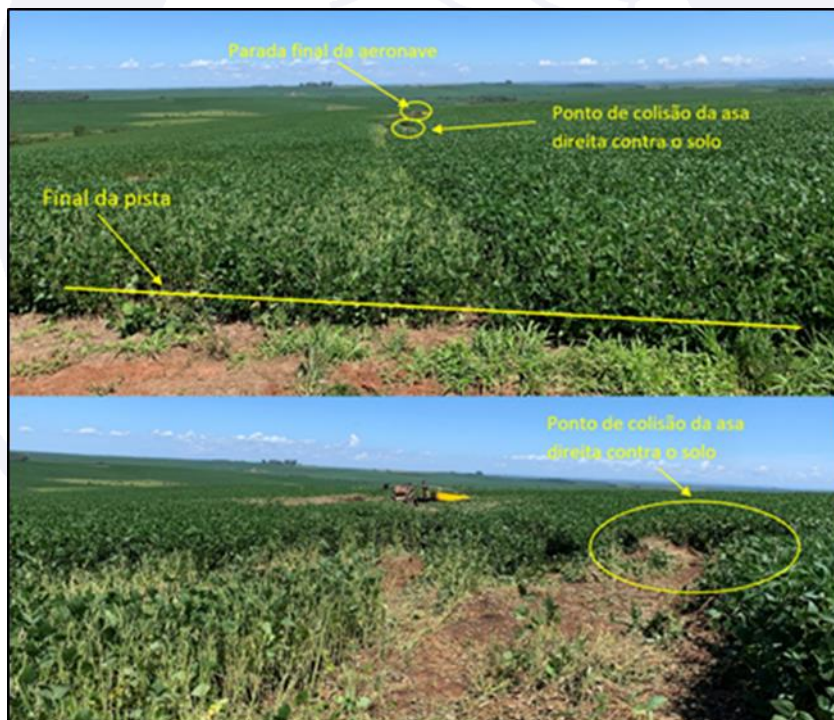
The first impact occurred when the right-hand wing hit the ground, causing the aircraft to roll and flip, as shown in Figure 4.

Figure 4 - Location of the runway excursion and point of impact with the ground.

- o) during the takeoff run, the aircraft failed to reach the minimum takeoff speed;
- p) after the aircraft overran the longitudinal limits of the airstrip, the right-hand wing collided with the ground, causing the aircraft to yaw and flip, stopping in an upside-down position in a direction opposite the one of departure, and catching fire;

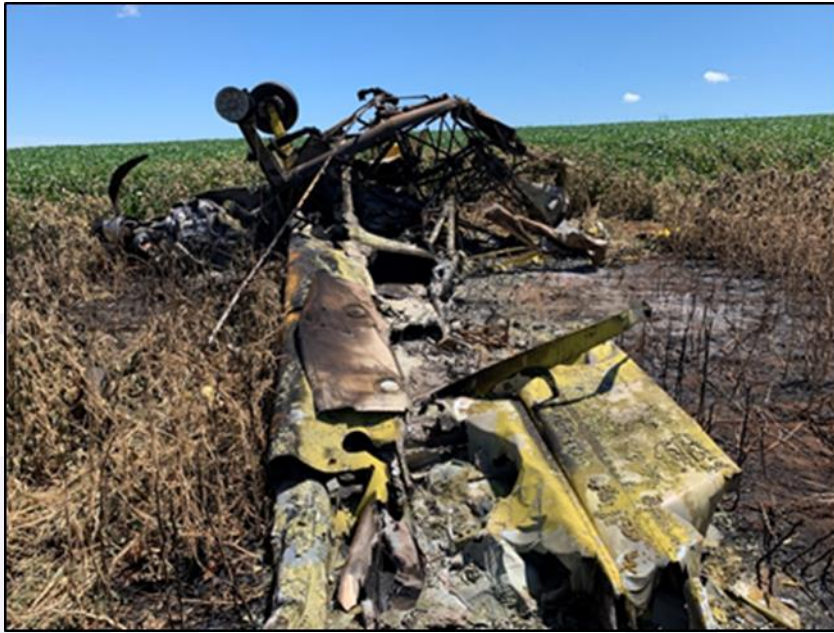
The aircraft caught fire after coming to a stop. The high degree of destruction and charring of the aircraft made it difficult to check both the equipment and the instruments (Figure 5).

Figure 5 - View of the PT-WVZ destroyed by fire.

According to the pilot, the fire started after the impact with the ground. Since the aircraft had been fueled for the start of the aerial application, there was a significant amount of fuel in the tanks, contributing to the persistence of the flames and the charring of the aircraft.

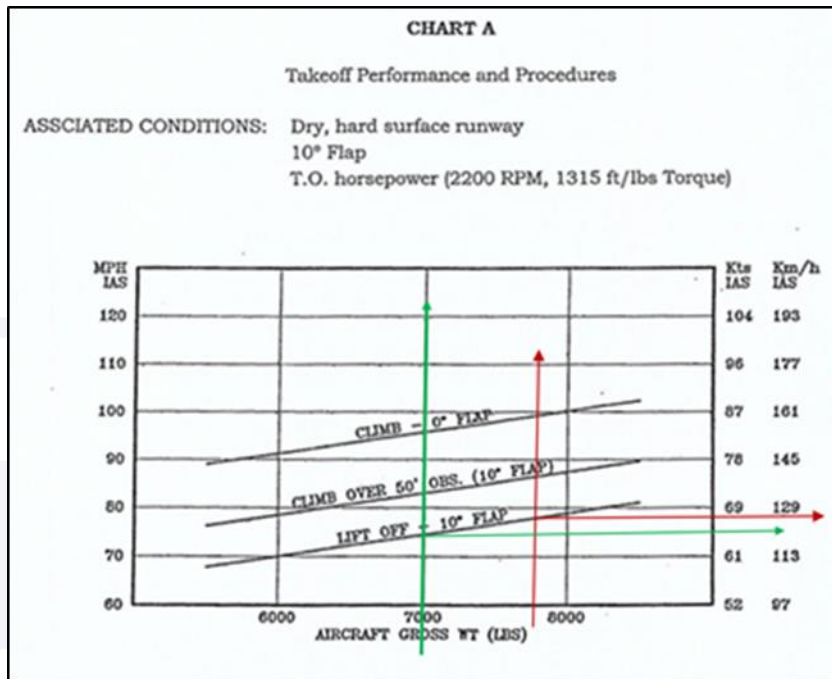
According to information collected during the initial action by the investigation team, the aircraft was operating with a weight of approximately 3,505 kg (7,727 lb.), that is, 330 kg above the maximum weight limit prescribed for the AT-402A (3,175 kg /7,000 lb.).

In accordance with Section 4 - Performance, CHART A, contained in the AT-402A AFM, for a weight of 3,505 kg (7,727 lb.), the indicated speed for takeoff would be around 68 kt, whereas, for the maximum takeoff weight within the limits established, the speed would be around 65 kt (Figure 9).

Figure 9 - AT-402A takeoff performance diagram.

Together with the performance diagram in Figure 9, the AFM presented a note informing that the takeoff roll and acceleration during takeoff would be impaired with the aircraft operating from a grassy or soft runway surface:

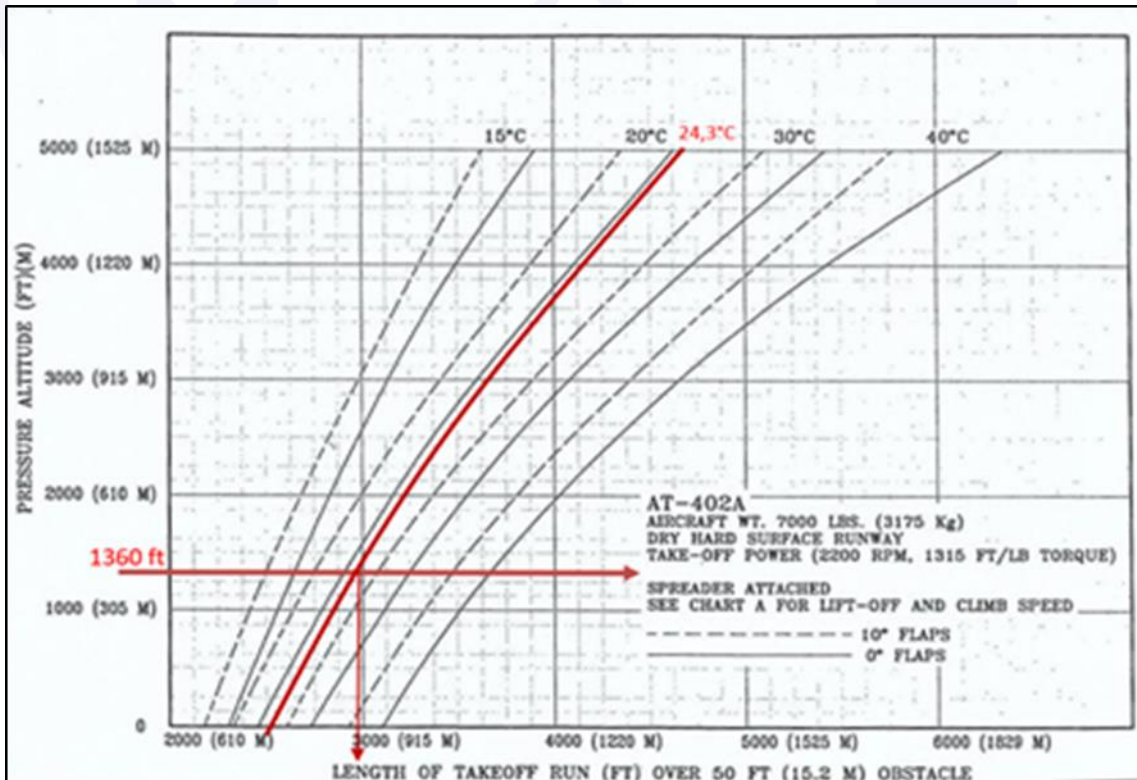
In turn, the takeoff distance required to clear an obstacle at 50 ft, for a weight of 3,175 kg (7,000 lb.), at an altitude of 1,360 ft, with a temperature of 24.3°C, with maximum takeoff power, from a hard dry surface, would be approximately 900 m. (Figure 10).

Figure 10 – Takeoff-distance diagram for a weight of 3,175 kg.
