FINAL REPORT
IG - 084/CENIPA/2016

OCCURRENCE:	SERIOUS INCIDENT
AIRCRAFT:	PT-YEL
MODEL:	206L-4
DATE:	13MAY2016

This is the Final Report of the 13MAY2016 serious incident with the 206L-4 aircraft, registration PT-YEL. The serious incident was classified as “[CTOL] Collision with obstacle during takeoff and landing”.

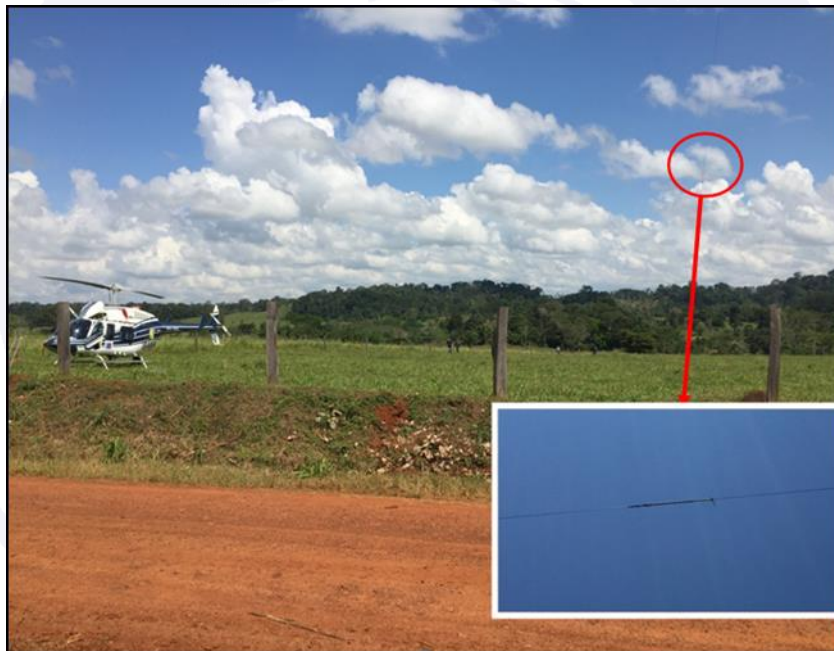
Figure 1 - View of the landing area and the wire, already repaired by the energy provider.

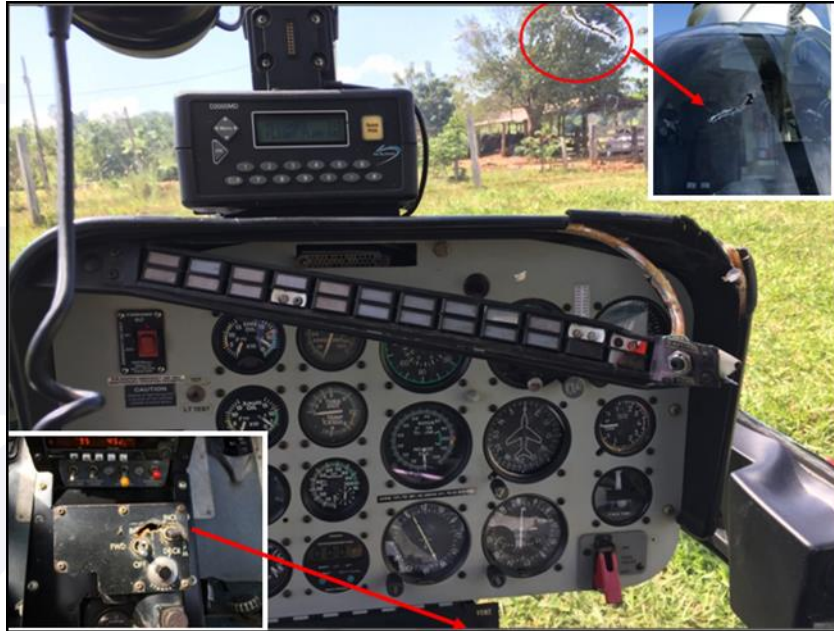
The aircraft had minor damage. The damages were restricted to two blades of the main rotor assembly, drift, right windshield, alarm panel and in the collective command.

Figure 2 - Panel, windshield and collective with the damages due to the collision against the wire.

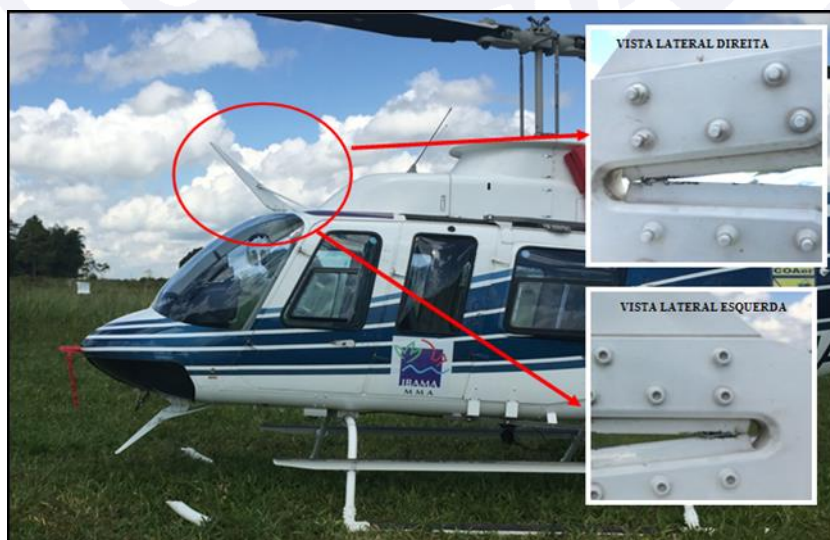
During the collision, there was the impact of the upper wire cutter (Figure 3) against the wire and subsequent section of the wire. The pilot landed without identifying any abnormality in the flight or vibration commands in the aircraft, making the engine shutdown.

Figure 3 - In detail, the top wire cutter that sectioned the wire after impact.

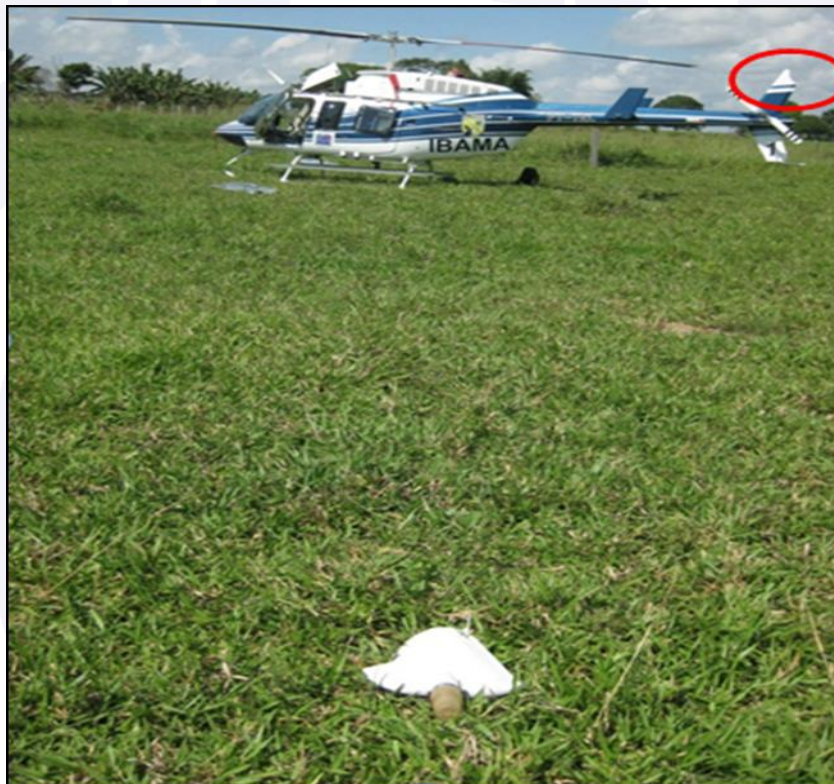
In addition to the external damages (blades, drift, pilot windshield and external thermometer), it was identified that windshield shrapnel caused damage to the alarm panel and the collective control (Figure 4).

Figure 4 - Overview. On the detail, the piece of the vertical stabilizer sectioned after the collision.

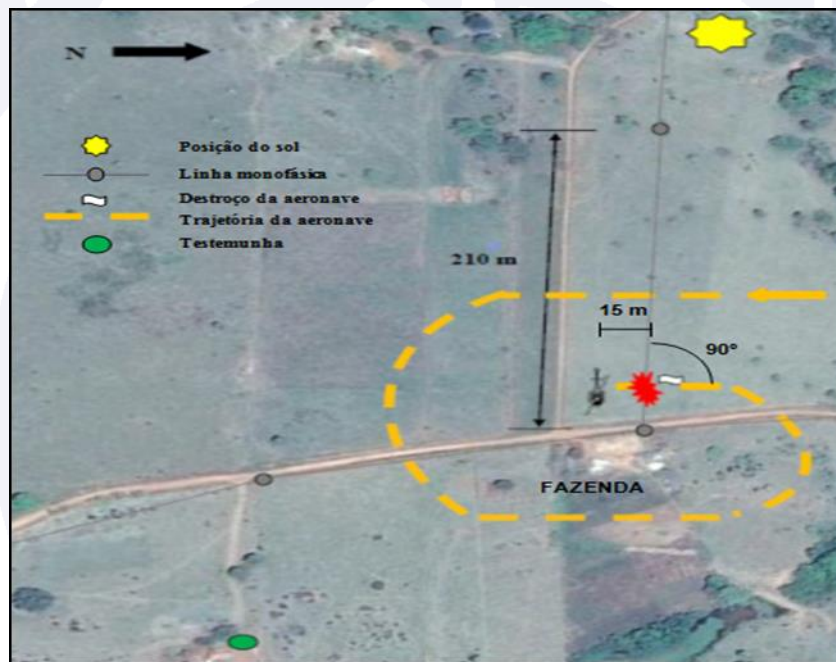
Figure 5 - Sketch of the occurrence.

Estimating a calm wind (observation of the local vegetation - whose branches did not vary in any direction), the commander defined the heading of approximation, around 185° . He made a pass in the profile that would be made the landing approach (Figure 5).
