**COMANDO DA AERONÁUTICA**  
**CENTRO DE INVESTIGAÇÃO E PREVENÇÃO DE**  
**ACIDENTES AERONÁUTICOS**

**FINAL REPORT**  
**A - 073/CENIPA/2019**

| <b>AIRCRAFT:</b> | <b>PT-YTJ</b> |
| <b>MODEL:</b> | <b>AS 350 B2</b> |

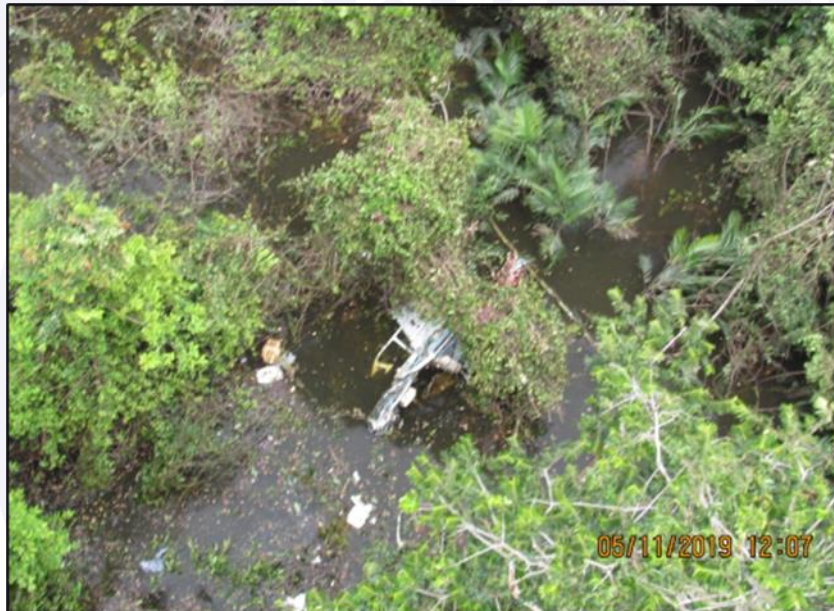
Figure 1 - General view of the PT-YTJ wreckage location.

The impact occurred in a forest area. The distribution of the wreckage was of the concentrated type. Due to the characteristics of the accident site, it was not possible to determine where the first impact occurred.

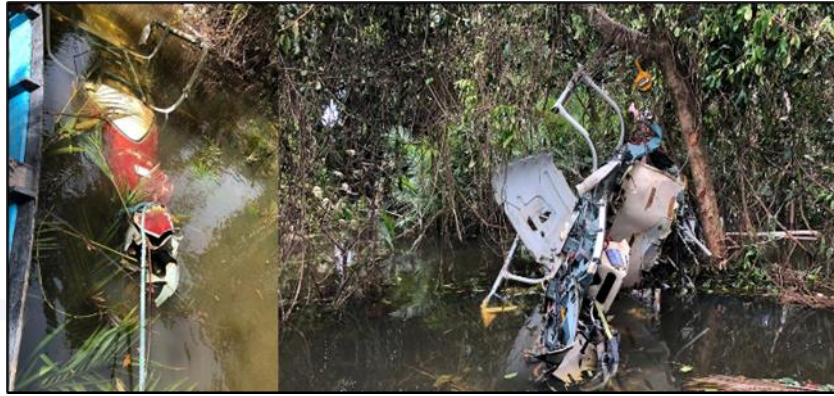
Upon arriving at the scene of the occurrence, the presence of third parties was verified, and it was observed that the wreckage had been searched and tied to the trees, which altered the evidence and distorted the accident scenario (Figure 3).

Figure 3 - View of the wreckage searched by persons. Source: photo taken by third parties.

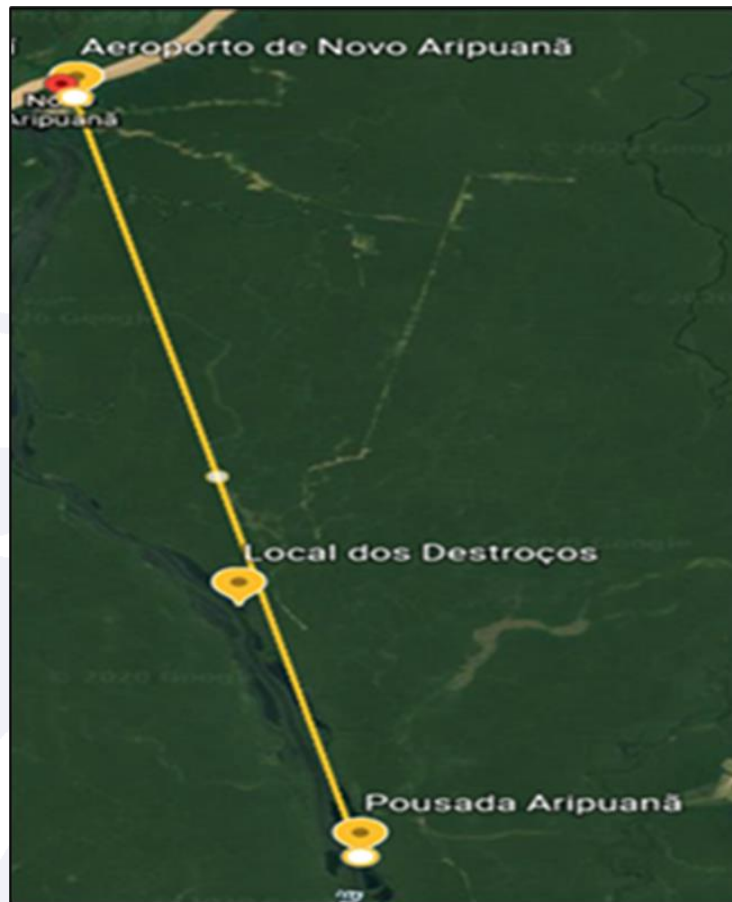
As the wreckage of the aircraft was found about 41 NM from SWNA and close to the planned route, it was inferred that there was no significant deviation from the planned course.

Figure 5 - Planned route for the aircraft and the wreckage site. Source: adapted from the Google Maps.

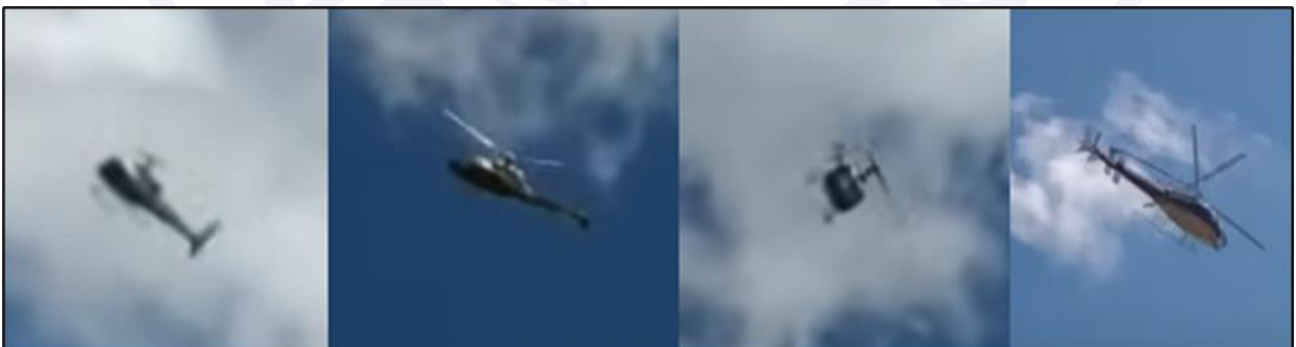
In a video received by the Investigation Team, it was possible to see the aircraft taking off for the flight in which the accident occurred. In this video, soon after the take-off and with passengers on board, an aerobatic maneuver was performed at low altitude, popularly known as "V-Zero" (Figure 6).

Figure 6 - Sequence of images from the aircraft PT-YTJ, performing the "V Zero" maneuver Source: ground observers in Novo Aripuanã - AM.

In this maneuver, the pilot would start an almost vertical climb, using high pitch attitude, until the speed reaches near zero and then, with the application of the tail rotor control, act in the vertical axis, approaching the ground in a pitched down attitude, in order to increase speed to allow recovery of level flight.

On the day of the accident, it was observed that, after the take-off and with the passengers on board, an aerobatic maneuver was performed at low altitude, contrary to both existing provisions of the ICA 100-4 and item 15 Restrictions, Section 2-1 - Operations Limitations of Flight Manual AS 350 B2.
