FINAL REPORT
A - 073/CENIPA/2018

OCCURRENCE:	ACCIDENT
AIRCRAFT:	PT-YZJ
MODEL:	BELL-407
DATE:	17APR2018

This is the Final Report of the 17APR2018 accident with the BELL-407 aircraft model, registration PT-YZJ. The accident was classified as “[SCF-PP] System/Component Failure or Malfunction Powerplant – Engine Failure in Flight”.

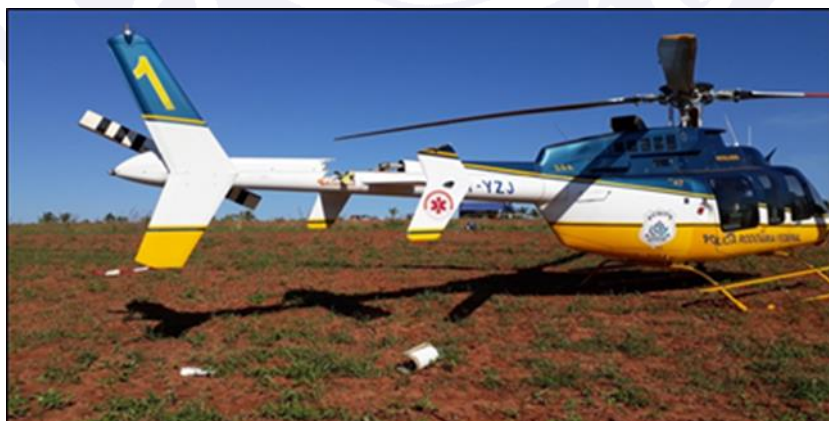
The aircraft had substantial damage to the engine, tail rotor driveshaft, tail cone fairing and finlets, as well as minor damage to the main rotor blades.

Figure 1 - General view of the aircraft after the occurrence.

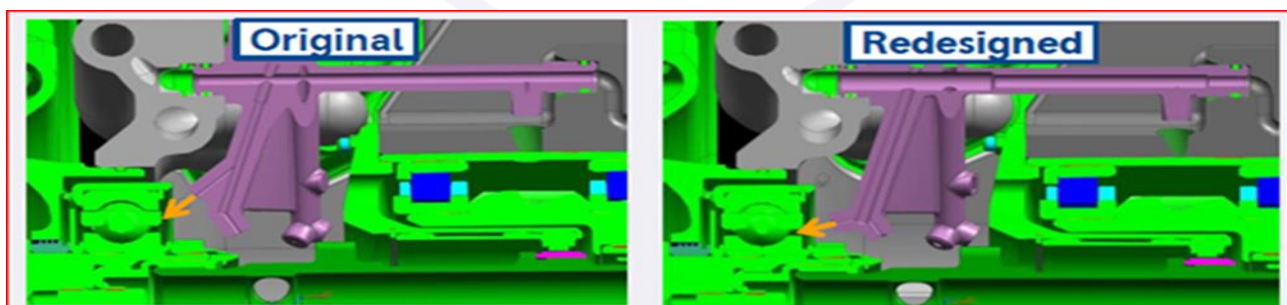
Figure 4 - Difference between the original *piccolo tube* and its new (redesigned) version.

Analysis shows that the angle of incidence of the oil jet was reduced, the oil injection hole was moved closer to the bearing, and the oil flow through the hole was unchanged. Tests carried out would have proven significant improvements in the passage of oil to the bearing and a reduction in its operating temperature.

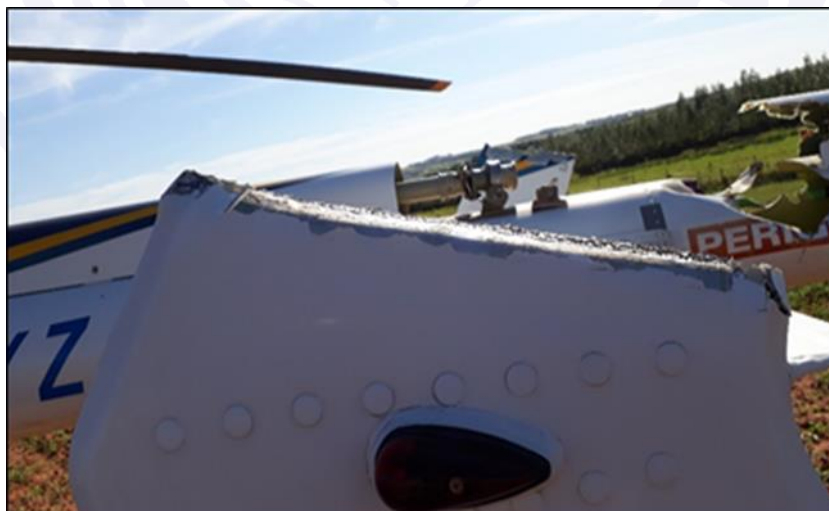
There was a collision of the main rotor against the tail boom, with the sectioning of the two finlets and the rupture of part of the transmission shaft of the tail rotor (Figures 6 and 7).

Figure 6 - Detail of the left finlet cutting angle caused by the main rotor.

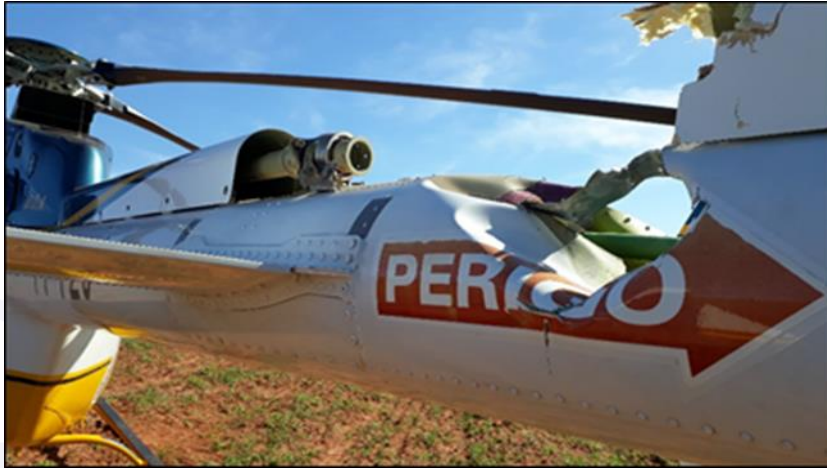
Figure 7 - Detail of the point of impact of the main rotor blades against the tail boom.

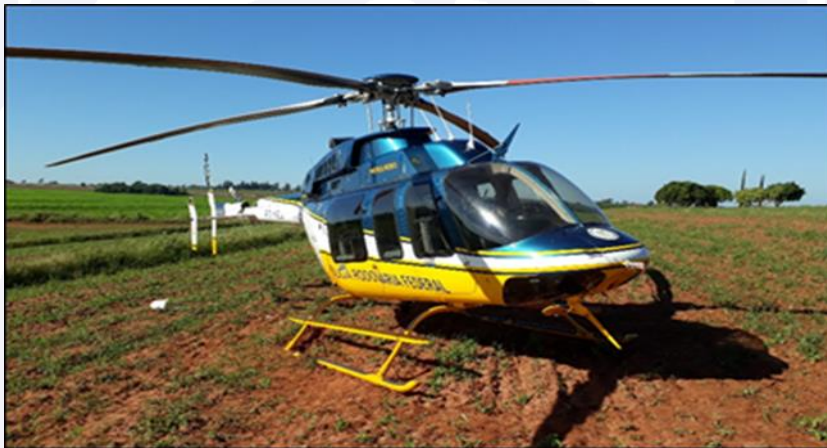
There were no signs of tail rotor or tail skid contact on the ground. There was a slight sinking of the rear part of the right ski into the ground, but there was no deformation of the skis (Figure 8).

Figure 8 - Overview of the aircraft's stopping position.

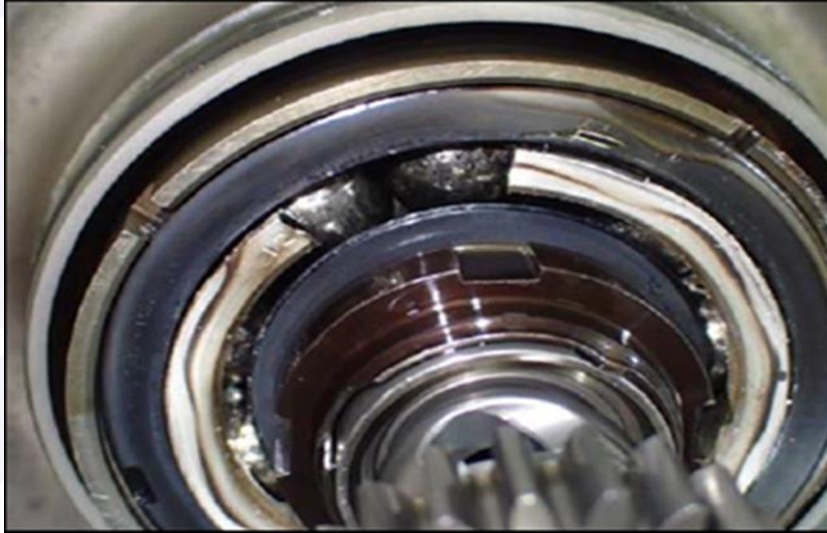
However, a section covering the area of approximately two spheres was missing.

The bearing retaining ring was also absent, with most of it located posteriorly inside the gearbox (Figures 9, 10, and 11).

Figure 9 - Bearing n° 2 in its correct position, but damaged.

After researching the engine, it was concluded that there was deficient lubrication of bearing n° 2, which resulted in its overheating and rupture, causing the loss of the axial support of the compressor disc, allowing its direct axial movement from its normal position.

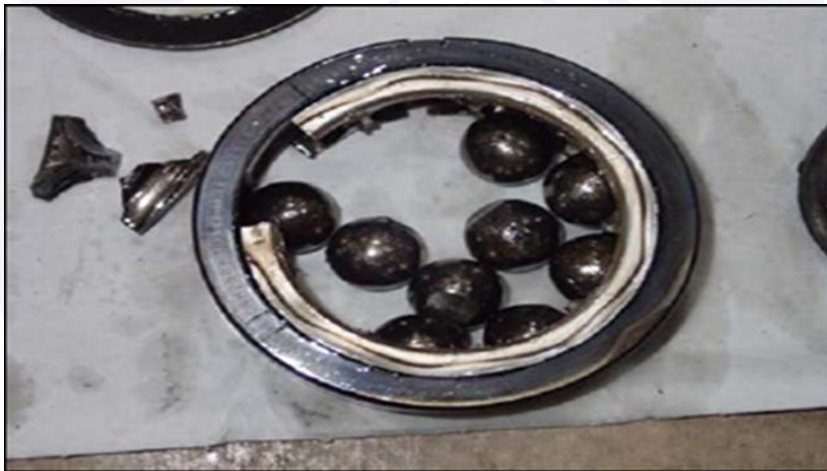
Figure 10 - Bearing n° 2 after being removed from the aircraft.

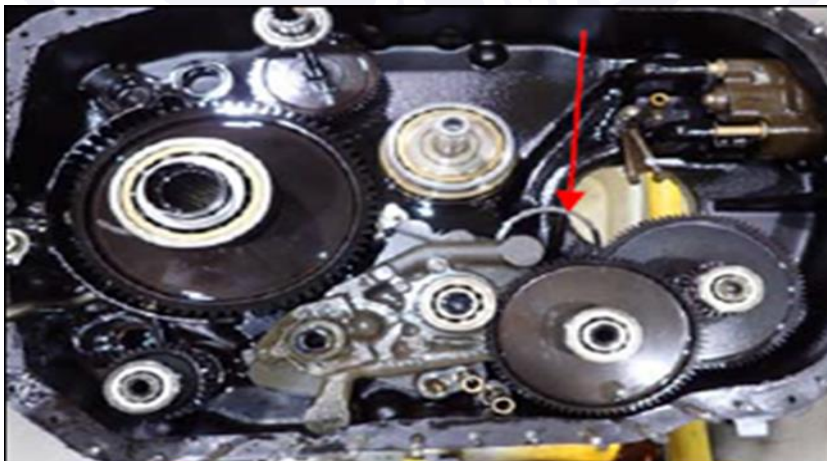
Figure 11 - Bearing Retaining Ring n° 2 found inside the gearbox.

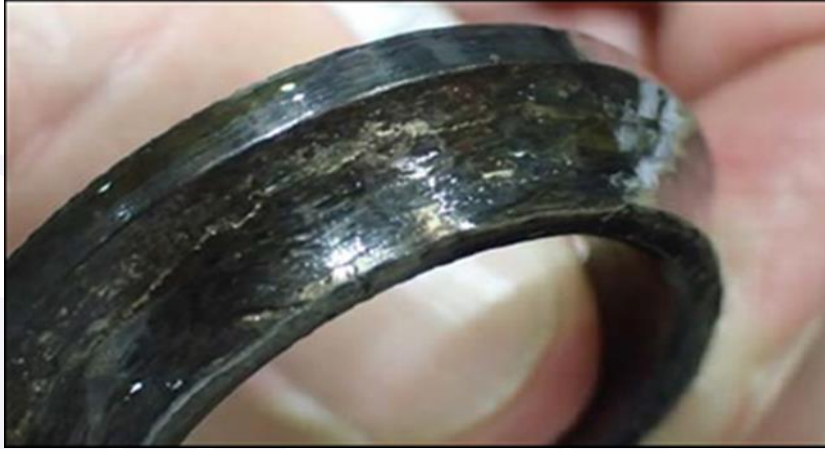
All spheres were present and retained within the bearing area, however, they exhibited evidence of slippage. Removal of bearing n°2 revealed marks on the two inner halves in the sphere rolling area (Figure 12).

Figure 12 - Scratch marks on the inner raceway of bearing n°2.

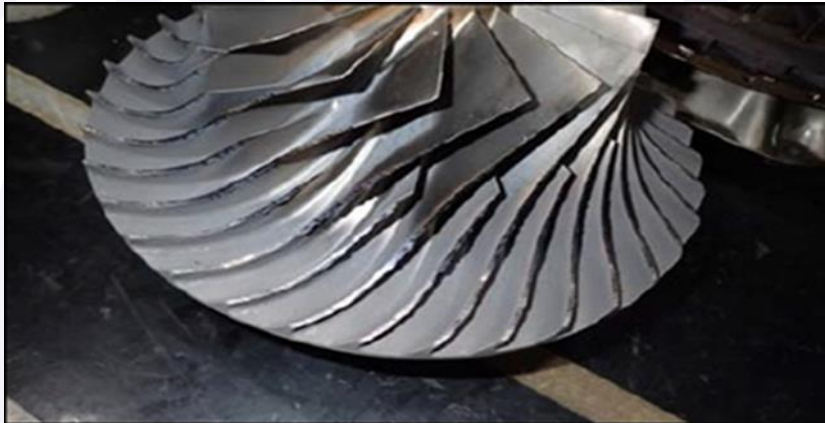
Disassembly of the compressor revealed that its rotating and stationary parts came into contact, resulting in the damage illustrated in Figures 13 and 14.

Figure 13 - View of the compressor axial stage.

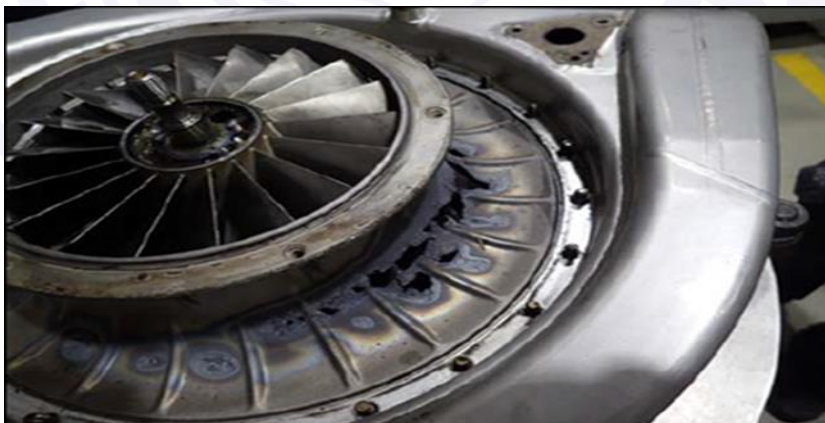
Figure 14 - Damage to the compressor area.

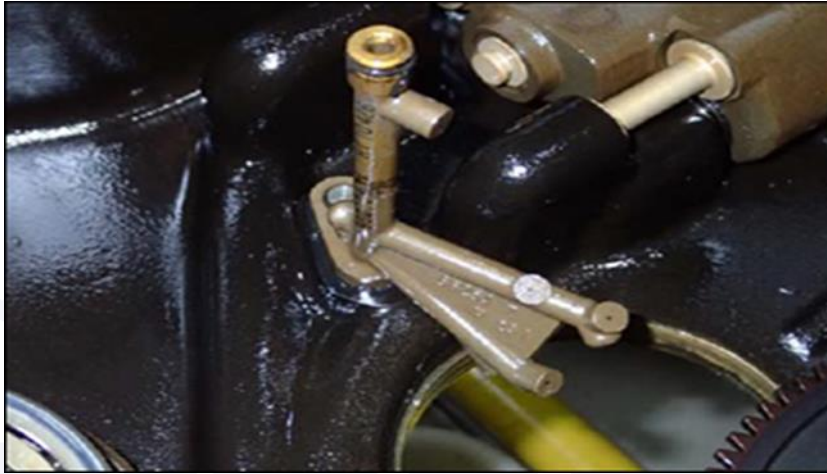
Non-compliance with the CEB N° 72-6081 was verified (replacement of *piccolo tube* P/N 23063357 by P/N M250-10767). However, the *piccolo tube* installed (P/N 23063357) was in its correct position and visually normal (Figure 15).

Figure 15 - *Piccolo tube* in its correct position.

Although compliance with the CEB 72-6081 (*piccolo tube* replacement) is not mandatory, it could have been configured as a barrier to the accident, since it represents significant improvements (reduction in its operating temperature according to tests carried out by Rolls-Royce) regarding the delivery of oil to bearing n° 2.

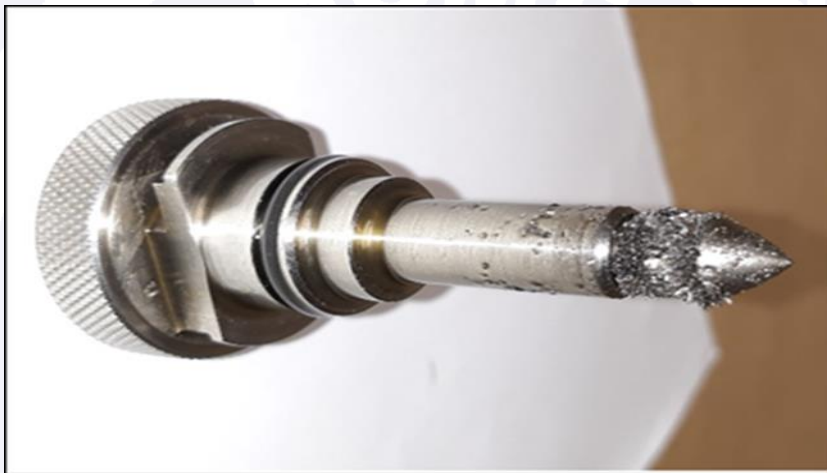
When removing the magnetic plugs from the aircraft (Lower Magnetic plug and Upper Magnetic plug), a considerable amount of metal particles was found (Figures 16 and 17).

Figure 16 - Lower Magnetic Plug.

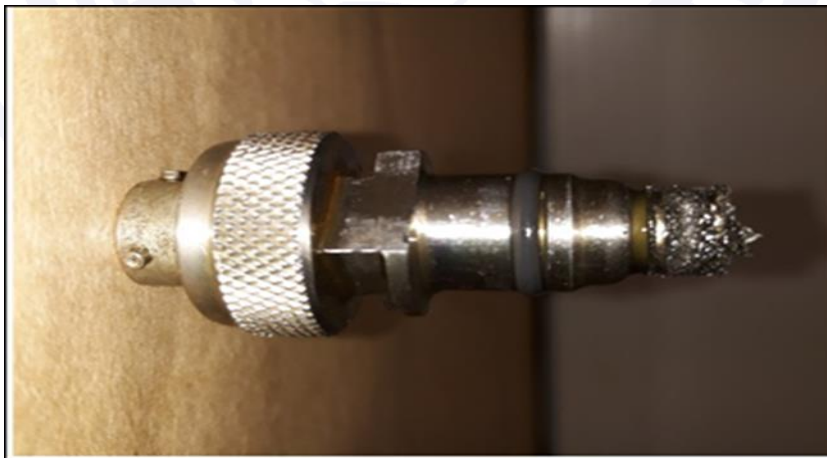
Figure 17 - Upper Magnetic Plug.

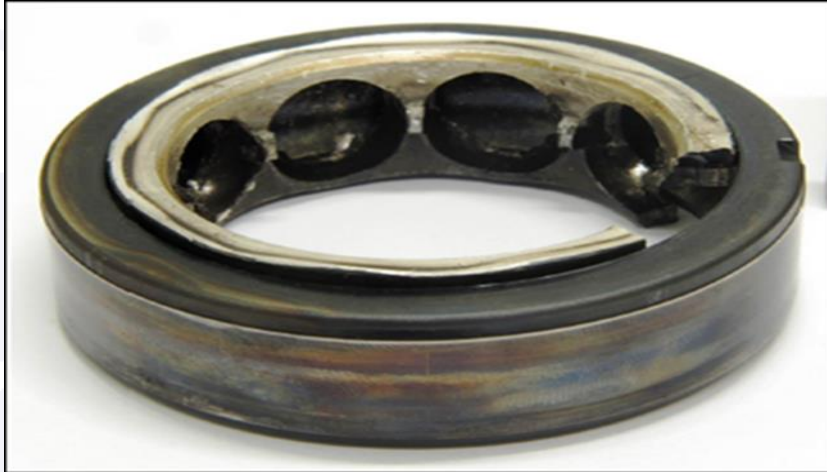
Figure 18 - General view of bearing n°2 and damage to its rail.

- all components of bearing n°2 exhibited signs of heat stress. There was a pattern of thermal wear on the inner ring, outer ring, and spheres;

- Engine damage was consistent with a bearing n°2 failure due to insufficient cooling and directing the lubricating oil flow. All other damages were considered secondary;

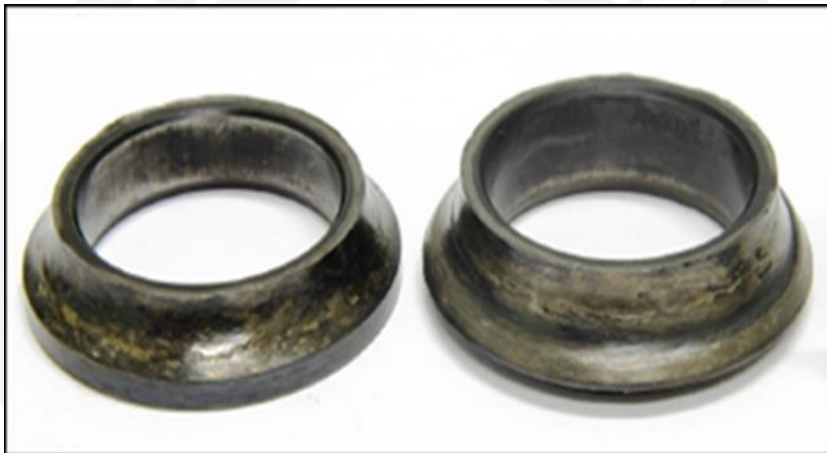
Figure 19 - View of the general condition of the inner rings of bearing n° 2.

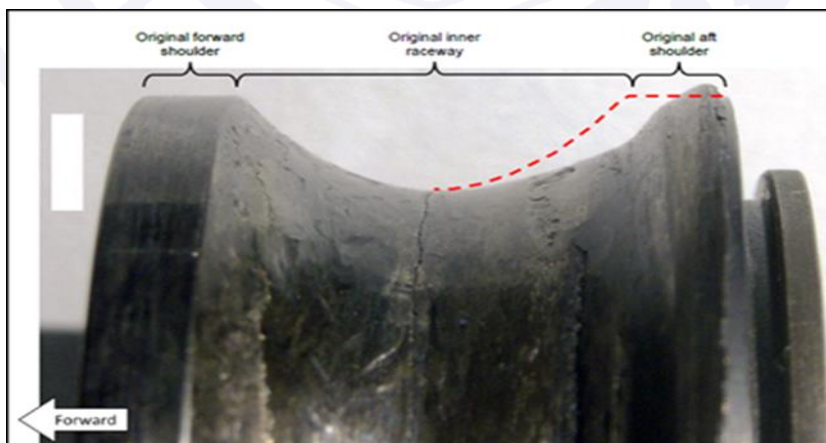
Figure 20 - Detailed view of the bearing's inner raceway, showing the profile distortion. The red dashed line approximates the original profile of the sphere rolling area.

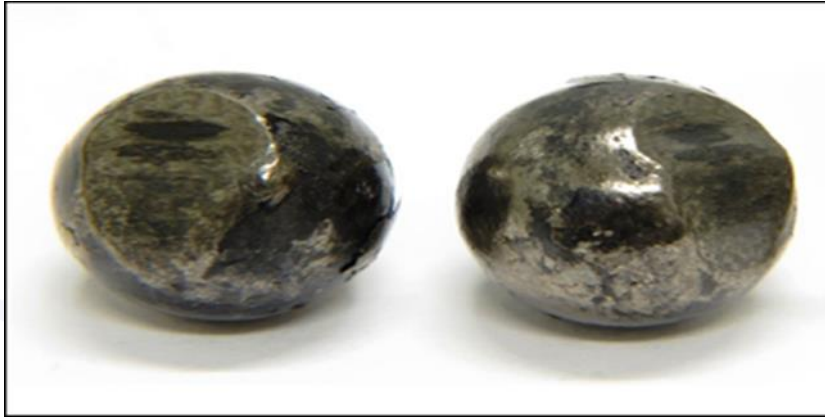
All spheres of bearing n°2 showed flattened parts, resulting from contact with the side of the inner ring (Figure 21).

Figure 21 - View of the damage caused to the spheres of bearing nº 2.

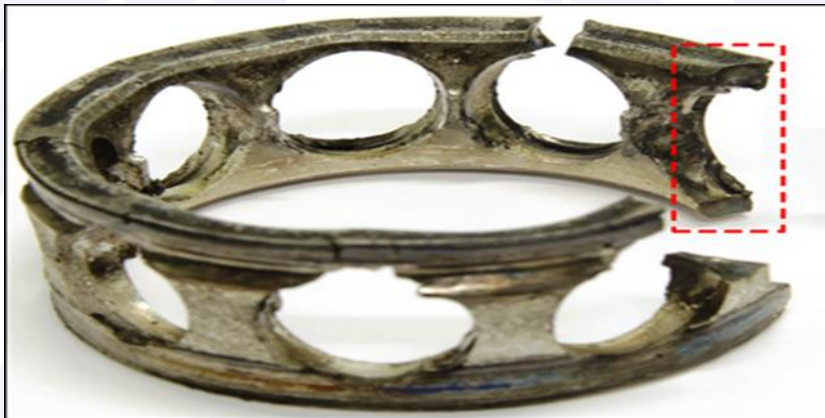
The bearing nº2 front and rear rails were fractured and detailed visual inspection revealed macroscopic indications consistent with progression of fatigue (Figures 22 and 23).

Figure 22 - View of the inner rails of bearing nº 2.

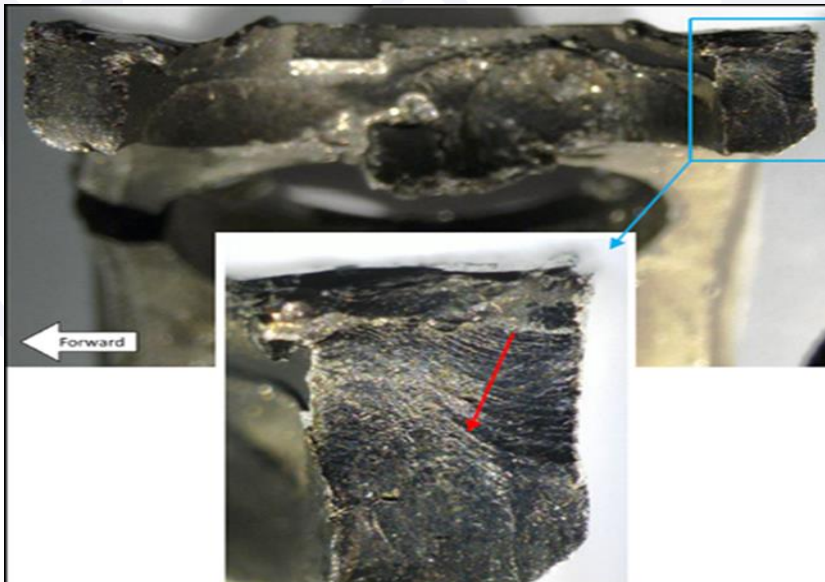
Figure 23 - Detailed view of the fractured rails of bearing nº2 showing macroscopic indications consistent with progression of fatigue (red arrow).

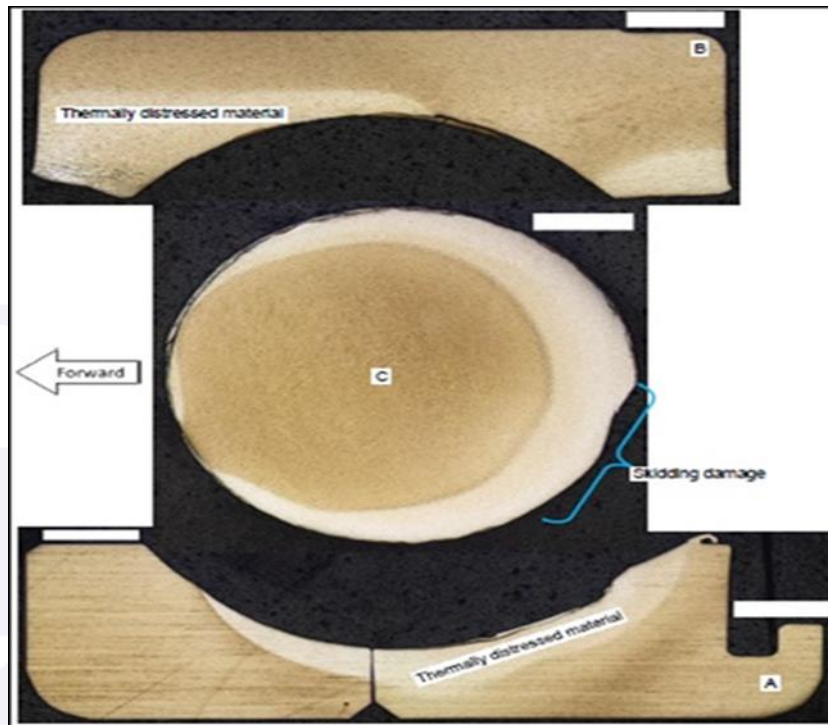
In the visualization of metallographic sections of the outer and inner rings and of a bearing nº2 sphere, it was possible to observe the extent of the raceway profile distortion and the thermal wear of the components. Thermal wear is indicated by the lighter areas shown in Figure 24.

Figure 24 - Thermal wear of the material.

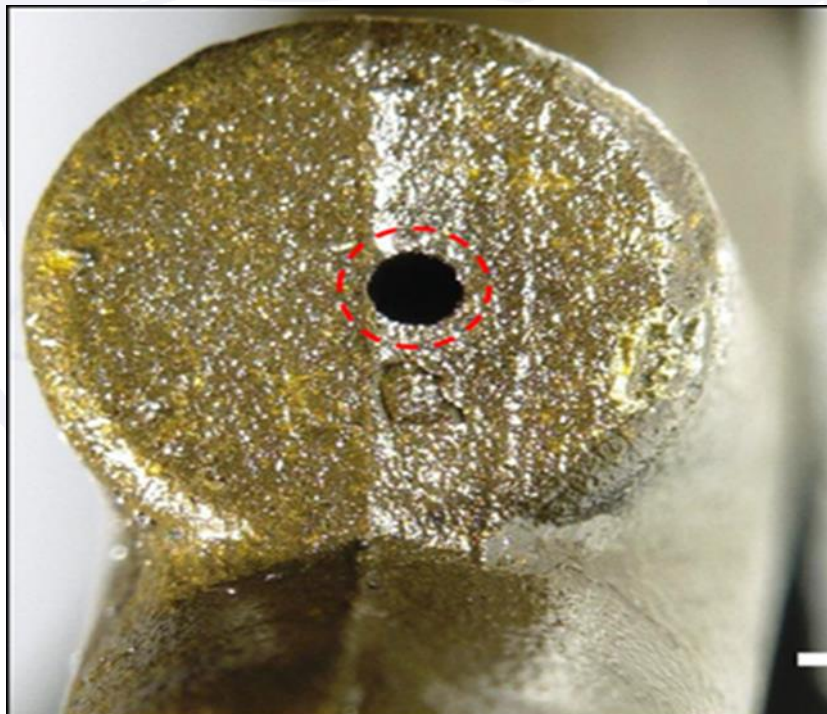
The visual examination of the main oil passage and oil directing duct to bearing n°2 did not reveal any blockage (Figure 25).

The normal continuity of the internal flow between the oil inlet port and the directing jet for bearing n°2 was confirmed through a liquid flow test in the *piccolo tube*.

Figure 25 - *Piccolo tube* outlet hole.

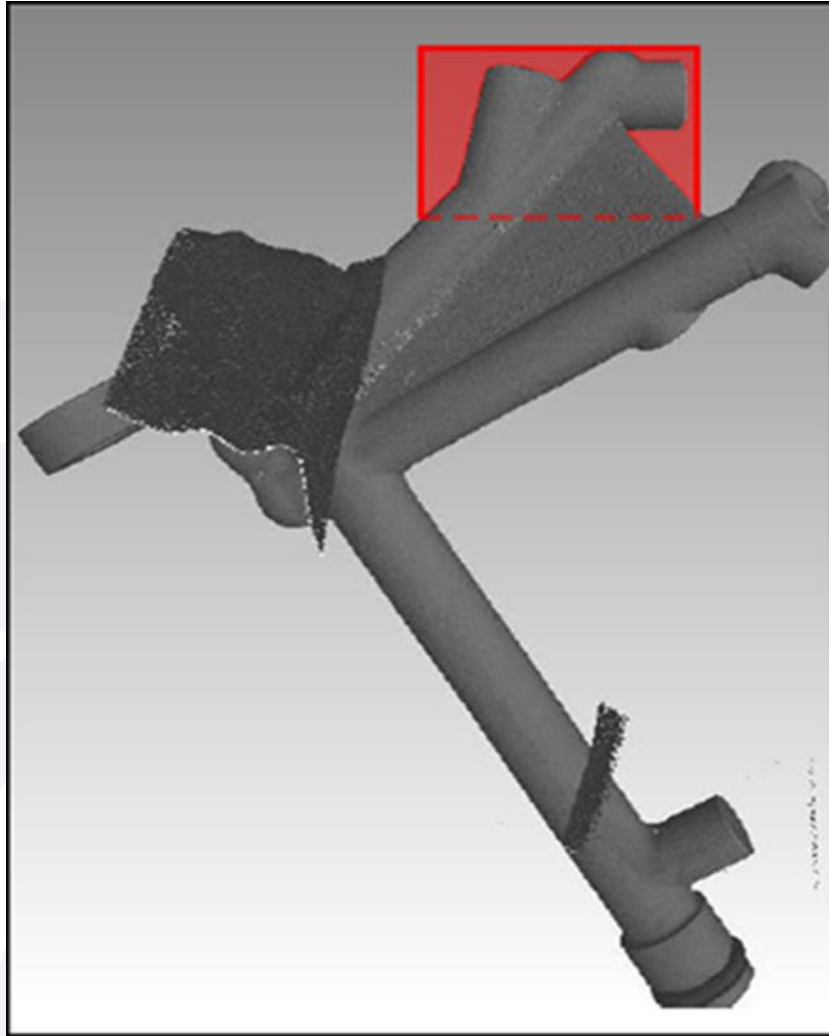
In addition, the *piccolo tube* was subjected to radiographic inspection by computed tomography. The resulting radiographs did not reveal any internal blockage or discontinuity of the internal passages in the oil delivery tube (Figures 26 and 27).

Figure 26 - Radiograph of the *piccolo tube*.

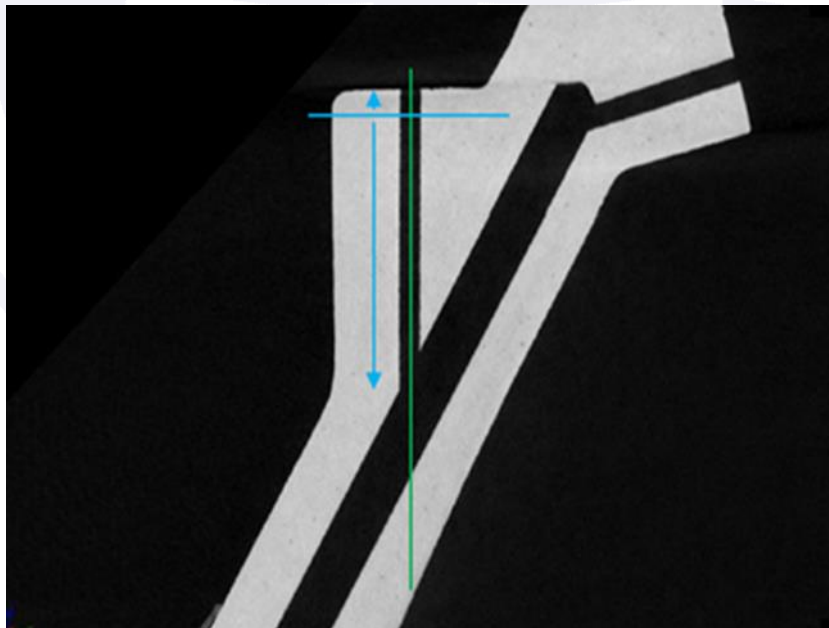
Figure 27 - Radiograph of the *piccolo tube*.

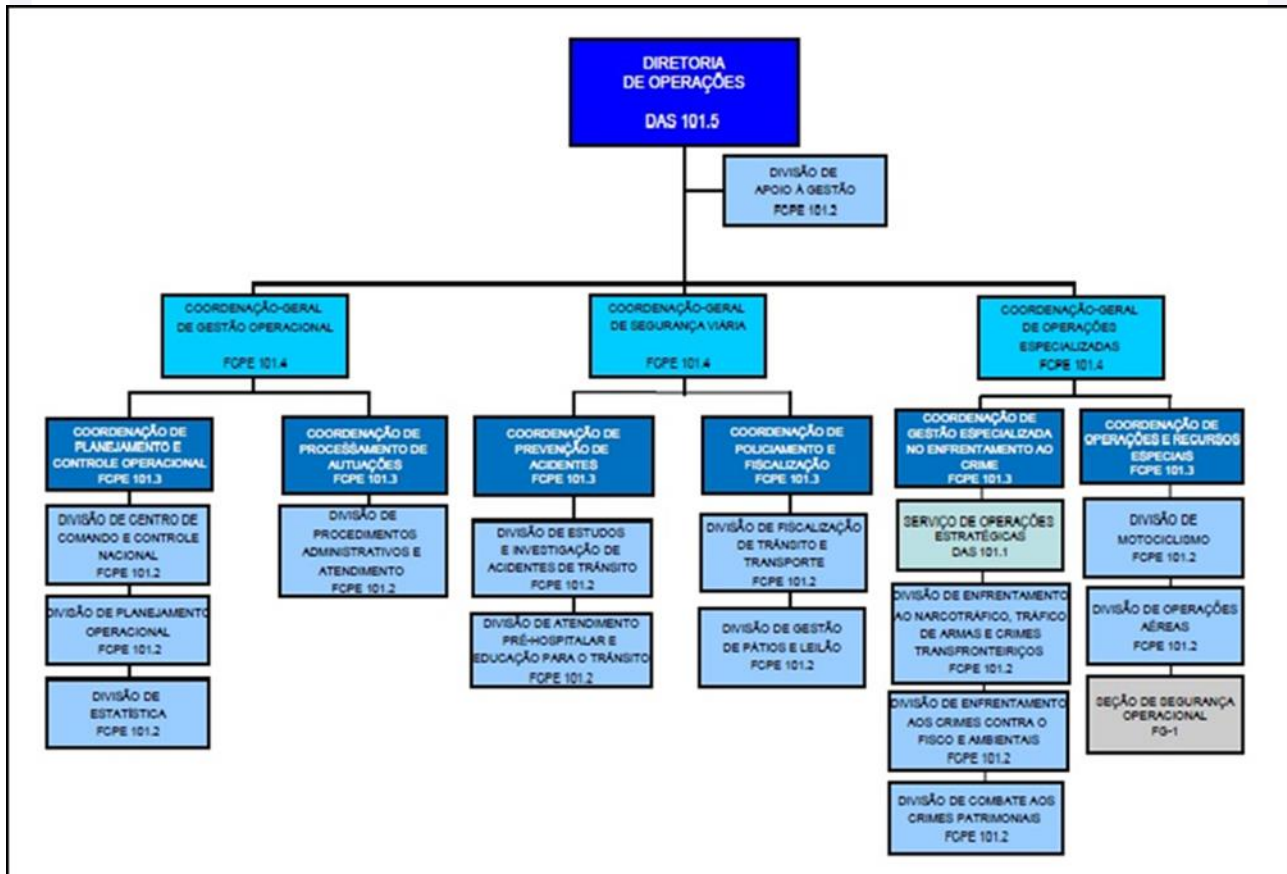
When analyzing the organization chart of the PRF Operations Director, it was observed that the GSO was subordinated to two coordination below the Operations Director, which contradicted the provisions of the MGSO (Figure 28).

Figure 28 - Organizational Chart of the PRF Operations Director - distance from the GSO.

It was found that there was no effective advice from the GSO. In addition to not having an exclusive dedication to the position, there was no adequate support structure, sufficient staff, and adequate and updated qualifications. The flow of information on issues related to Flight Safety was not effective, which undermined the importance that should be given to matters related to safety by the Operations Director and the General Director of the PRF.
