**COMANDO DA AERONÁUTICA**  
**CENTRO DE INVESTIGAÇÃO E PREVENÇÃO DE**  
**ACIDENTES AERONÁUTICOS**

**FINAL REPORT**  
**A - 104/CENIPA/2016**

<b>OCCURRENCE:</b>	<b>ACCIDENT</b>
<b>AIRCRAFT:</b>	<b>PT-YZK</b>
<b>MODEL:</b>	<b>407</b>
<b>DATE:</b>	<b>29JUL2016</b>

This is the Final Report of the 29JUL2016 accident with the 407 aircraft model, registration PT-YZK. The accident was classified as “[LOC-I] Loss of Control in Flight and [ARC] Abnormal Runway Contact”.

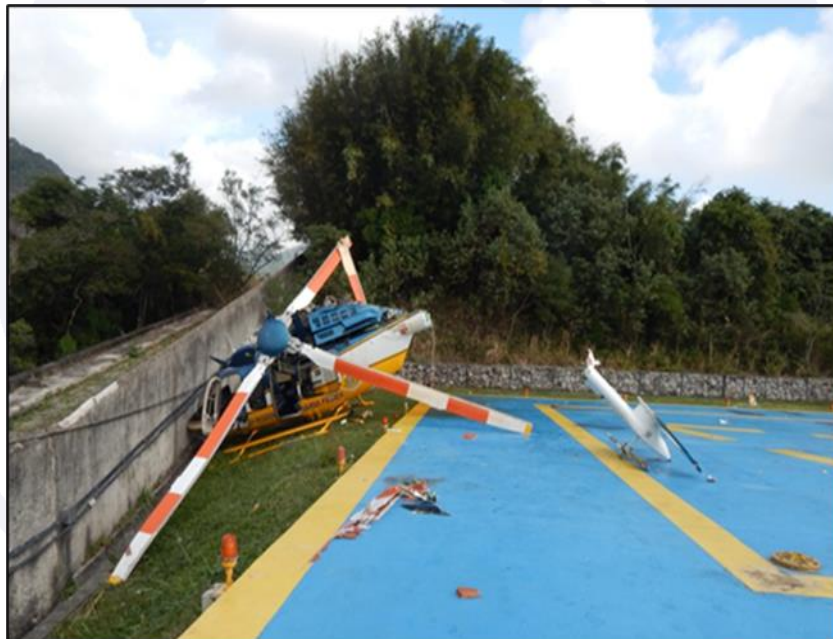
Figure 1 - View of the PT-YZK at the accident site.

The wreckage was concentrated, with the tail cone separated from the helicopter's central structure.

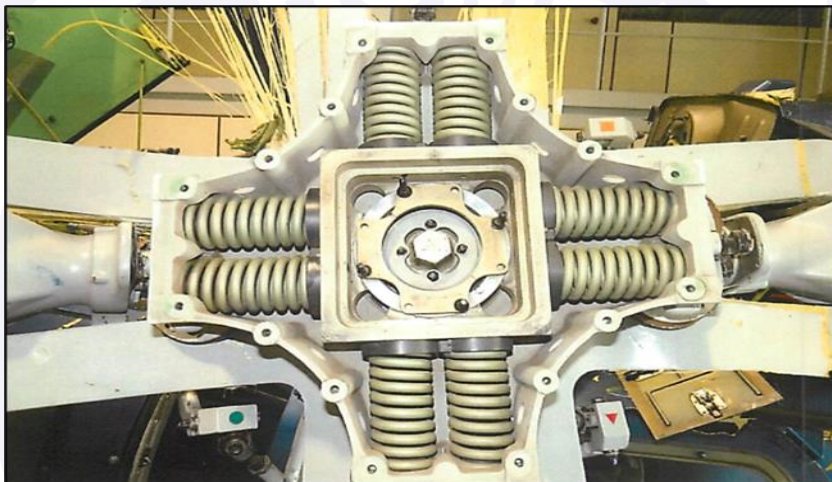
The damping system in the main rotor star did not show component failures or fractures. The springs were in normal conditions of use (Figure 2).

Figure 2 - View of the vibration damping system in the main rotor star, without failure in the springs.

The vibration damping system in the main rotor star had its springs intact, without any indication of failure or malfunction, which excluded the possibility that this system had contributed to the strong vibration reported by the crew.

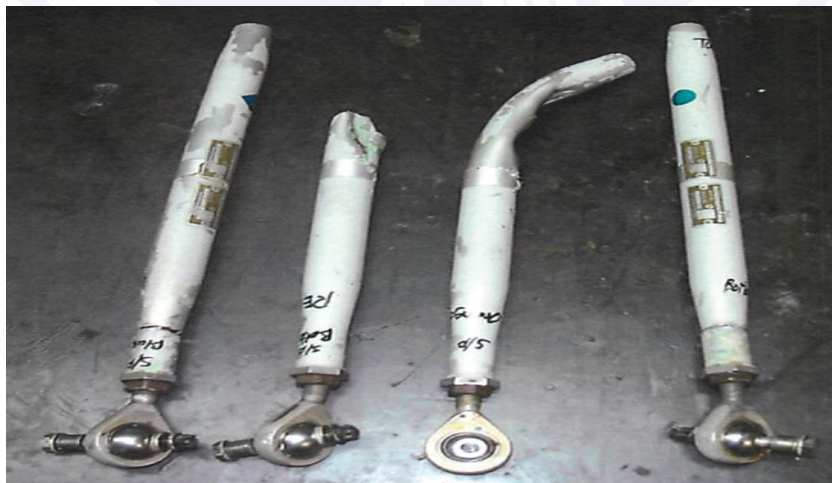
The failures and fractures in the set of blades and in the main rotor control link system were consistent with the impact of the helicopter against the ground (Figure 3).

Figure 3 - Main rotor blade links. Deformation fractures caused by overload.

The failures and fractures in the blades assembly and the main rotor control link system were consistent with the helicopter's impact against the ground.

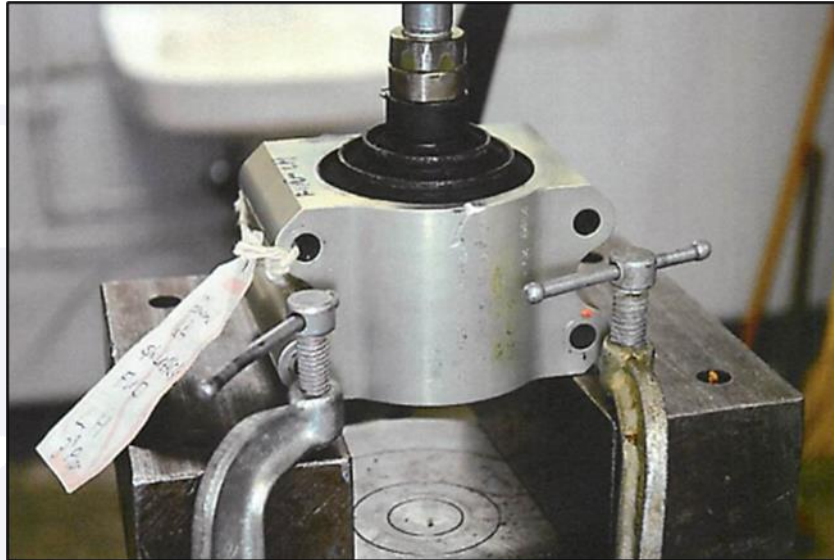
Tests and analyzes were performed on the Corner Mounts due to the possible contribution of this element to the vibration observed by the crew (Figure 4).

Figure 4 - Dynamic test on the Corner Mounts.

The results obtained indicated that the Corner Mounts were within acceptable parameters for service, even after the accident.

The Corner Mounts showed behavior and parameters within the acceptable range for use. The analyses of the Corner Mounts revealed that they were in acceptable condition for use and operation even after the accident, ruling out failure or incorrect functioning.

The Corner Mounts were within acceptable parameters for service, even after the accident, being discarded the failure or malfunction of these components as the cause of the reported abnormal vibration.

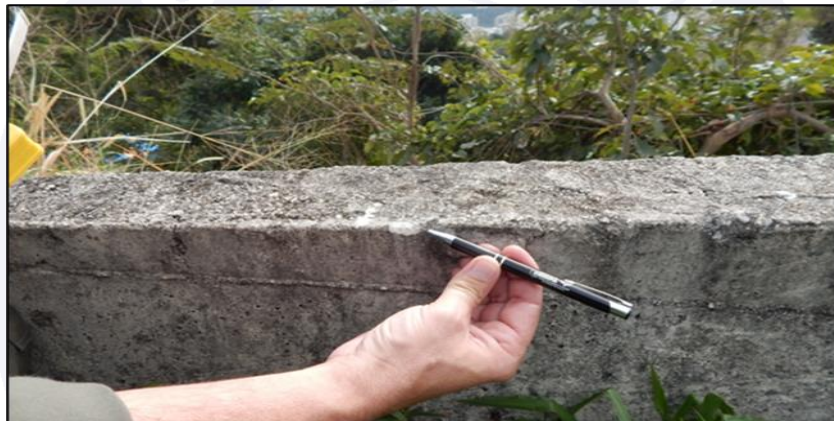
The first impact of the aircraft against the wall occurred in a descending profile of approach to land on the helipad. The tail rotor touchdown occurred out of the touchdown area, about 2 meters before the beginning of the landing area.

During the final approach, the helicopter experienced strong vibration. The PIC decided to proceed to landing. According to the PIC, close to the ground, the vibration became uncontrollable, and the tail rotor touched a wall out of the landing area (Figure 5).

Figure 5 - Point of impact of the tail rotor against the wall.

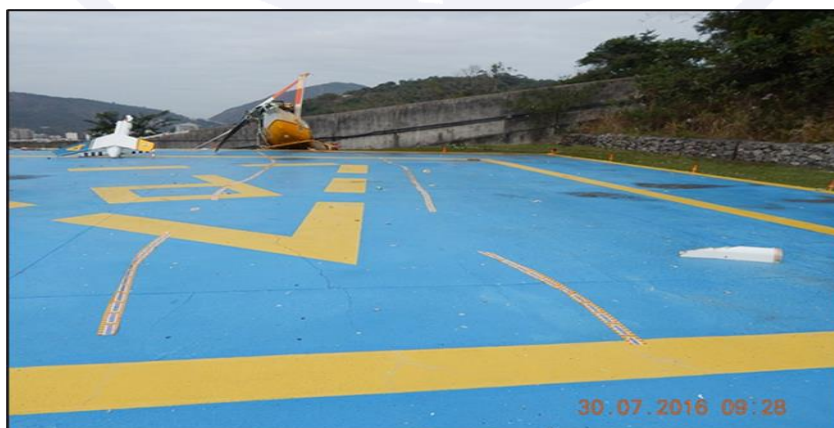
After this impact, the skis collided sharply against the surface of the outer edge of the landing area, and the PT-YZK continued its uncontrolled forward movement in the approach direction until it passed the rear edge of the helipad and crashed into a wall located about 2 meters from the landing and takeoff area (Figure 6).

Figure 6 - Trajectory taken by the aircraft over the helipad.

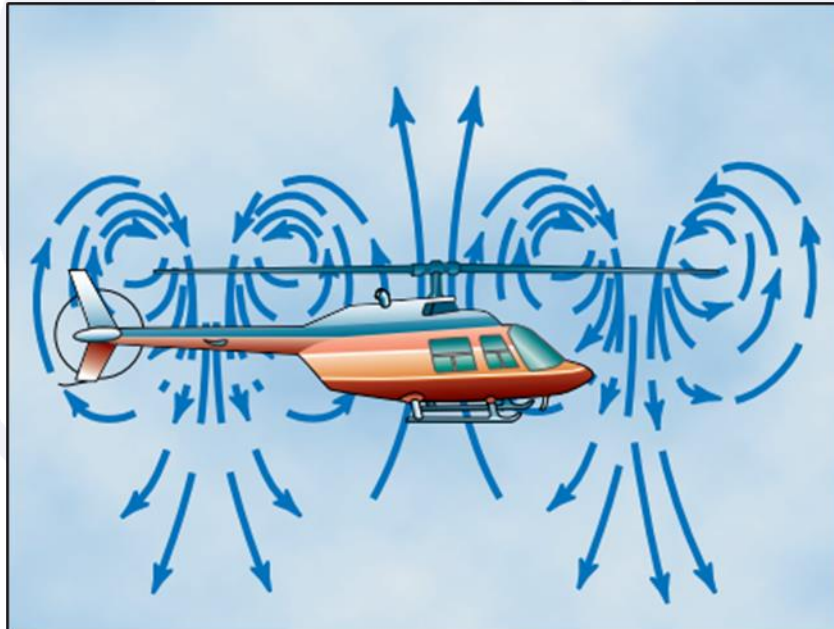
The helicopter reaches a point where most of the power developed by the engine is wasted, accelerating through the air in a "nut" pattern. In effect, the helicopter is flying in its own disturbed airflow (Figure 7).

Figure 7 - Vortex Ring State. Source: Rotorcraft Flying Handbook (FAA).

According to the FAA manual, the VRS comes accompanied by high levels of vibration and can occur during any maneuver that places the main rotor in a condition of high upward airflow and low forward speed.
