COMANDO DA AERONÁUTICA
CENTRO DE INVESTIGAÇÃO E PREVENÇÃO DE
ACIDENTES AERONÁUTICOS

FINAL REPORT
A - 061/CENIPA/2013

OCCURRENCE:	ACCIDENT
AIRCRAFT:	PT-HUW
MODEL:	BELL 412
DATE:	27MAR2013

This is the Final Report of the 27MAR2013 accident with the BELL 412 aircraft model, registration PT-HUW. The accident was classified as “[LOC-I] Loss of Control in Flight”.

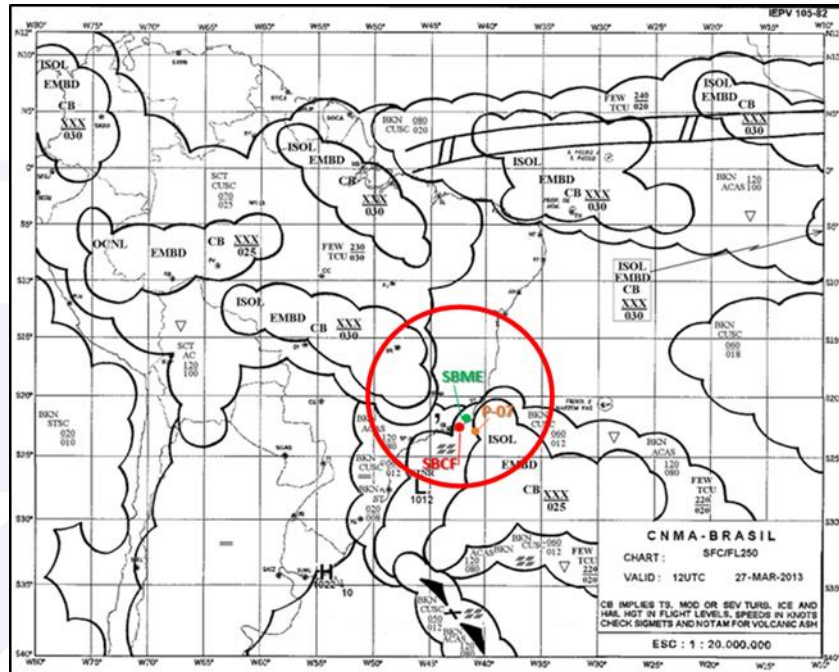
The SIGWX of 1200 (UTC) in South America presented the possibility of cloud formations in the region where the occurrence happened, in addition to rain, as highlighted in Figure 1.

Figure 1 - SIGWX weather chart.

In addition, there was a restriction on the visibility caused by the rain. The SIGWX chart at 1200 (UTC) in South America, also presented the possibility of cloud formations in the region where the accident occurred.

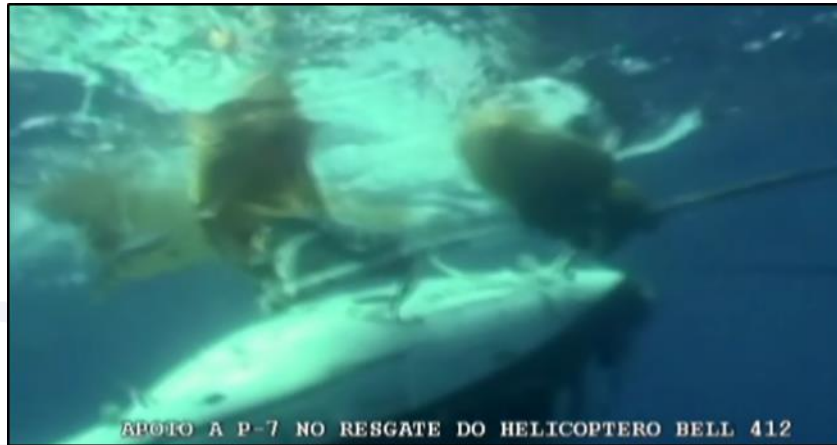
Due to the automatic activation of the floats, the helicopter did not sink and remained floating in the back position (Figure 2).

Figure 2 - Helicopter floating in the back position.

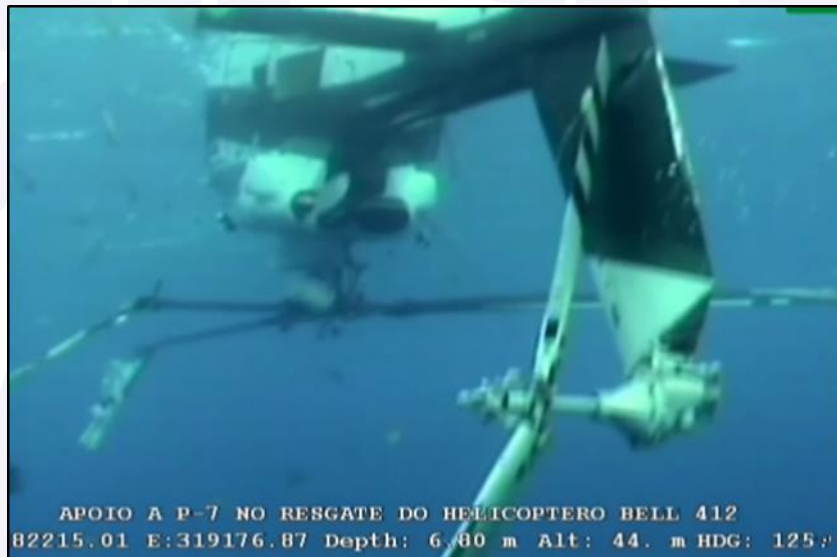
There was no detachment of the Tail Boom or Tail Rotor (Figure 3).

Figure 3 - Tail Boom and Tail Rotor connected to the aircraft.

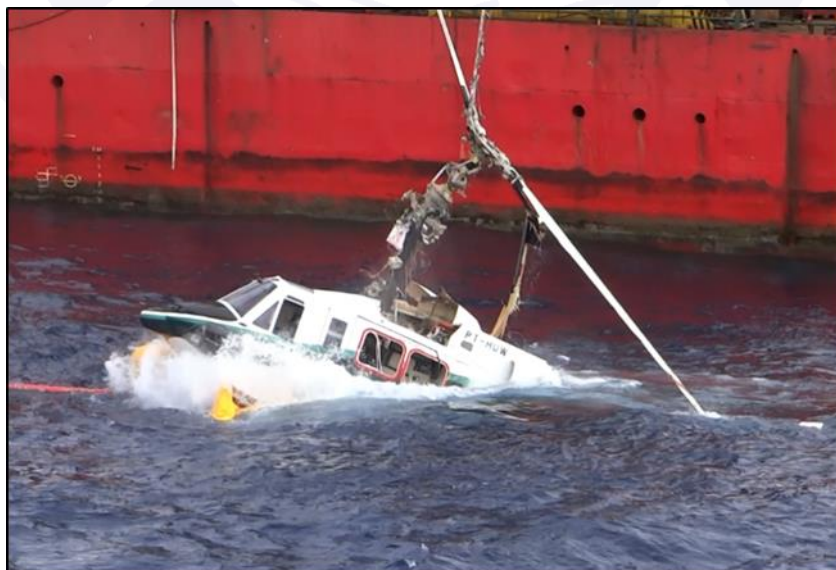
During an attempt to remove the aircraft from the water, there was a section between the fuselage and the Main Rotor Assy, the Main Gearbox and the Driveshaft (Figure 4).

Figure 4 - Moment of the section between the fuselage and the Main Rotor Assy, the Main Gearbox and the Driveshaft.

Thus, only these pieces were removed from the water. The rest of the wreckage sank until it reached the sea floor at 111 meters of depth, not being recovered.

Work with the aircraft operator in order to reinforce the use of appropriate techniques for the conservation of the wreckage of damaged aircraft, with the purpose of preserving them so that they can be analyzed within the scope of the SIPAER.

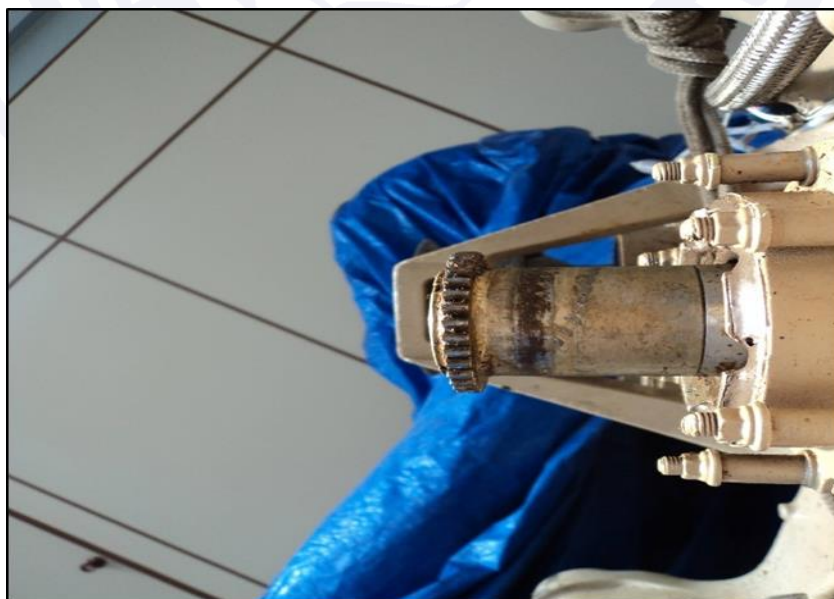
The head, mast and main rotor transmission were disassembled, all showing normality for the event, except the Tail Rotor Drive Quill and the Flexible / Coupling of the Main Driveshaft, at the connection end with the MGB. The coupling of the Tail Rotor Drive Quill had rubbing marks (Figures 5 and 6).

Figure 5 - Rubbing marks on the coupling of the Tail Rotor Drive Quill.

In the examinations performed by the DCTA, in the parts that could be recovered, it was possible to verify that there were rubbing marks in the coupling of the Tail Rotor Drive Quill. However, if the decoupling of this component had occurred during the flight, the helicopter would have been subjected to rotational movements around the vertical axis, due to the loss of the anti-torque effect of the tail rotor, which did not occur.

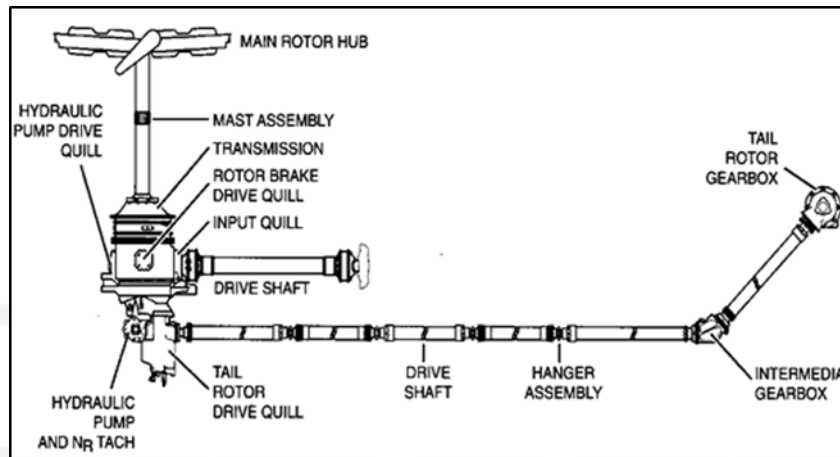
Figure 6 - Position of the Tail Rotor Drive Quill on the power transmission system diagram.

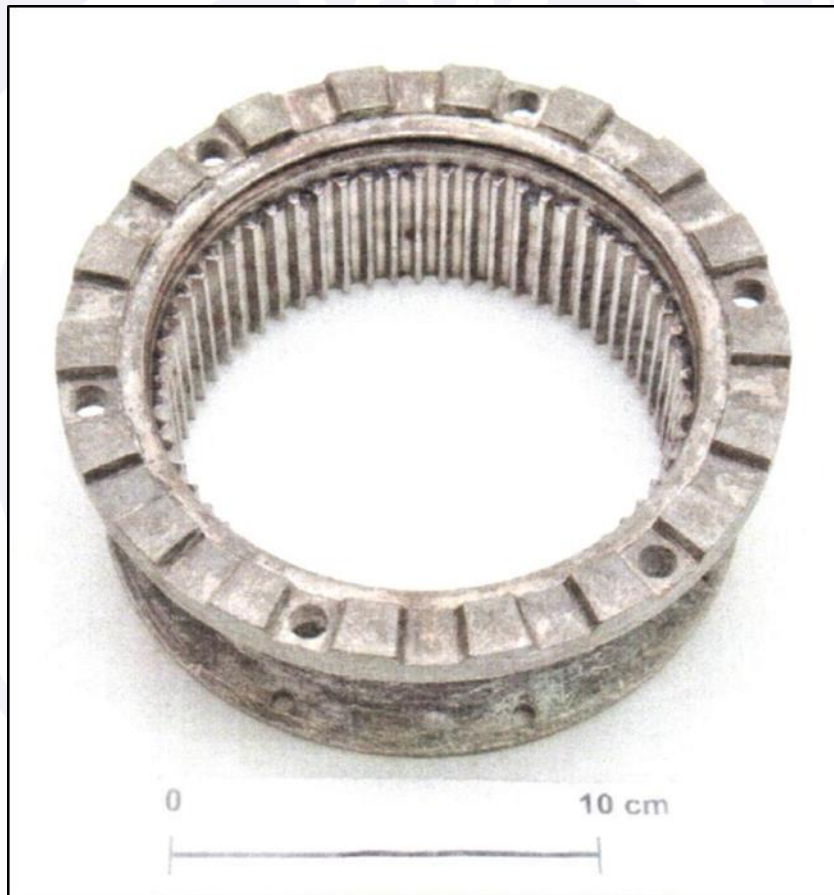
The Main Driveshaft was sent to the DCTA for analysis. As stated in the report issued, the Flexible Coupling had marks on the teeth of the gear and fractures at its ends (Figures 7, 8, 9 and 10).

Figure 7 - Flexible Coupling.

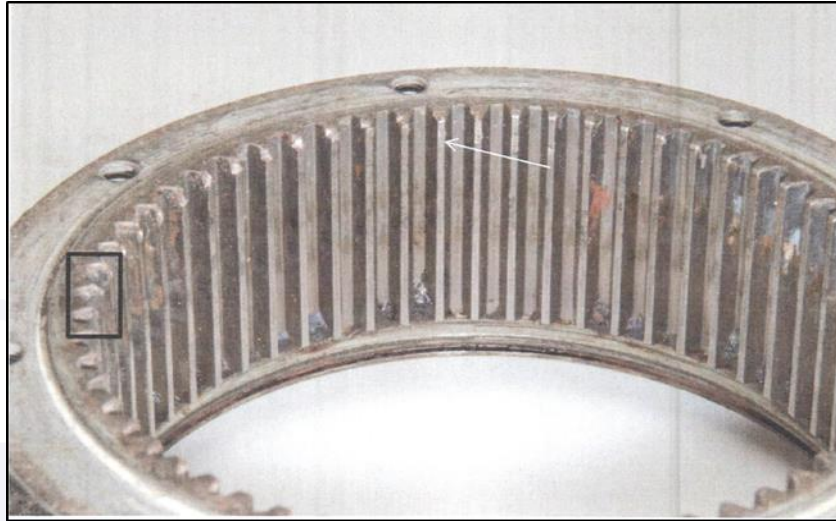
Figure 8 - General aspect of the gear. The white arrow indicates the sequence of marks observed on the gear teeth.

The DCTA's technical report brought as a result of the analysis of the parts presented, that the marks and fractures observed in the Flexible Coupling gear teeth seem to indicate that there was a decoupling between the Flexible Coupling and the gear coupled to it. However, for a greater degree of certainty, it would be necessary to analyze the gear that uncoupled, but it has not been recovered.

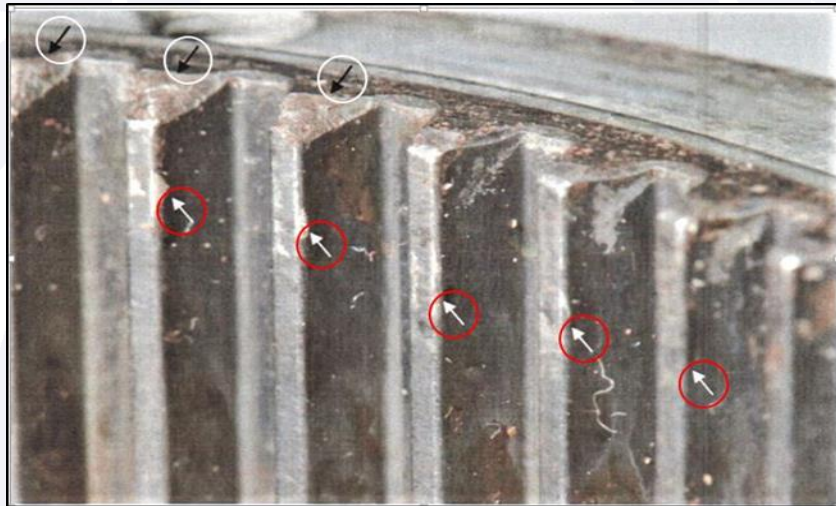
Figure 9 - Detail of the previous figure showing the marks on the gear teeth (white arrows) and fractures on the tips of the teeth (black arrows).

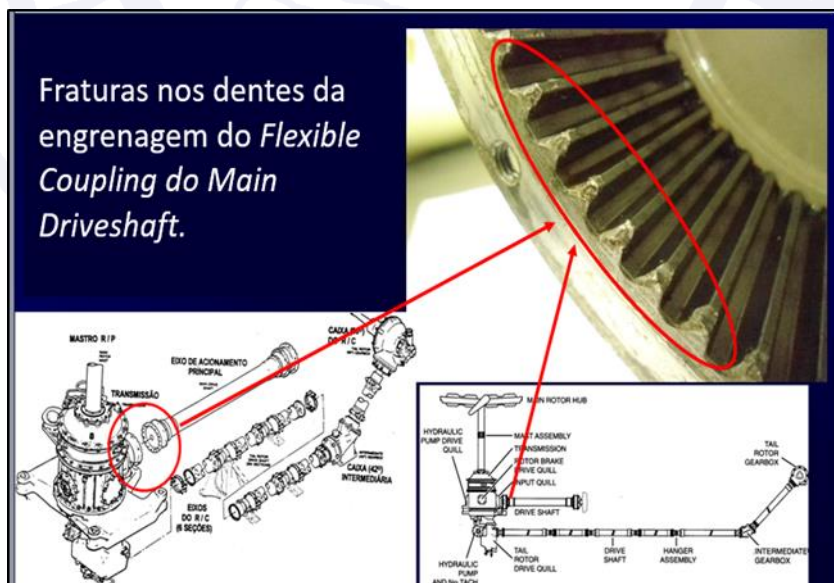
Figure 10 - Fractures in the tips of the teeth of the Flexible Coupling of the Main Driveshaft, at the connection end with the MGB.

According to a report issued by the DCTA, in relation to the Flexible Coupling on the Main Driveshaft, the marks and fractures found on the tips of its teeth seemed to indicate a decoupling. However, it also points out that, for a greater degree of certainty, it would be necessary to analyze the gear that it uncoupled, but it got stuck to the part of the helicopter that sank. Thus, it was not possible to conclude whether or not there was an uncoupling of the axis in flight.

The reports cited did not address whether the damage presented occurred before or after the impact with water.

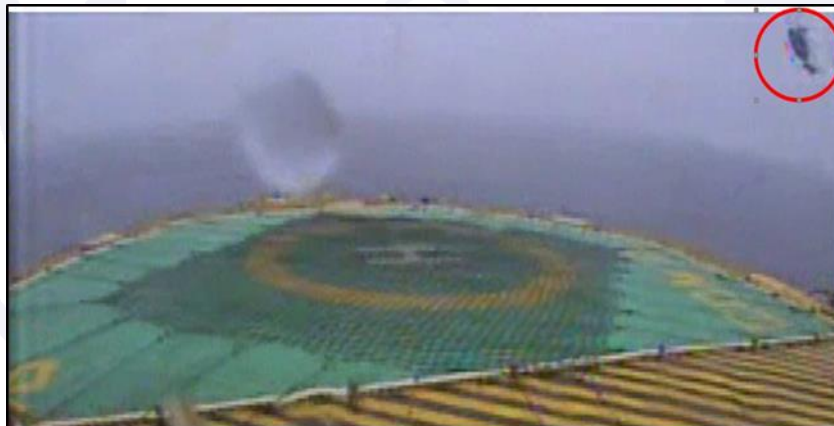
The images from the platform camera recorded a flare, with a large pitch up angle, performed by the helicopter (Figure 11), however, on an interview; the pilot did not manifest having performed such a maneuver.

Figure 11 - Image captured from the aircraft approach record.

According to the images from the camera positioned on the platform helideck, which recorded the moments immediately before the loss of control of the aircraft, it was possible to check the helicopter with a high pitch up angle.

During an interview, the pilot did not say that he had reached a high pitch up during the final approach for landing. Thus, there was no way to determine whether the attitude shown in the video recording was intentionally performed by the pilot or if it was the result of some other factor.
