COMANDO DA AERONÁUTICA
CENTRO DE INVESTIGAÇÃO E PREVENÇÃO DE
ACIDENTES AERONÁUTICOS

FINAL REPORT
IG - 190/CENIPA/2018

OCCURRENCE:	SERIOUS INCIDENT
AIRCRAFT:	PT-MUG
MODEL:	777-32WER
DATE:	20DEC2018

This is the Final Report of the 20DEC2018 serious incident with the 777-32WER aircraft model, registration PT-MUG. The accident was classified as “[SCF-NP] System/Component Failure or Malfunction Powerplant”.

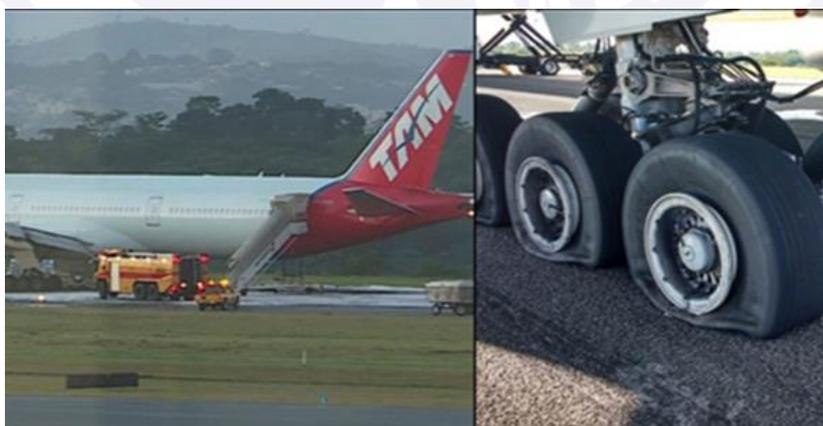
The aircraft showed locking and damage to the brake and wheel sleeves. Due to Overweight Landing, there was overheating of the tires and consequent deflation (Figure 1).

Figure 1 - Image of the aircraft and tires.

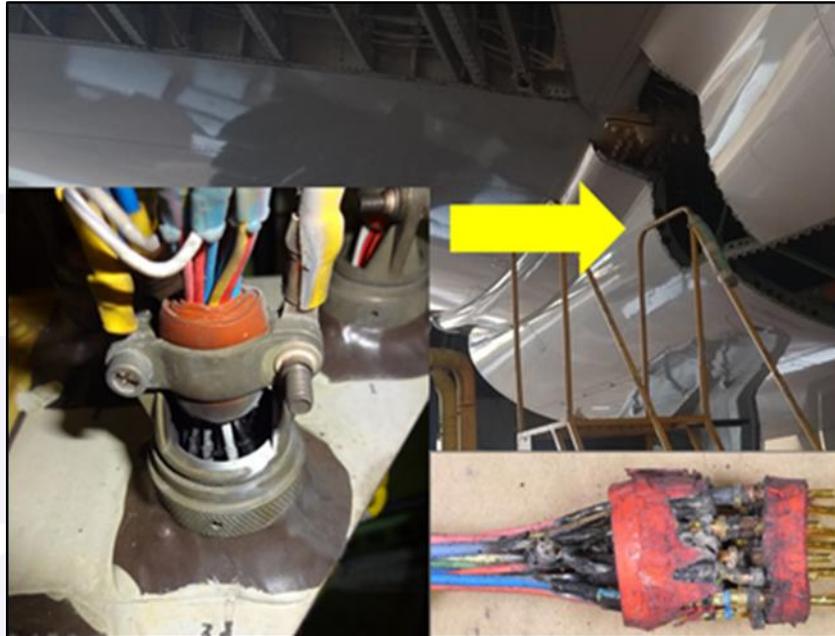
Damage was also found to the W8821 cabling and to the D7232 connector related to the events of the multiple failures that occurred in flight (Figure 2).

Figure 2 - Location and damage to the D7232 connector.

It was found damage to the indicated connector, as shown in section 1.3 of this report.

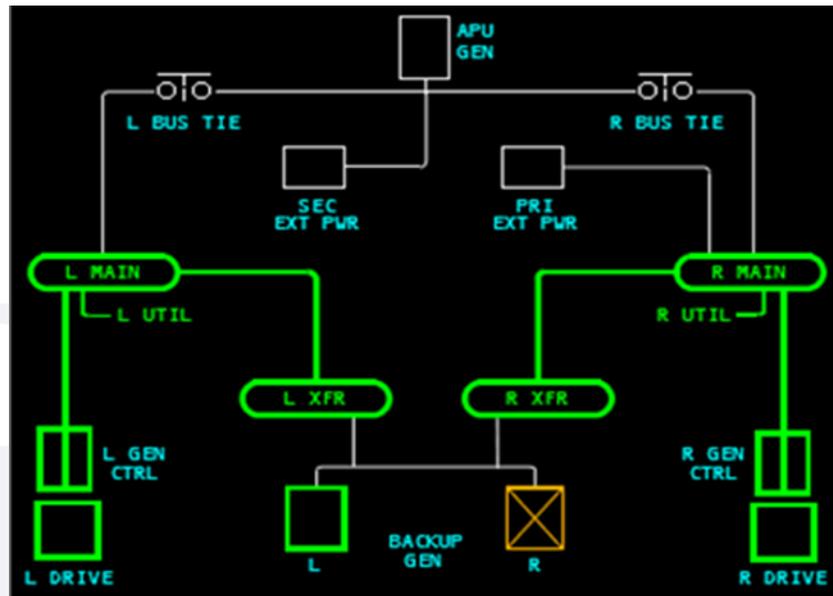
It was possible to supply electrical power as planned through the APU and from the left engine. When the right engine was started, the synoptic page of the electrical system showed that its Main Generator (IDG) was also operational for the supply of electricity, however, the Backup Generator was not available.

Figure 11 - Representation of the synoptic screen of the aircraft's electrical system during ground tests.

The Backup Generator active fault messages were related to the PMG power and low oil pressure.

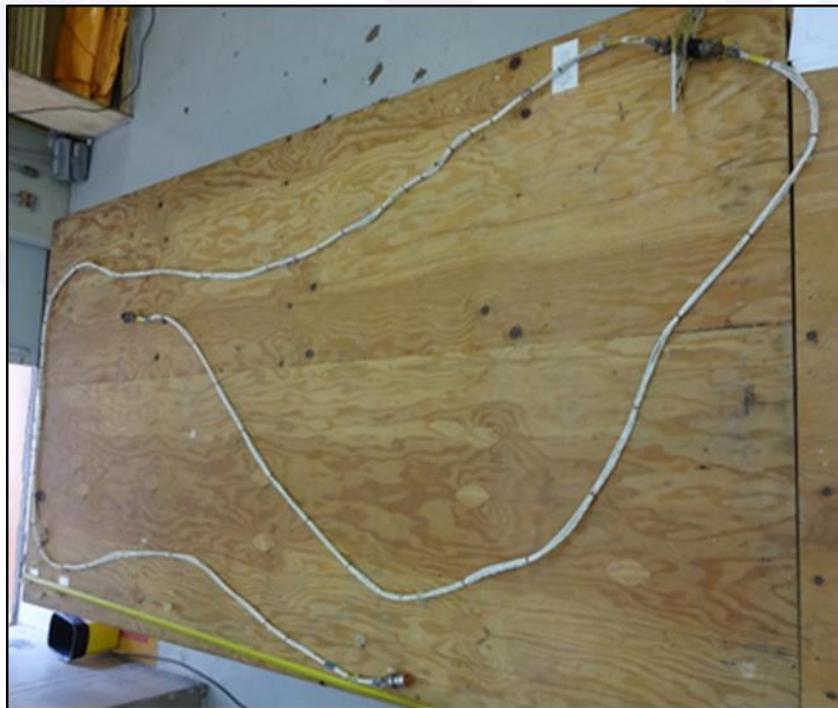
The D7232 connector has been removed from the aircraft along with its attachment structure and adjacent connectors for more detailed inspections.

Figure 12 - Part of the wiring removed from the aircraft.

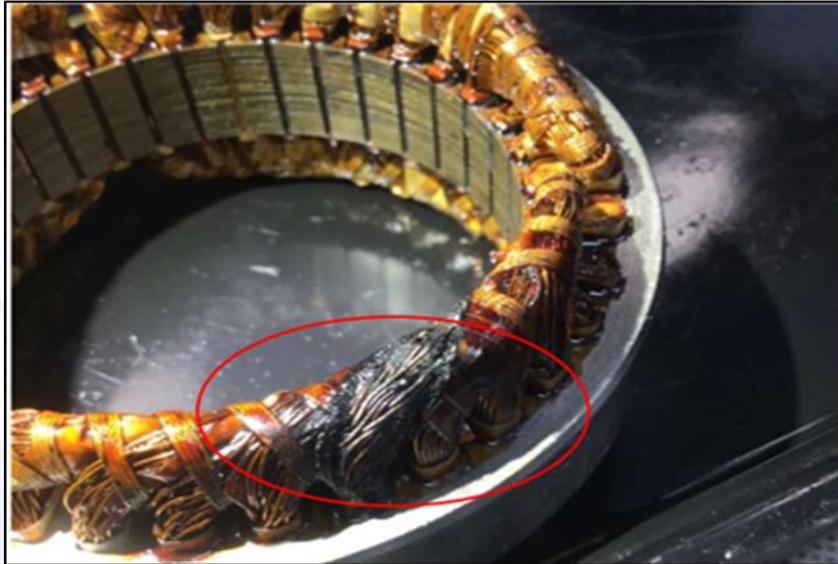
Figure 13 - Damage to the PMG stator.

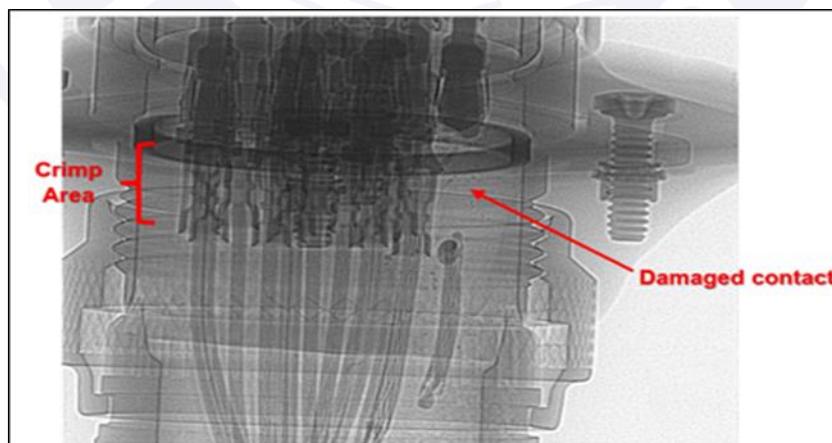
Then, the area of the connector where the short-circuit occurred was prepared to carry out x-ray and computed tomography scanner inspections. Figures 17, 18 and 19, below, present an overview of the conditions of the connector.

Figure 17 - Overview of damage to the connector on an x-ray inspection.

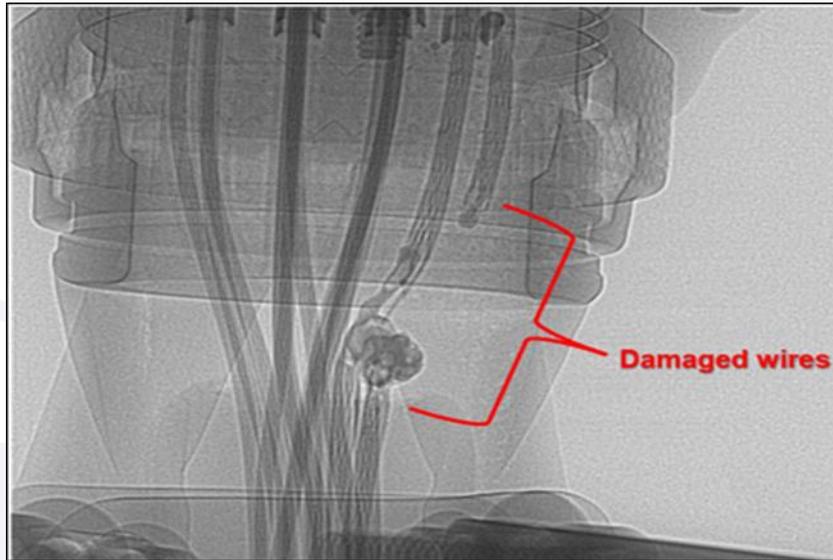
Figure 18 - Overview of damage to the wiring on an x-ray inspection.

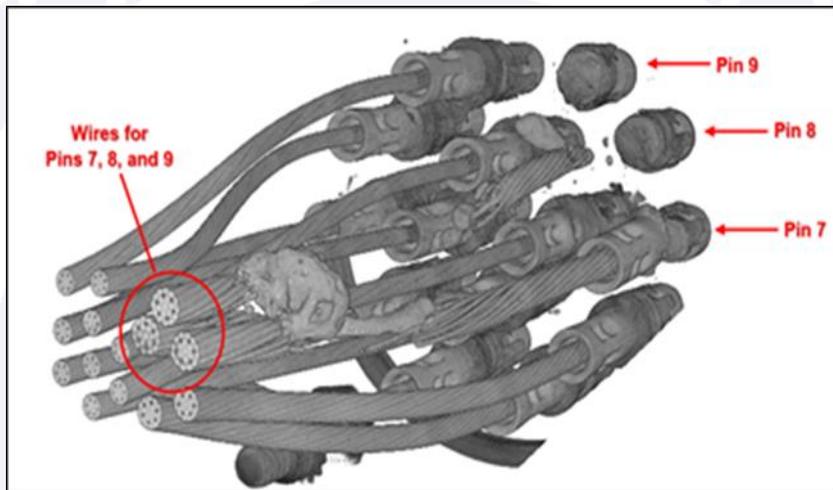
Figure 19 - Overview of damage to the connector. Computerized tomography scanner.

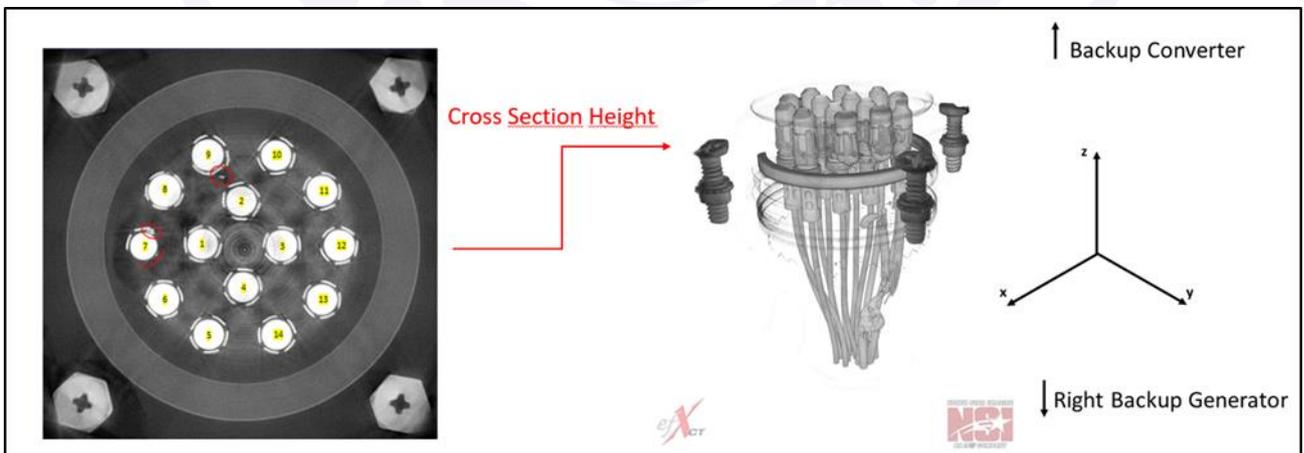
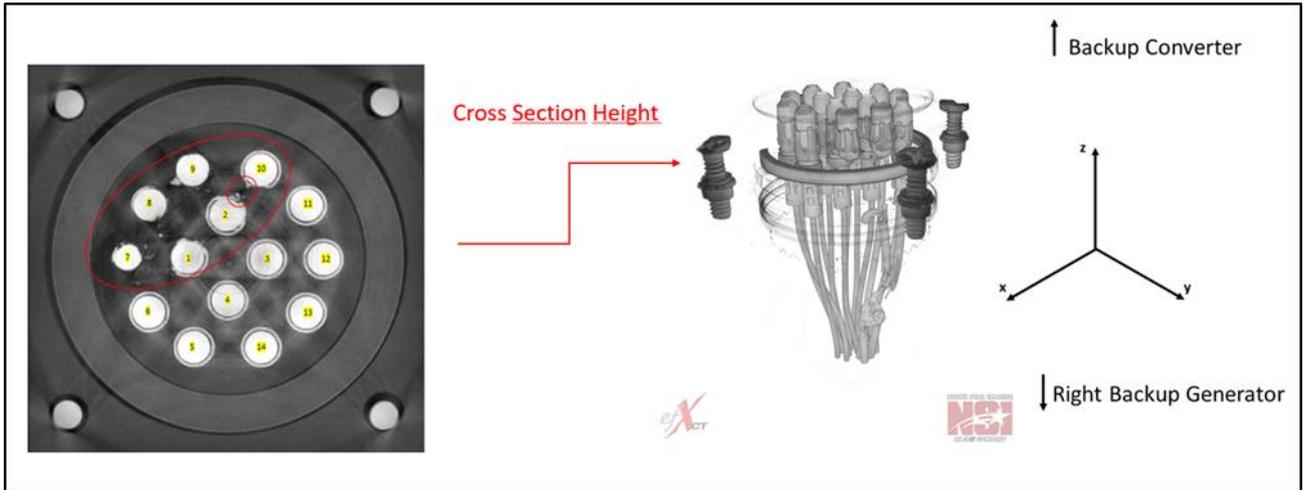
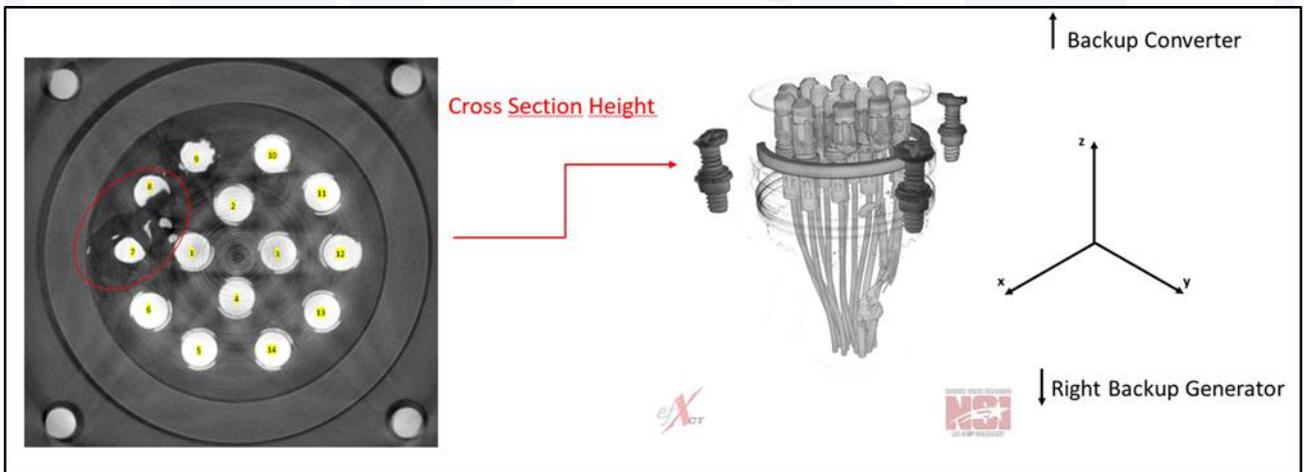
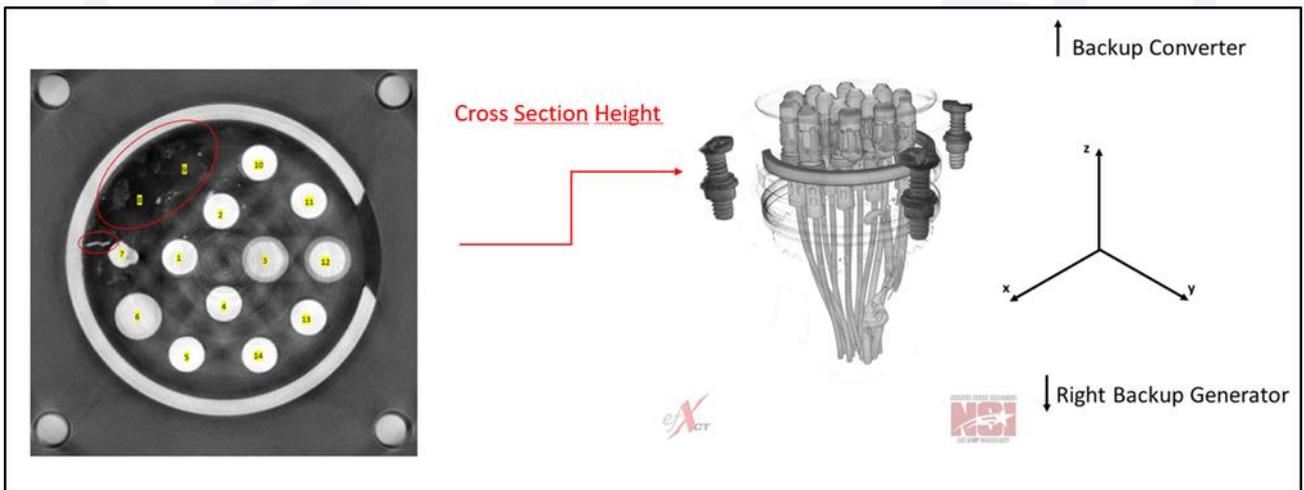
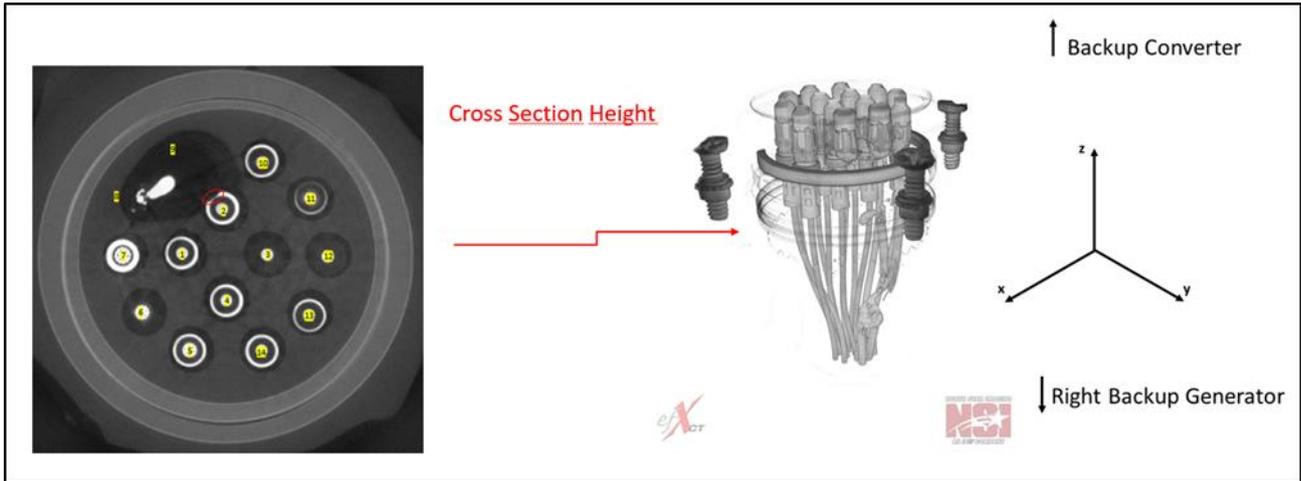
The points where signs of damage were found are shown in the sequence of Figures 20 to 24, below:

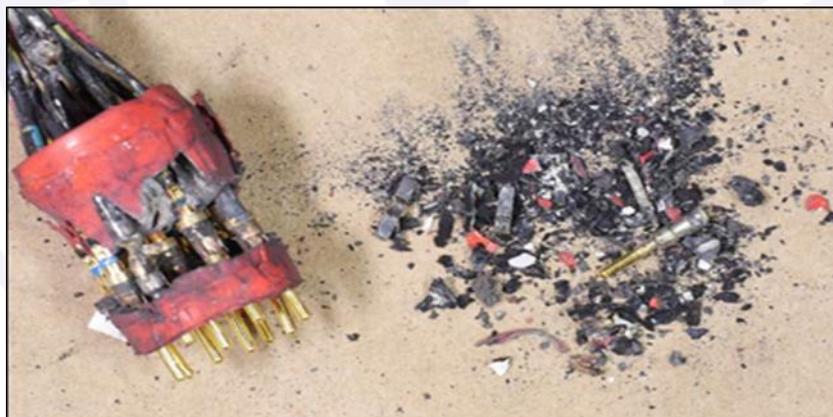
Figure 29 - Fragmented material from the disassembly of the D7232P connector.

Analyzes of the connector material were carried out in order to identify the presence of any foreign material. Due to the diversity of the connector material, it was not possible to determine if there was a foreign body inside.

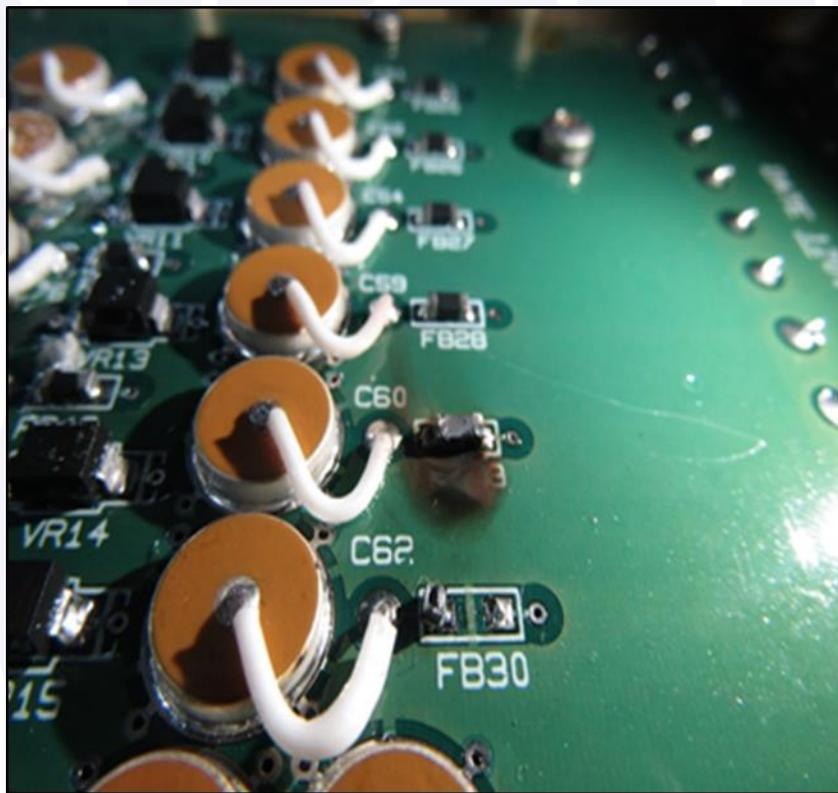
- The components (Ferrite Beads) FB29 and FB30 showed visible signs of failure. These components were related to the remote oil level monitoring circuit of up-level and sub-level, respectively, on the right side.

Figure 30 - Damage to components FB29 and FB30.

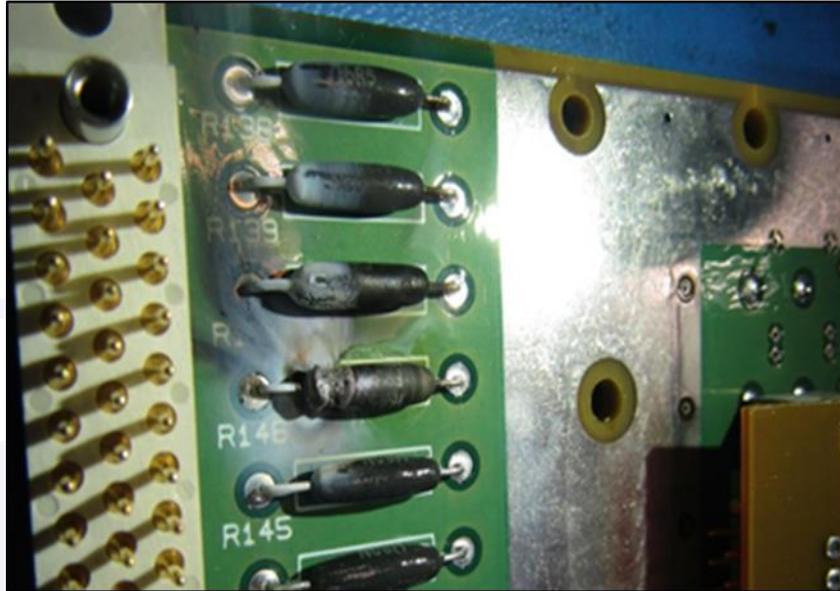
- The component (Resistor) R146 showed visible signs of failure. This resistor was related to the monitoring circuit of the current transformers of the Backup Generator on the right side.

Figure 31 - Damage to resistor R146.

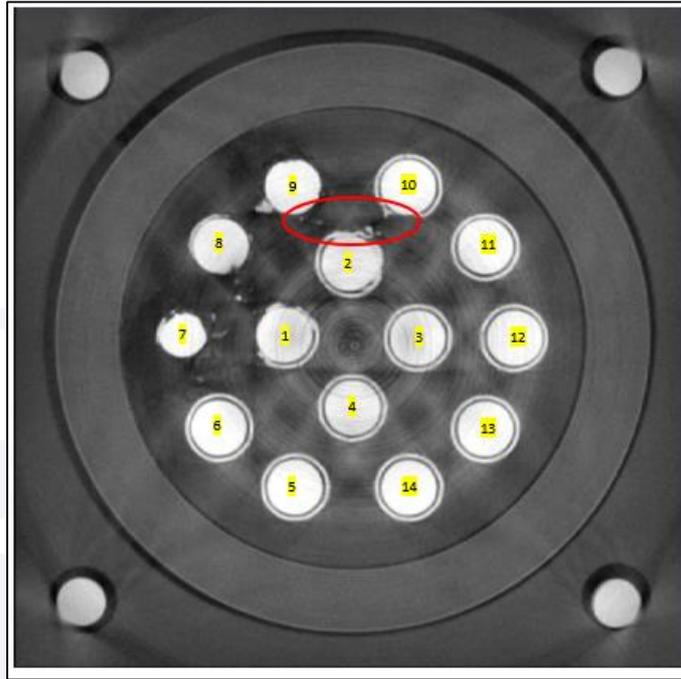
Figure 33 - Wiring condition associated with the first fault messages.

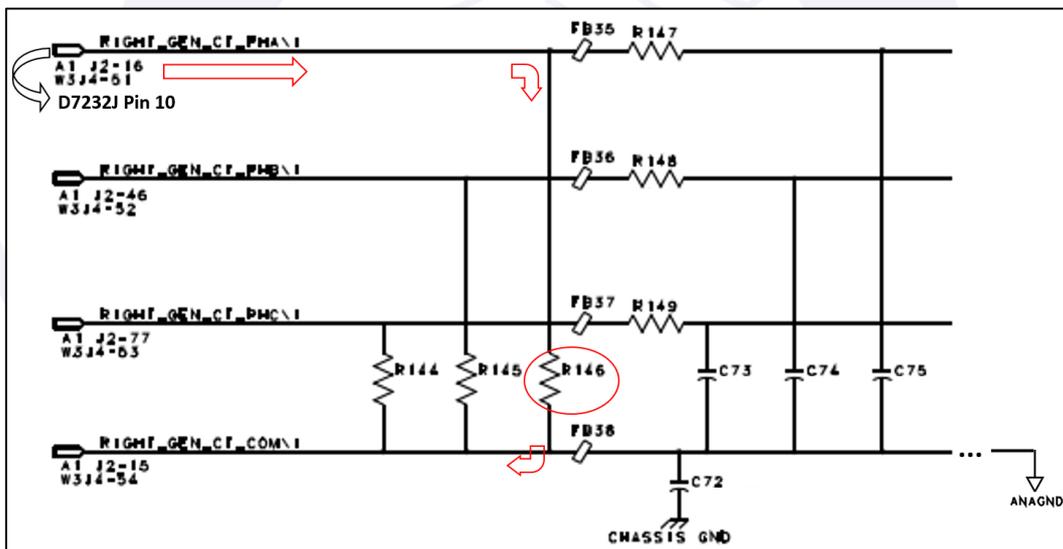
Figure 34 shows a possible path taken by the current from the short-circuit. It would have entered through pin 10, passing through resistor R146 and closing the circuit with the aircraft grounding (Chassis Gnd). This scenario would be consistent with the damage observed only in resistor R146.

Figure 34 - Current transformers monitoring circuit. The red arrows indicate a possible current path from the short-circuit. Adapted from the Backup Converter's CMM.

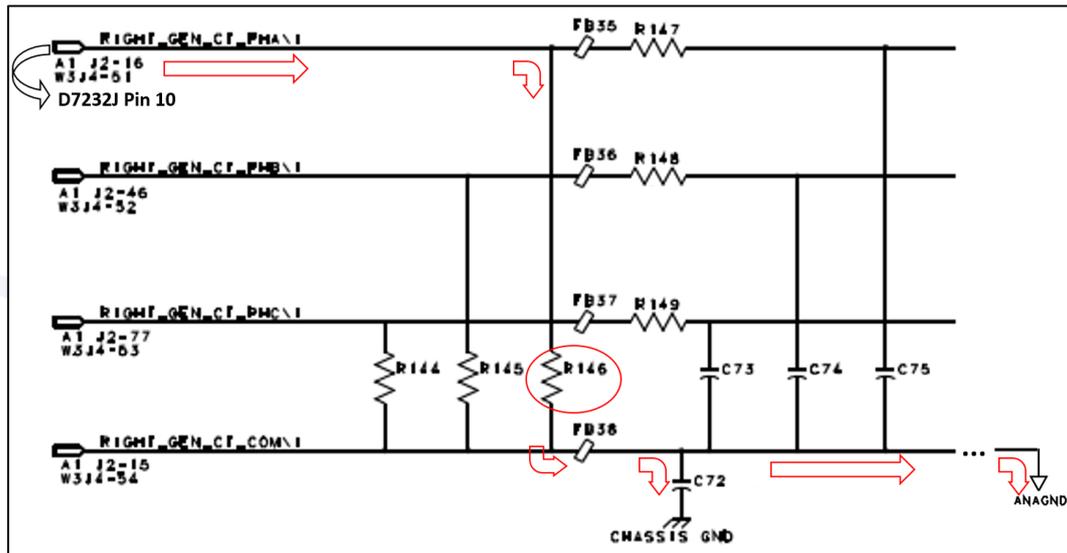
The reference signal called RIGHT_GEN_CT_COM, shown at the bottom of Figure 35, was connected to the internal analog ground of the Backup Converter, ANAGND, which was isolated from the Chassis Gnd.

Figure 35 - Current transformers monitoring circuit. The red arrows indicate another possible current path from the short-circuit. Adapted from the Backup Converter's CMM.

Still in this scenario, in addition to the short-circuit between one of the PMG phases and the RIGHT_GEN_CT_COM signal, secondary faults may have occurred between the connector housing and one of the PMG phases, which would make it possible to create the path shown in Figure 35, being consistent with the damage found in the connector region.

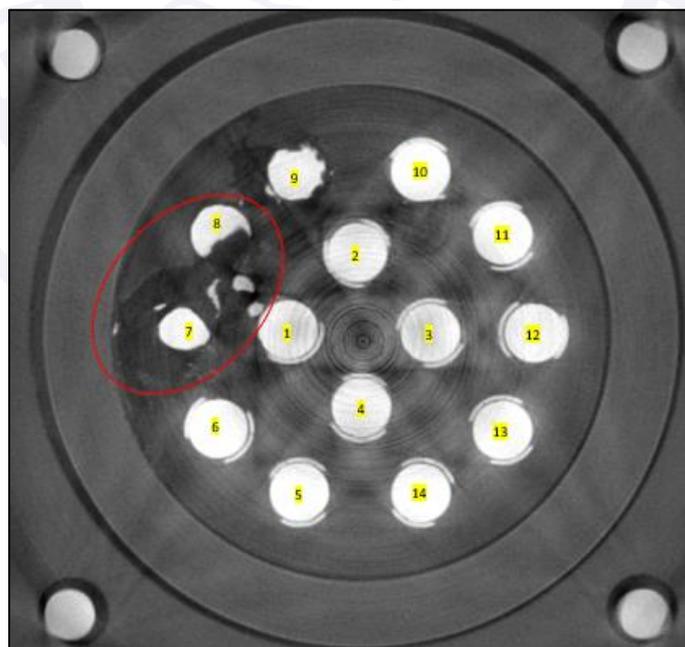
The conditions of the connector led the short-circuit to progress to the area corresponding to pins 1, 7 and 8, responsible for the oil level monitoring circuit of the Backup Generator on the right side, as shown in Figure 36.

Figure 36 - Damage to pins 1, 7 and 8.

Message number 3 “Left Low Oil Pressure Trip”, related to the oil pressure of the left Backup Generator, could be associated with the damage observed between the PMG pins (7, 8 and 9) and the return pin 1 of the oil level monitoring.

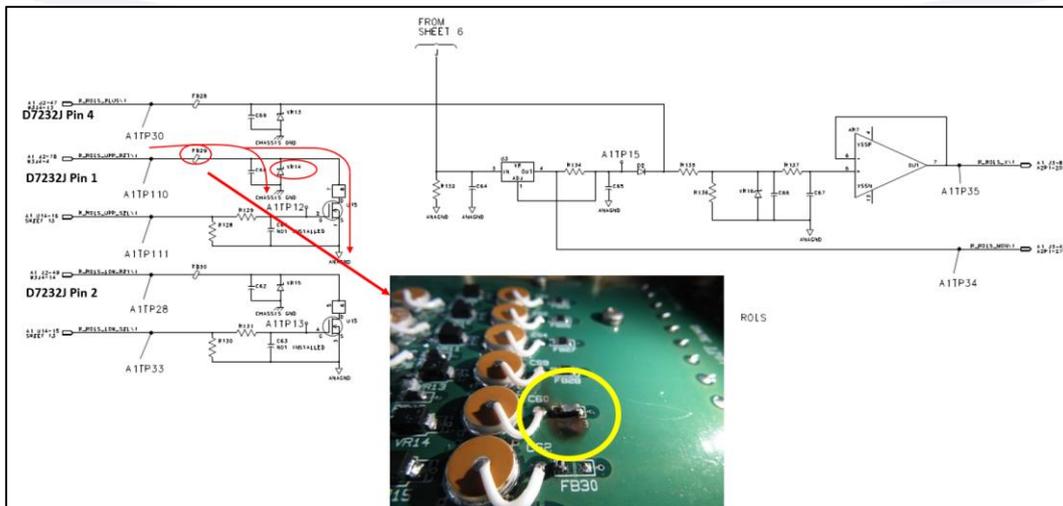
The current originated from the short-circuit between the pins of the PMG and pin 1, possibly, covered the path shown in Figure 37, reaching the analog ground (ANAGND) internal to the Backup Converter. The current path is consistent with the damage found in components FB29 and VR14.

Figure 37 - Possible current path of the PMG in the internal circuits for remote monitoring of the oil level in the Backup Converter. Adapted from the Backup Converter's CMM.

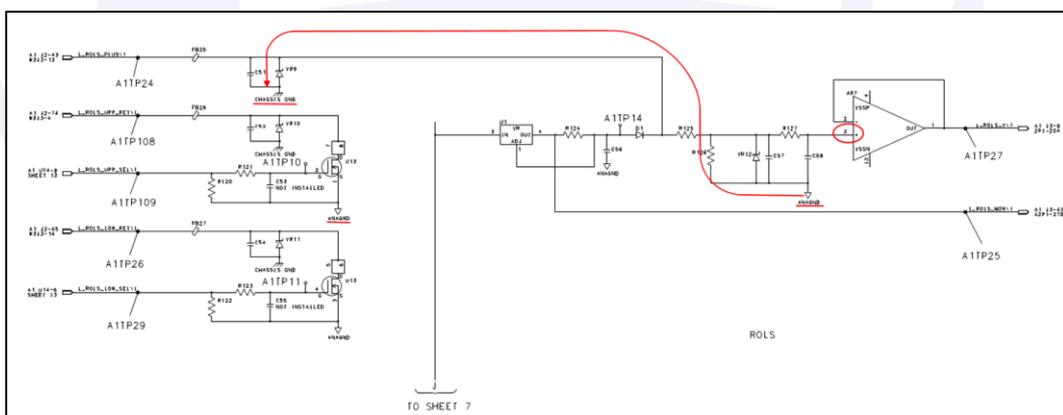
Thus, the capacity of the ANAGND would have been exceeded, allowing a leakage of current in the oil level monitoring circuit on the left side to the Gnd Chassis. This current would have produced a voltage compatible with that of activating the Left Low Oil Pressure Trip message at input 3 of the AR7 amplifier (Figure 38).

Figure 38 - Possible current path of the short-circuit in the connector related to the Left Low Oil Pressure Trip message. Adapted from the Backup Converter's CMM.

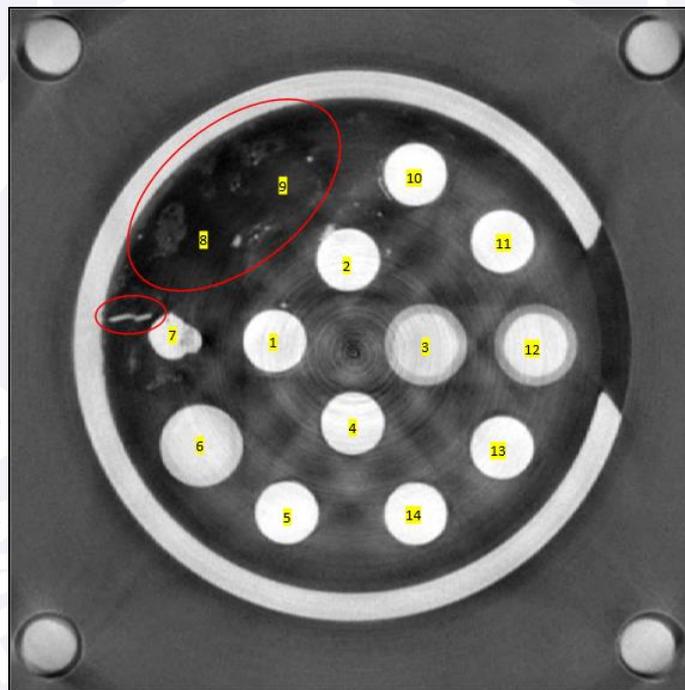
Between the execution of the actions described in the QRH and the occurrence of new failures, the short-circuit in the connector remained restricted to the PMG pins (7, 8 and 9), not resulting in new failures in the Backup Converter (Figure 39).

Figure 39 - Damage to pins 7, 8, 9 and in the connector housing.

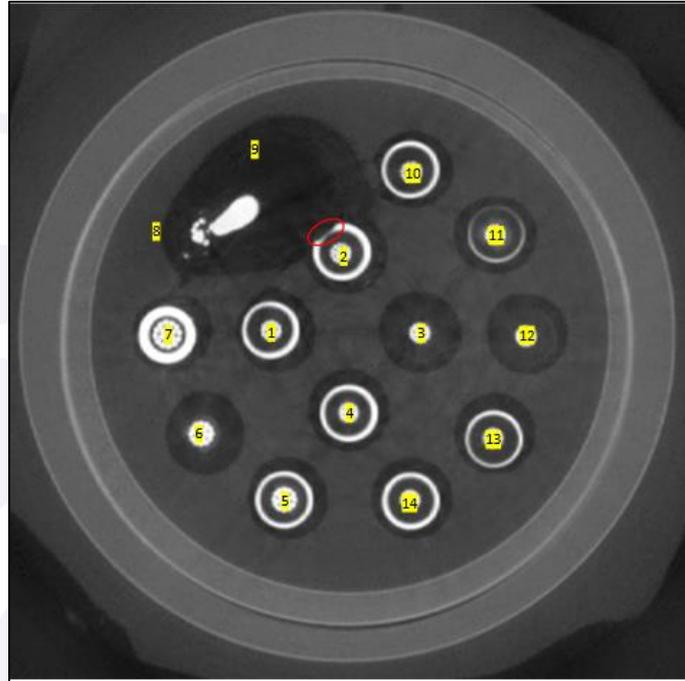
At the time of recording this set of messages, a change in the state of the connector was observed, with contact between pins 8 and 9 of the PMG and pin 2 of the oil level monitoring circuit (Figure 40).

Figure 40 - Evidence of contact between pins 8 and 9 of the PMG and pin 2 of the oil level monitoring circuit.

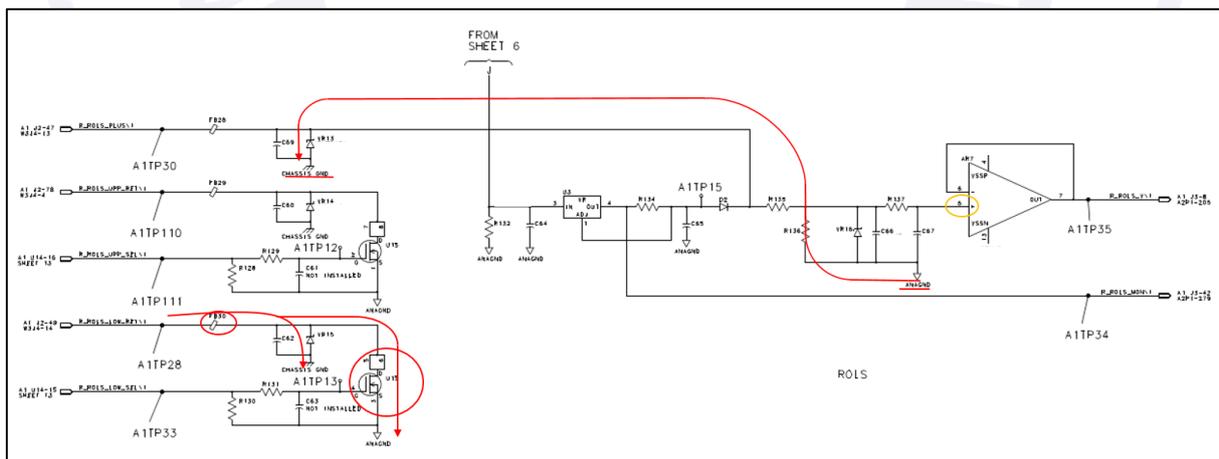
The message Right Low Oil Pressure Trip can be associated with the current originated from the short-circuit between pins 8, 9 and 2. The current path in this second short-circuit was consistent with the damage found in the Backup Converter's FB30 and U15 components (Figure 41).

Figure 41 - Possible current path of the short-circuit in the connector related to the message Right Low Oil Pressure. Adapted from Backup Converter's CMM.

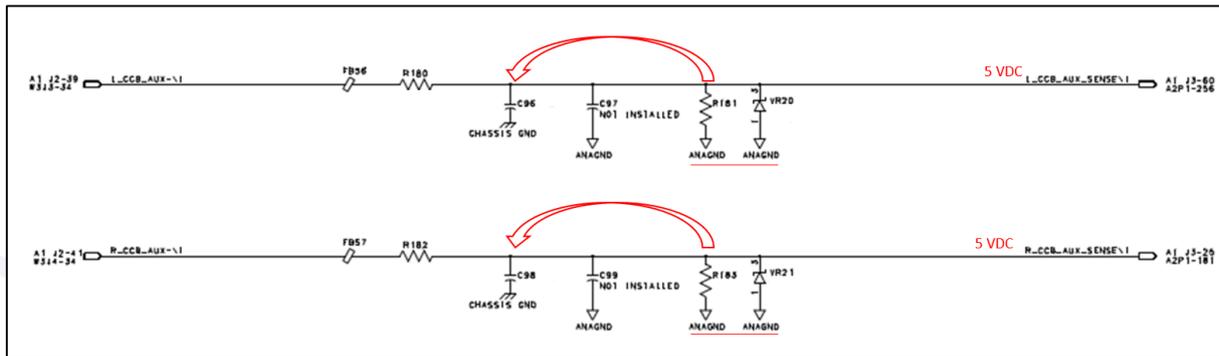
Thus, similarly to the first set of messages, the capacity of the ANAGND would have been exceeded allowing a leakage current in the oil level monitoring circuit on the right side and, soon after, in the circuit for detecting the position of the contactors (Figure 42).

Figure 42 - Possible current path of the short-circuit of the connector affecting the monitoring circuit of the position of the contactors. Adapted from the Backup Converter's CMM.
