FINAL REPORT
A - 060/CENIPA/2018

OCCURRENCE:	ACCIDENT
AIRCRAFT:	PT-OVJ
MODEL:	PA 25-235
DATE:	03APR2018

This is the Final Report of the 03APR2018 accident with the PA 25-235 aircraft model, registration PT-OVJ. The accident was classified as “[SCF-PP] System/Component Failure or Malfunction Powerplant – Engine Failure in Flight”.

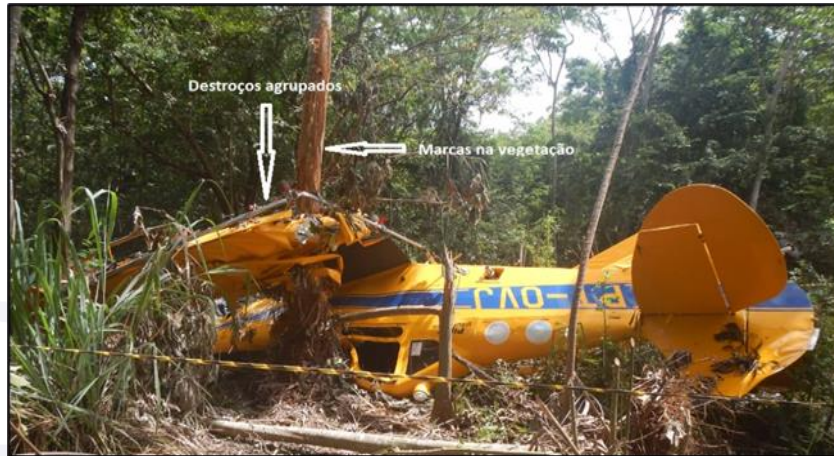
The evidence found at the accident site indicated that the first impact was against the top of one of these trees. The marks in the vegetation were suggestive of reduced horizontal displacement of the wreckage, which were grouped, as can be seen in Figure 1.

Figure 1 - View of the aircraft at the location of the occurrence, indicating the characteristics of the wreckage and the marks left in the vegetation.

The marks on the vegetation and the damage caused to the aircraft, whose wreckage was grouped, indicated that the collision with the ground occurred with low speed ahead and with a wide angle of impact.

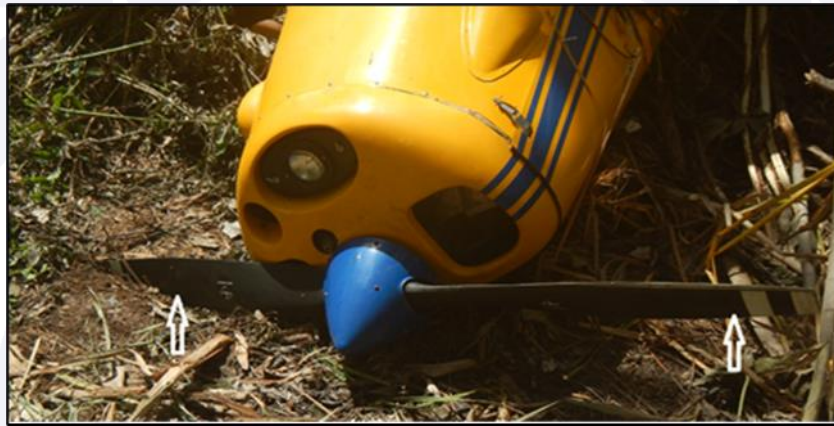
The propeller blades were practically free of deformation, as can be seen in Figure 2.

Figure 2 - View of the propeller blades, highlighting the low degree of deformation.

In this sense, the aspect and deformations observed in the propeller blades corroborate to this condition, since they allow us to observe that they did not suggest power development. On the contrary, they indicated that at the moment of impact, the propeller had low or no rotation. The results of the analysis and research did not find evidence of operational error or malfunction of any of the aircraft's systems.

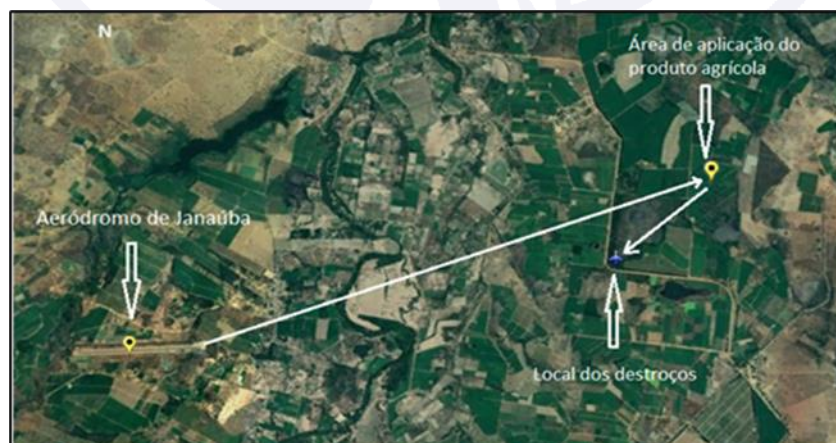
The sketch in Figure 3 illustrates the aircraft's trajectory, since the takeoff from the Janaúba runway to the location of the occurrence.

Figure 3 - Sketch of the aircraft's trajectory.
