**COMANDO DA AERONÁUTICA**  
**CENTRO DE INVESTIGAÇÃO E PREVENÇÃO DE**  
**ACIDENTES AERONÁUTICOS**

**FINAL REPORT**  
**A - 045/CENIPA/2021**

| <b>AIRCRAFT:</b> | <b>PU-AVD</b> |
| <b>MODEL:</b> | <b>ASTORE</b> |

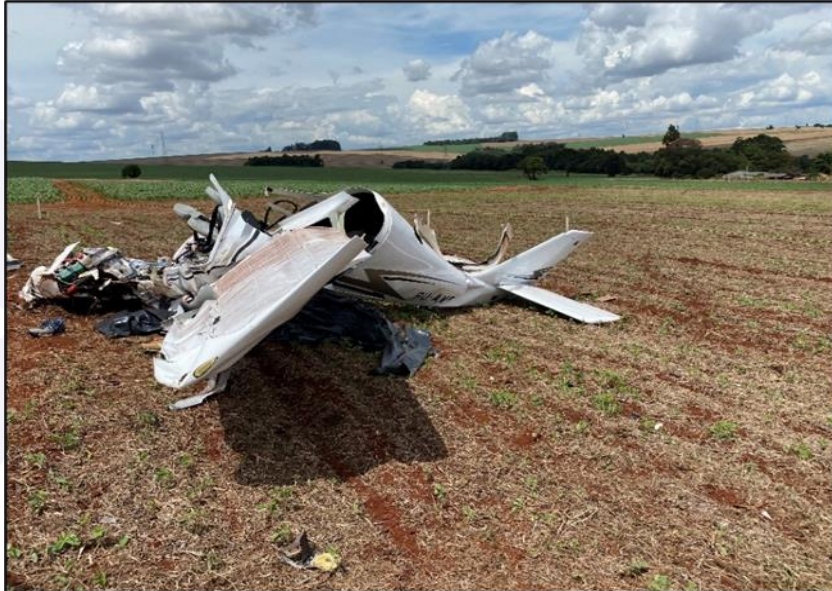
Figure 2 - Situation of the wreckage.

The impact occurred in a pitched down attitude (approximately 60°) and with the wings leveled, causing the collision of the powertrain system against the ground and the rupture of the fuselage at the height of the cabin (Figure 2).

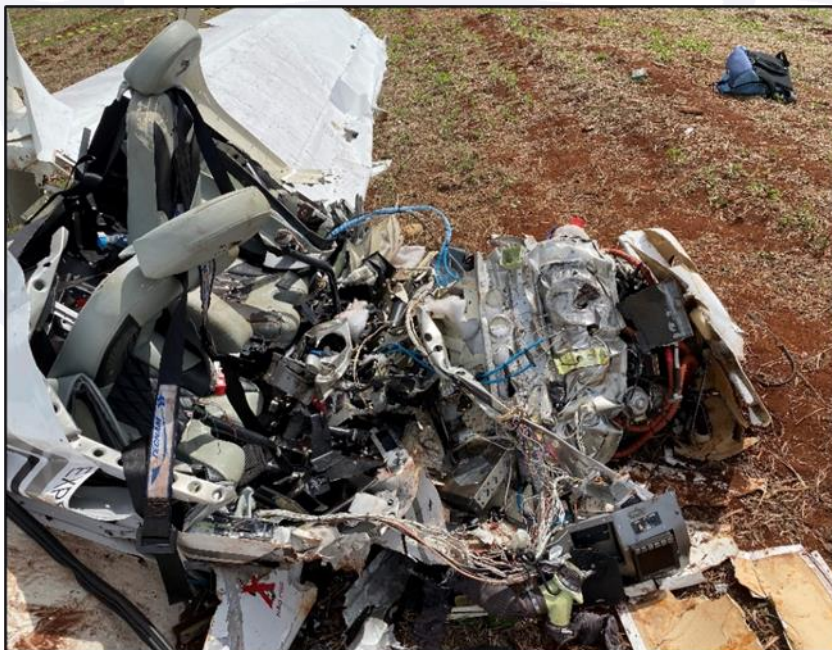
The aircraft had substantial damage. The impact occurred with the front of the aircraft and wings against the ground. The auxiliary landing gear detached and was thrown forward. There was extensive damage to the powertrain and nacelle.

Figure 3 - General condition of the nacelle.

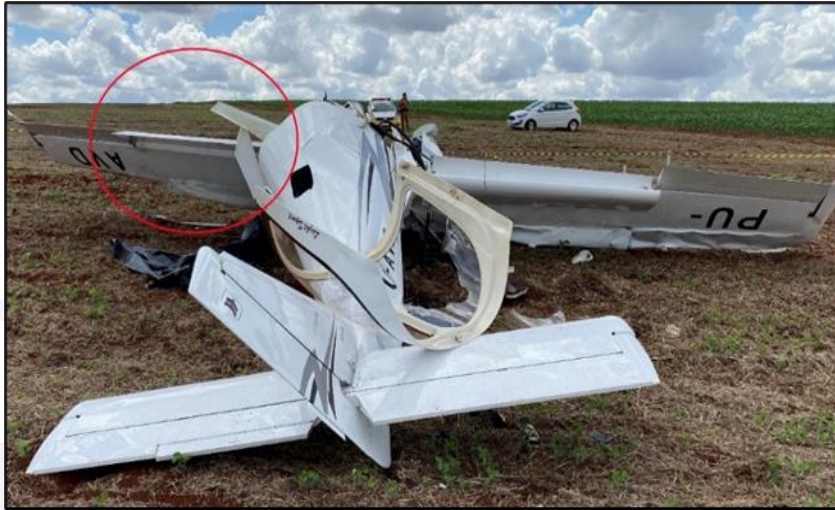
The landing gear was fixed. The flaps were down. The elevator trim tabs were symmetrical and positioned in neutral.

Figure 4 - View of the lowered left flap position.

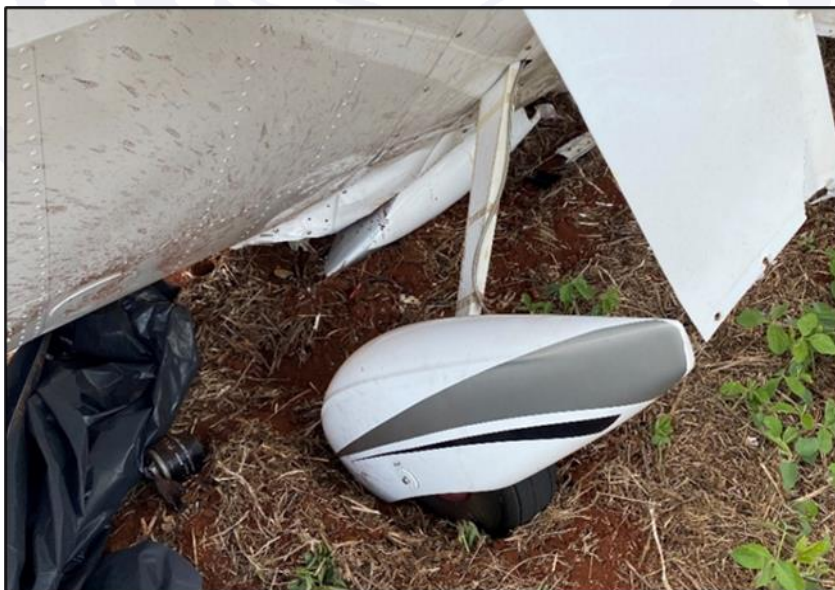
Figure 6 - Left main landing gear of the PU-AVD.

It was found that the main landing gear did not have significant damage. The distribution of the wreckage and the verification of the damage caused by the impact against the ground indicated a possible frontal collision, with low speed ahead and high impact angle.

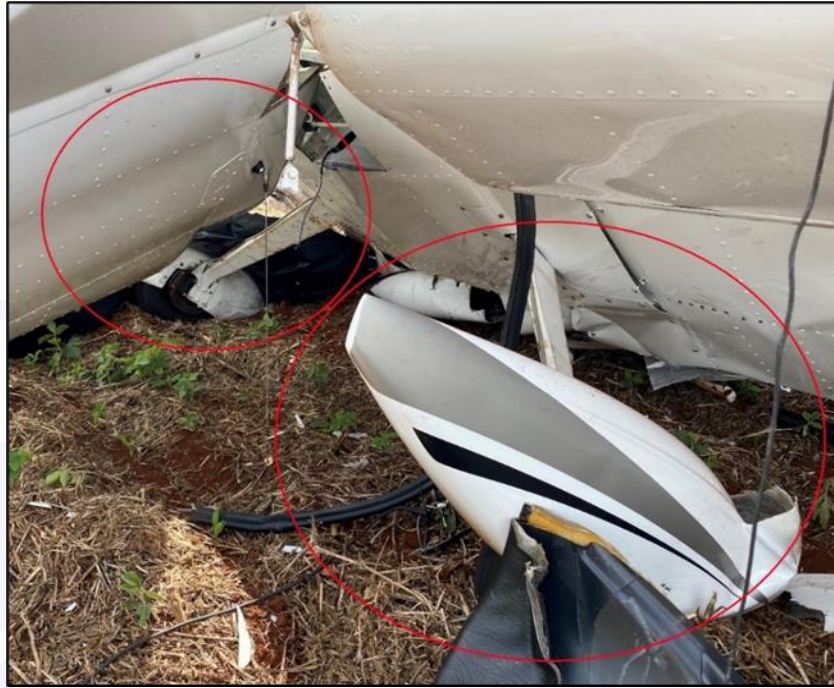
Figure 7 - Condition of the main landing gears after impact.

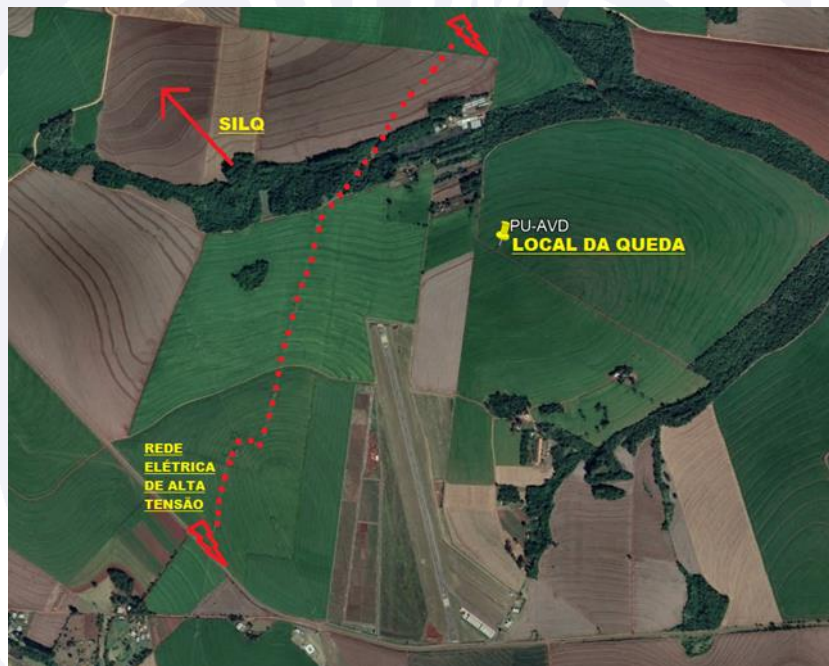
During the investigation, it was observed that the take-off profile from the SDSJ Aerodrome to the SILQ Aerodrome, crossed a high voltage power grid, with a height of about 35 meters above the ground (Figure 10).

Figure 10 - Top view of the SDSJ take-off profile.

Based on the aircraft's operation manual, it was concluded that the take-off distance, under the conditions prevailing at the time of the accident, would be between 501 and 545 meters, which would give the PU-AVD about 1,250 meters of distance to cross the power grid.
