COMANDO DA AERONÁUTICA
CENTRO DE INVESTIGAÇÃO E PREVENÇÃO DE
ACIDENTES AERONÁUTICOS

FINAL REPORT
A-141/CENIPA/2021

OCCURRENCE:	ACCIDENT
AIRCRAFT:	PU-MDJ
MODEL:	P2002 SIERRA DE LUXE
DATE:	11DEZ2021

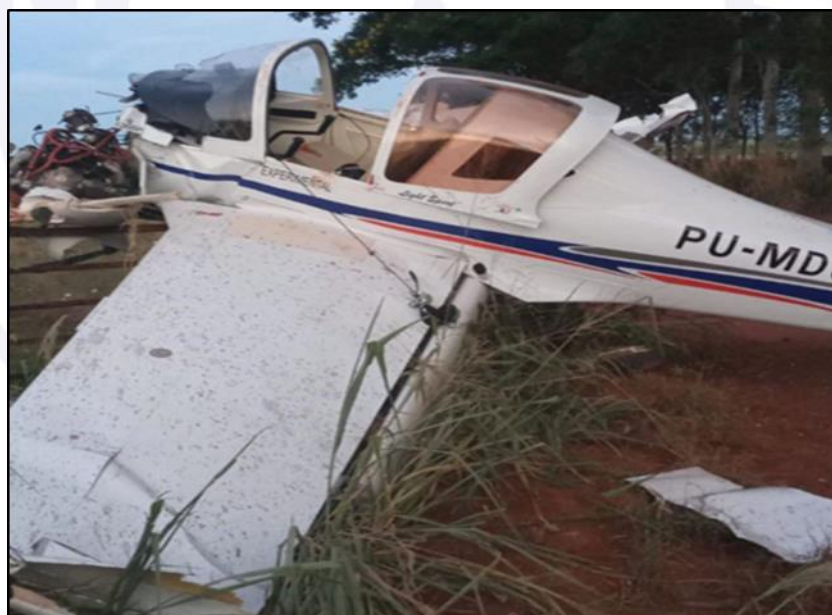
The pilot attempted to continue gliding towards the runway, but the plane collided with the gate of a fence located at a distance of approximately 400 meters short of the runway.

Figure 1 – View of the aircraft at the accident site.

The aircraft sustained substantial damage to its front section, landing gear, and wings.

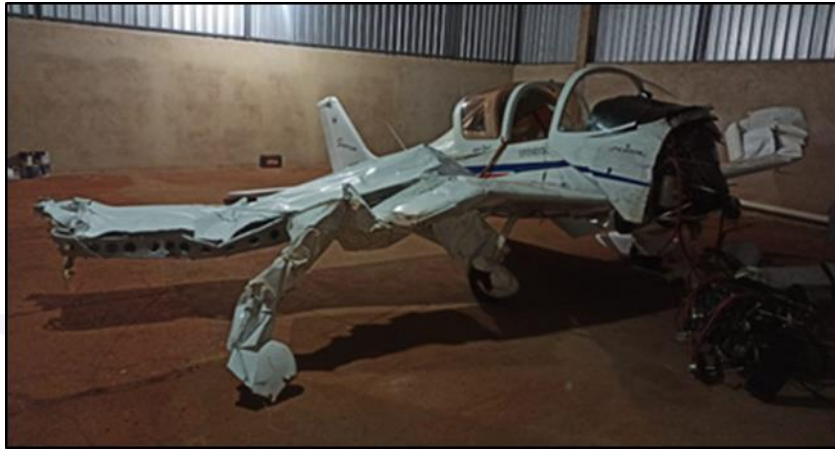
The aircraft was removed from the site without proper authorization issued by the SIPAER authority.

Figure 2 – view of the aircraft after removal from the scene of the occurrence.

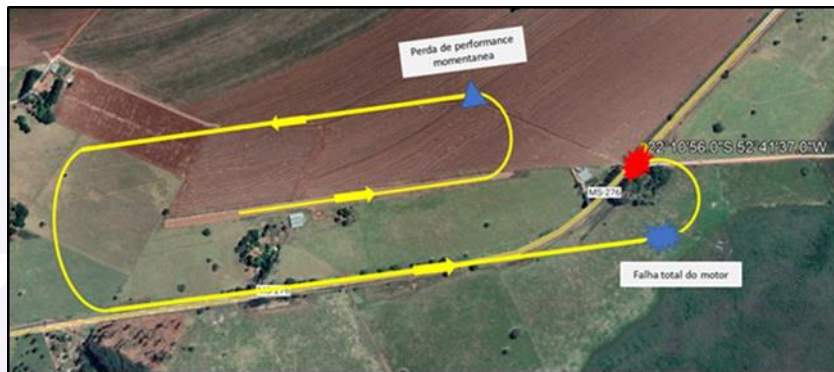
According to the PIC's report, due to the existence of a eucalyptus tree plantation close to the runway threshold, he extended the wind leg and, during the turn to the base leg of the traffic pattern, the aircraft sustained total engine failure, stalled, and fell onto a fence of the farm (Figure 3).

Figure 3 - Sketch of the sequence of events.
