COMMAND OF AERONAUTICS
AERONAUTICAL ACCIDENT INVESTIGATION AND
PREVENTION CENTER

FINAL REPORT
IG - 014/CENIPA/2013

<u>OCCURRENCE:</u>	SERIOUS INCIDENT
<u>AIRCRAFT:</u>	PR-GUL
<u>MODEL:</u>	B737-800
<u>DATE:</u>	16 OCTOBER 2011

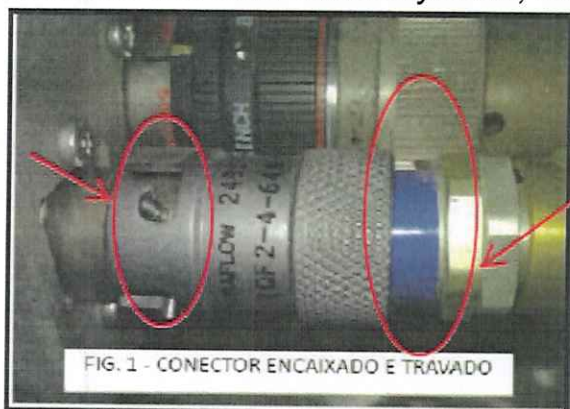
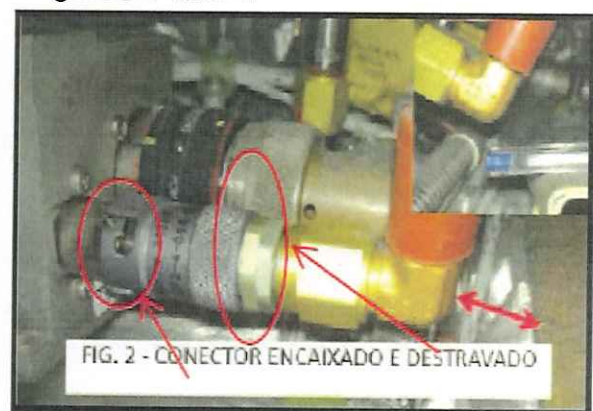
In one of the prescribed tests, it was possible to see that the left *HOSE ASSY - P/N B394DDB0106D* of the ADM (*Air Data Module*) was not connected, thus allowing the release of the air coming from the left hand side pitot tube, which the feeds the captain's instruments and other aircraft systems, as seen in figures 1 and 2.

Figures 1 and 2 – the blue color detail indicates a correct locking.

However, it was observed that, upon completion of the procedure, the left ADM pneumatic hose was fitted but not locked correctly, allowing it to disconnect and release air, generating wrong information for the ADM and, consequently, for the PF instruments (altimeter and ASI).

However, the most likely hypothesis is that the misconnection took place in Congonhas, since otherwise the failure in question would have occurred in Confins.

After a correct hose connection was made, the *Air System Data Test* was carried out, and no abnormalities were identified.

On account of the criticality of the item, notwithstanding that the failure had already been fixed, the company maintenance decided to take the following actions:

- 1- Replace the left static ADM;
- 2- Replace the right static ADM with the same component of another aircraft;
- 3- Replace the left AOA (*Angle of Attack*) sensor;
- 4- Replace the right AOA sensor with the same component from another aircraft.

Then, a new Air System Data test of both systems was carried out, and no failures were found.
