**FINAL REPORT**  
**A - 061/CENIPA/2019**

<b>OCCURRENCE:</b>	<b>ACCIDENT</b>
<b>AIRCRAFT:</b>	<b>PT-DME</b>
<b>MODEL:</b>	<b>ST-10</b>
<b>DATE:</b>	<b>13APR2019</b>

This is the Final Report of the 13APR2019 accident with the ST-10 aircraft model, registration PT-DME. The accident was classified as “[SCF-PP] Engine Failure or Malfunction – Engine Failure in Flight”.

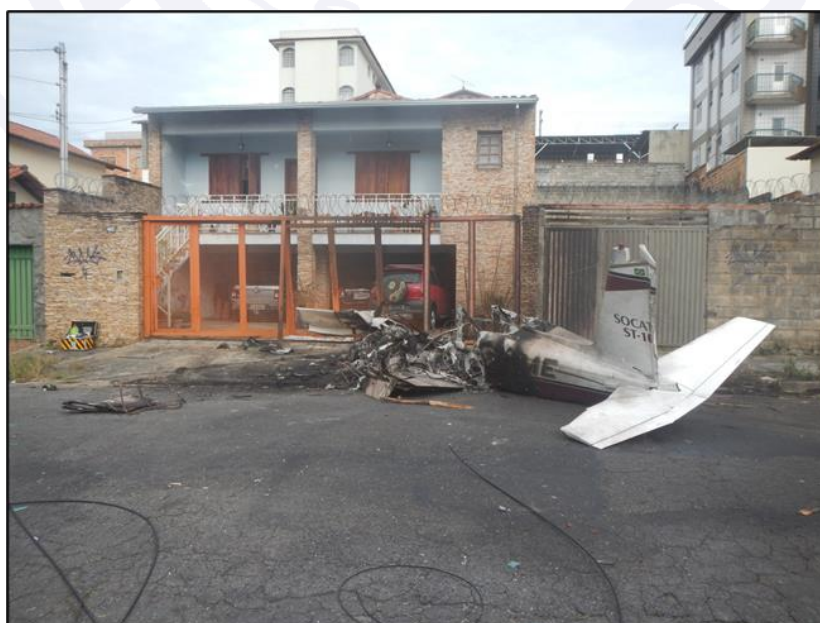
The aircraft had damage to its entire structure and was partially consumed by the fire that followed the impact (Figure 1).

Figure 1 - Image of the aircraft wreckage at the accident site.

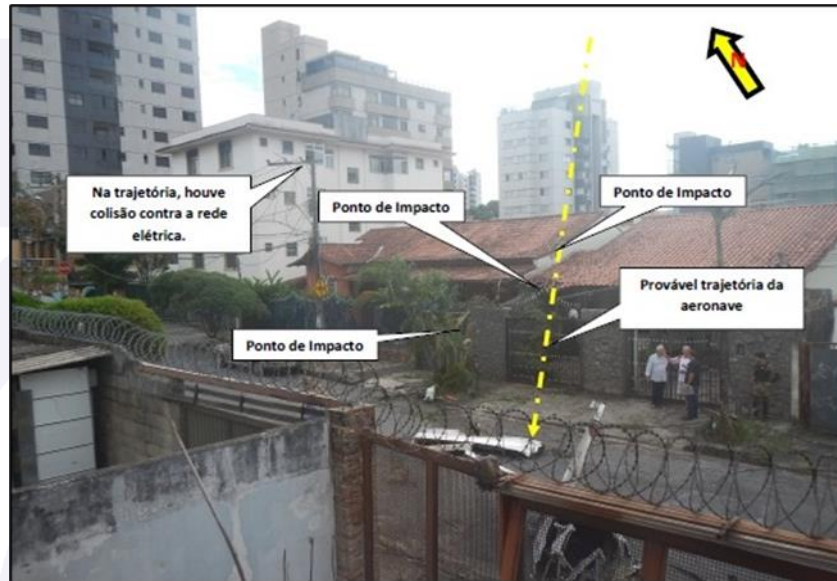
Other points of impact showed that the aircraft reached the ground in a high-angle trajectory, practically at 90 degrees with the public road.

Figure 2 - Image of the accident site and estimated trajectory in the last moments of the flight.

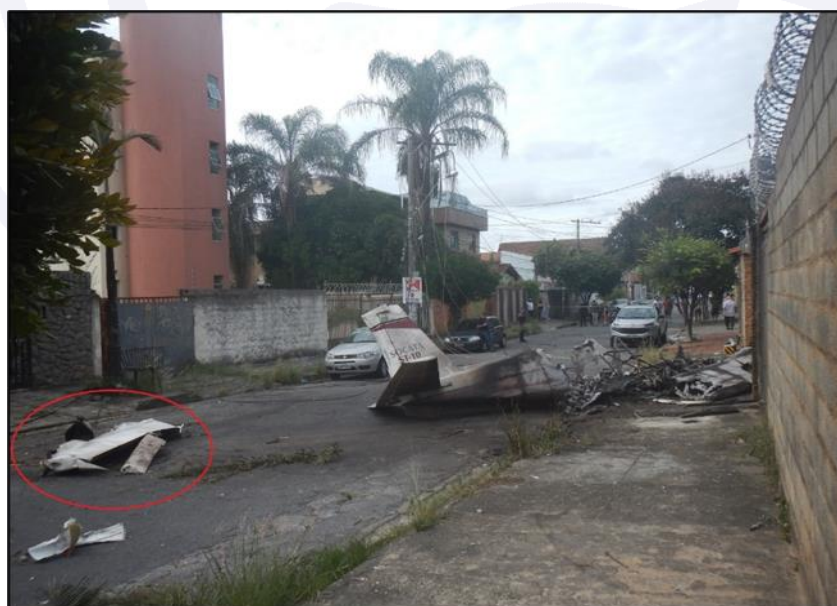
Part of the left wing came off the plane during the first few impacts. It was found a few meters from the rest of the wreckage (Figure 3).

Figure 3 - Image of the accident site. In the red highlight, the part of the left-wing that separated from the plane.

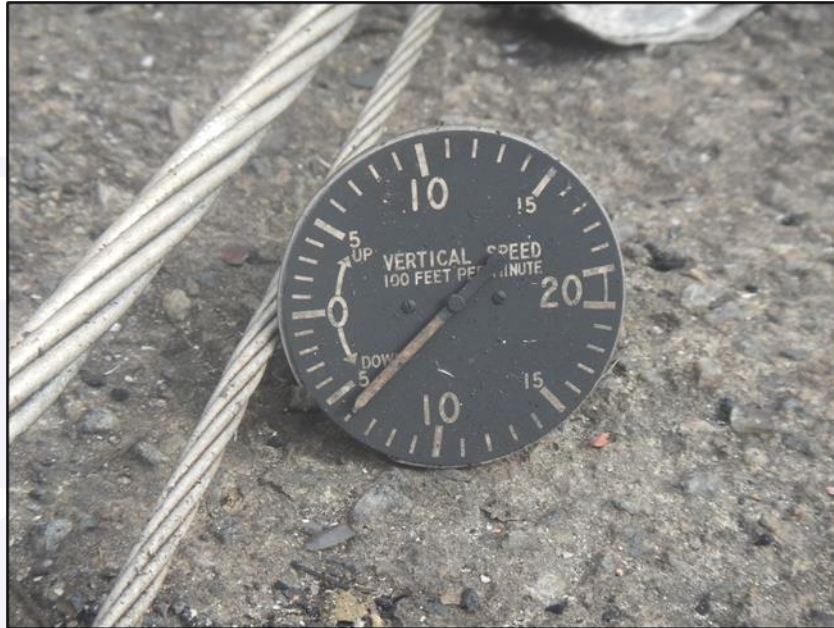
The Vertical Speed Indicator (Climb) showed a rate of descent of 600 ft/min. However, it was not possible to certify that this was the aircraft's rate of descent at the time of collision with the ground (Figure 4).

Figure 4 - Vertical Speed Indicator (Climb) showing a descent rate of 600 ft/min.

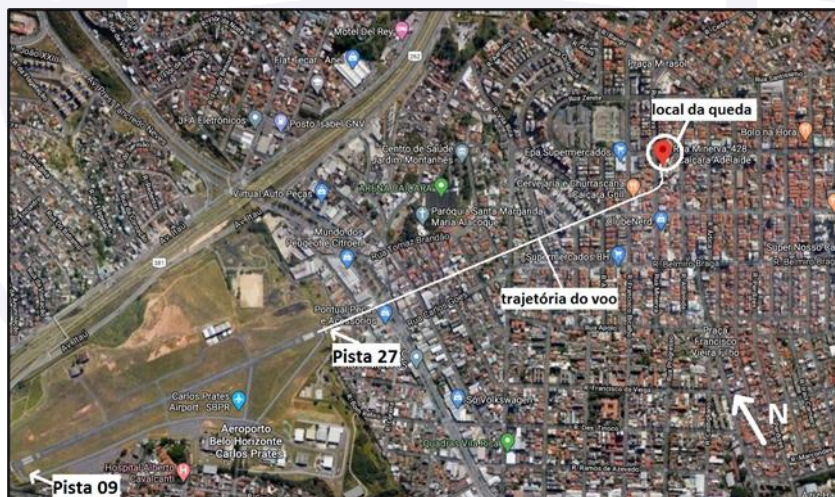
The plane was flying over a densely populated area, and there were no suitable places for a forced landing (Figure 5).

Figure 5 - Sketch of the occurrence.
