COMANDO DA AERONÁUTICA
CENTRO DE INVESTIGAÇÃO E PREVENÇÃO DE
ACIDENTES AERONÁUTICOS

FINAL REPORT
A - 121/CENIPA/2021

OCCURRENCE:	ACCIDENT
AIRCRAFT:	PT-ONJ
MODEL:	C90A
DATE:	05NOV2021

During the approach phase, under Visual Meteorological Conditions (VMC), the aircraft collided against a lightning arrester cable of a power grid on the final approach to threshold 02 of Caratinga Aerodrome (SNCT), Ubaporanga - MG, resulting in loss of control and the impact of the aircraft against the ground.

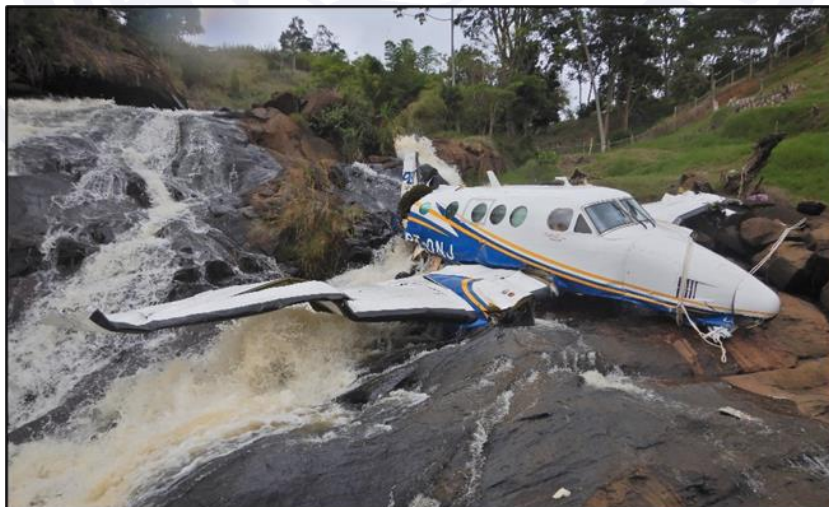
The aircraft had substantial damage throughout its length.

Both engines were detached, the fuselage and wings flexed downwards, and the tail cone was sectioned (Figure 1).

Figure 1 - Extent of damage to the aircraft.

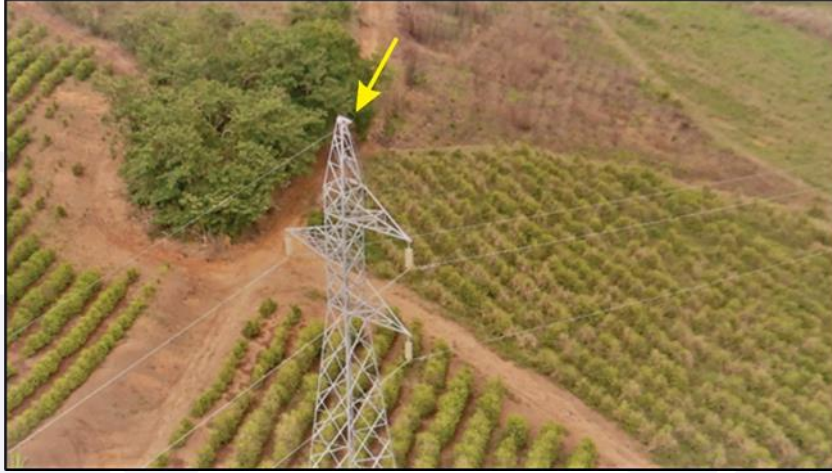
The lightning arrester cable in the gap between towers 8 and 9 of the power grid that operated in 69 kV of the “*Pipoca*” Small Hydroelectric Power Plant broke (Figure 2).

Figure 2 - Position of the lightning arrester on the right of Tower 8.

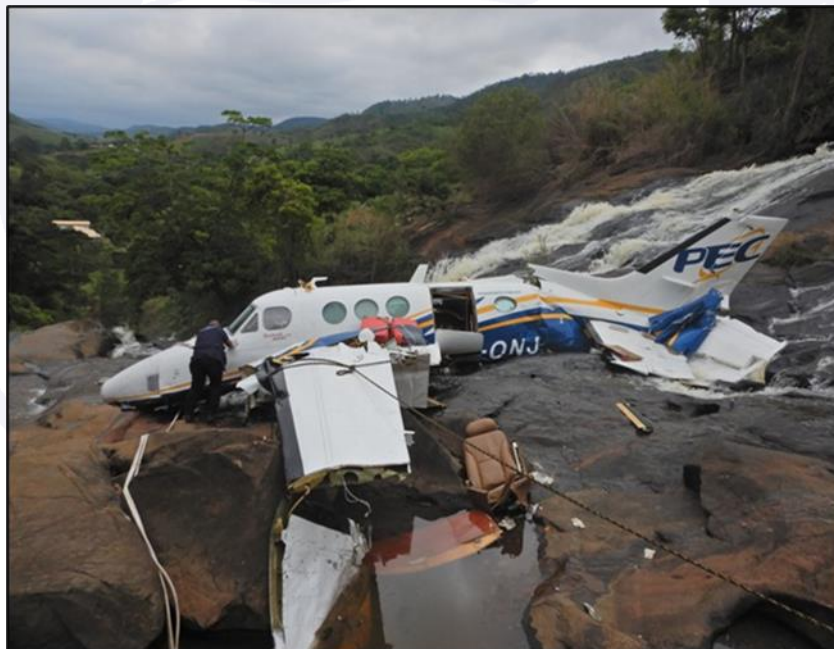
Except for the engines, auxiliary landing gear, and small parts of the fuselage, most of the wreckage was concentrated where the aircraft stopped. The structure had several deformations, folds, dents, and fractures, mainly due to the impact against the ground.

Figure 19 - Location of the final stop and damage to the aircraft structure.

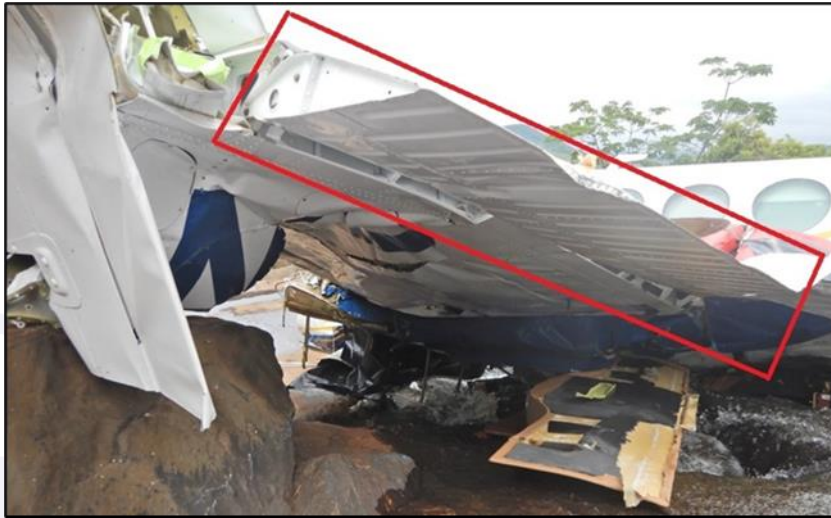
The angle of the flaps identified in the wreckage was compatible with the APPROACH position (Figure 20).

Figure 20 – Left-wing flap position after impact with the ground.

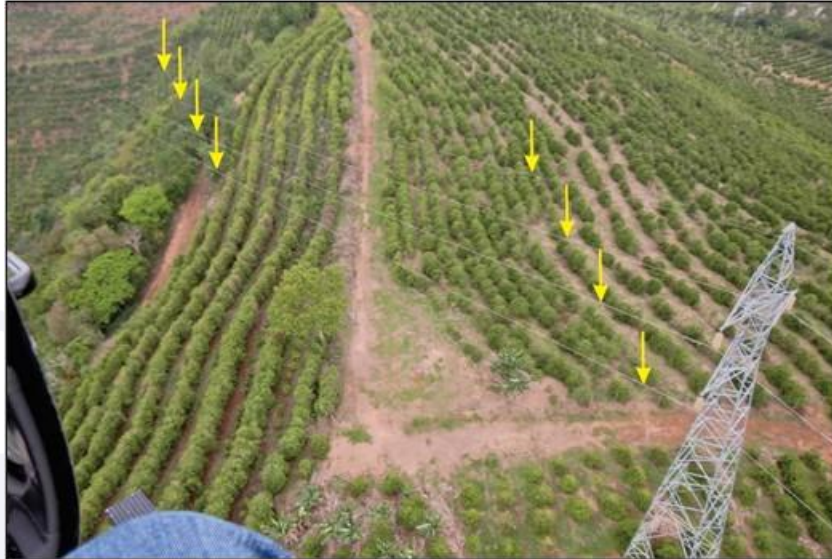
In the scenario where the accident with the PT-ONJ occurred, it was verified that the power grid had low contrast concerning the vegetation in the background. On the other hand, the tower supporting the line was on a high area and presented a more favorable contrast to its identification (Figure 21).

Figure 21 - Demonstration of the contrast of the cables and the tower, in relation to the terrain. The arrows indicate the positions of the cables between the two towers.

Thus, the way to compensate for a low-contrast condition must be considered through signage that allows the identification of objects at greater distances.

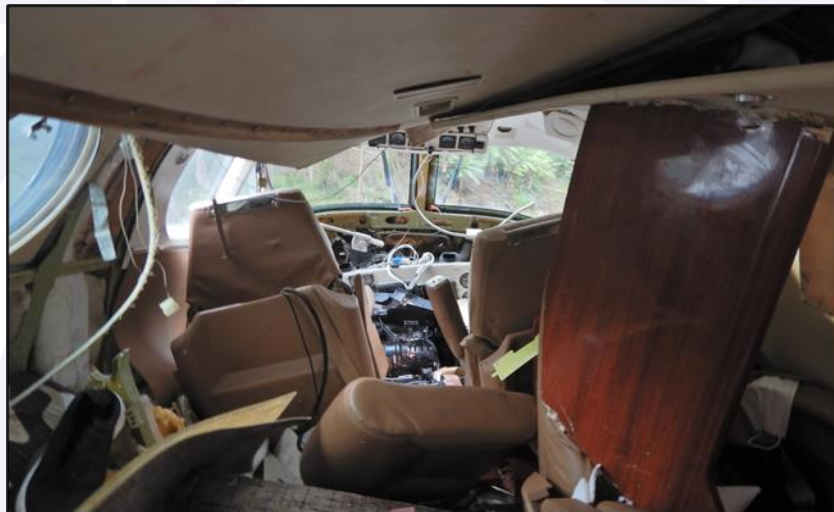
The aircraft's interior had an extensive detachment of its internal lining, the instrument panel, the floor, and all the seats (Figure 22).

Figure 22 - Extent of damage inside the aircraft.

It could not be determined whether the passengers were wearing their seatbelts. The force of the impact was much greater than the resistance and absorption capacity of both the fuselage and the seats.

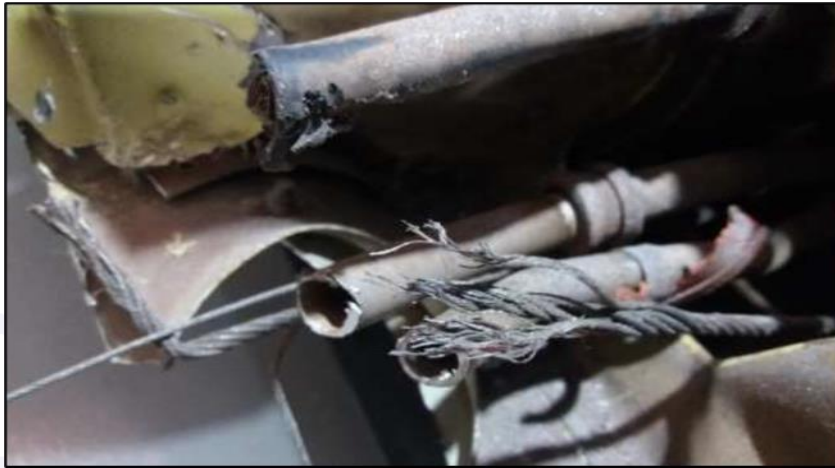
From the examinations performed on the primary flight control cables, it was observed: the spreading of the wires that composed the cables, different heights of wire breakage, and stranding; were indicative of overloading due to the aircraft impact (Figure 23).

Figure 23 - Aircraft control cables with overload indicator.

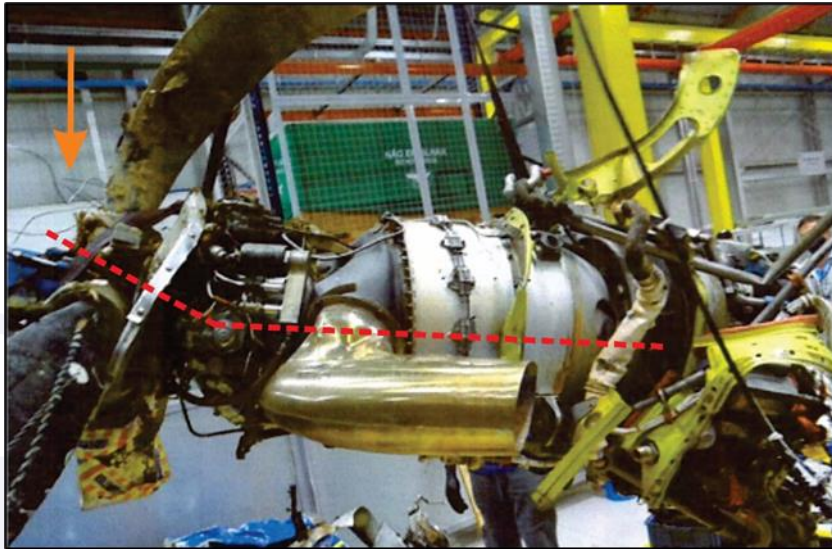
The exams of the left engine revealed that the external part was covered with dirt and organic debris, and that there was a piece of steel cable wrapped around the propeller hub. The front was deformed and twisted upwards, altering the engine shaft (Figure 26).

Figure 26 - View of the left side of the left engine without fairing. The dashed line projects the engine's longitudinal axis. The arrow indicates the cable wrapped around the propeller hub.

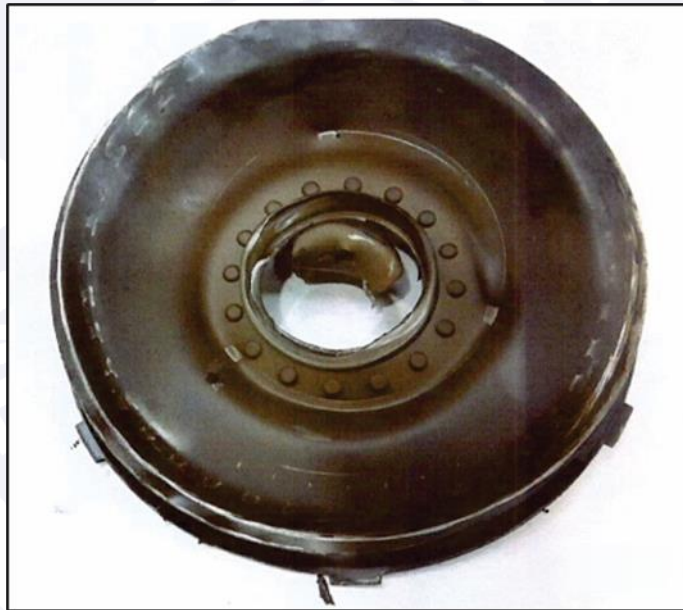
On the other side of the same diaphragm, facing the power turbine, there were impact marks left by the turbine rotor. The marks indicated that the rotor was stationary the moment the engine suffered compression and the consequent misalignment (Figure 29).

Figure 29 - Rear view of the diaphragm with smooth rubbing and impact marks with the power turbine rotor stopped.

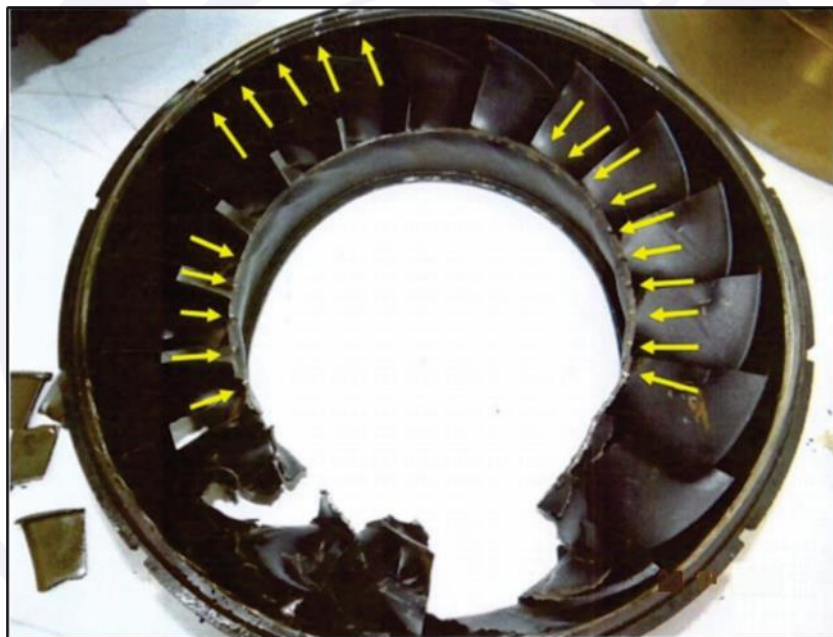
Like the rotor, the power turbine stator also showed marks of stopped impact and damage to the fins (Figure 31).

Figure 31 - Rear view of the left engine power turbine stator with stopped impact marks and damage to the fins.

The impact marks with the stopped power turbine rotor appeared due to the locking caused by the lightning rod cable on the propeller. This lock condition passed through the reduction box and reached the engine's power turbine.

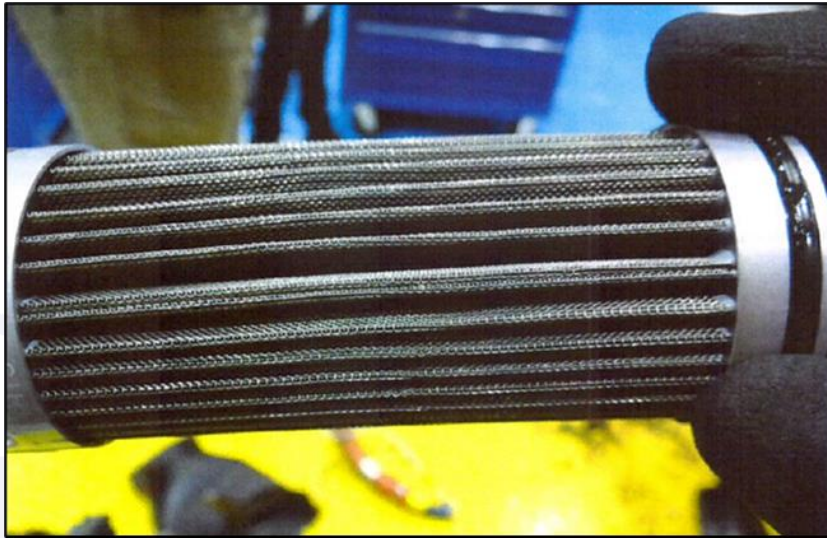
In the engine lubrication system, no abnormality was detected that could compromise the engine operation. During disassembly, it was noticed that the internal components, which require lubrication, showed evidence that they worked lubricated all the time (Figure 32).

Figure 32 - Left engine oil filter without abnormalities.

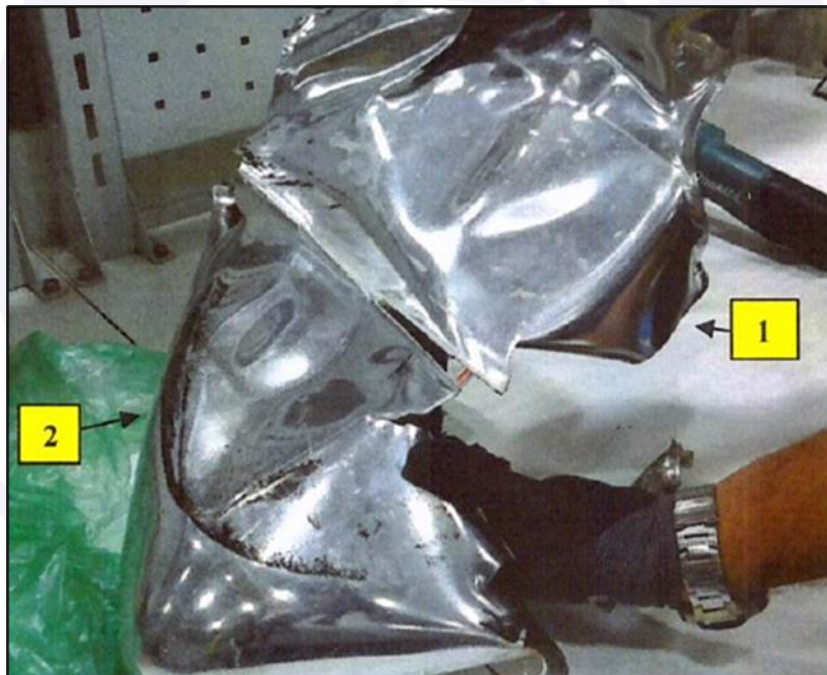
Analysis of the left engine propeller showed that initially, the lightning arrester cable hit the spinner and sectioned it. Then, the spinner was pulled from its attachment point to the propeller plate. The lightning arrester cable, when wrapped around the propeller, blocked the servo piston and the propeller blades in the position they were in at that moment of the flight (Figure 33).

Figure 33 - Impact marks on the left engine spinner.

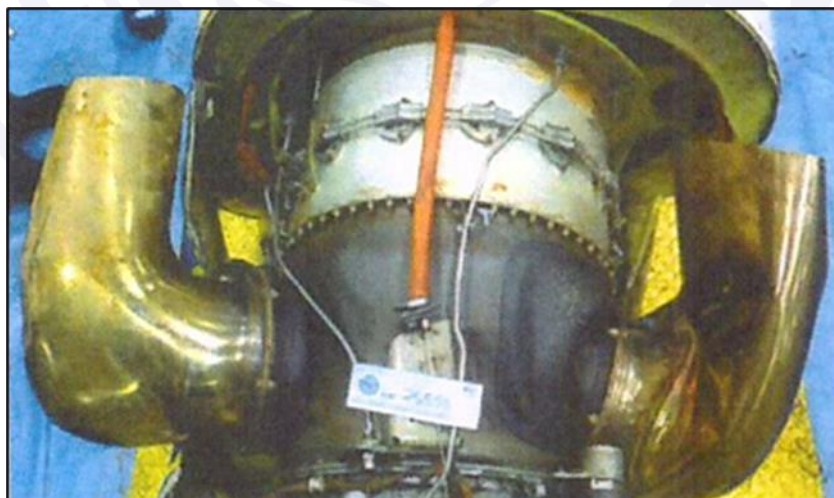
Figure 35 - Detail of the deformations of the lower part of the exhaust duct of the right-hand side engine.

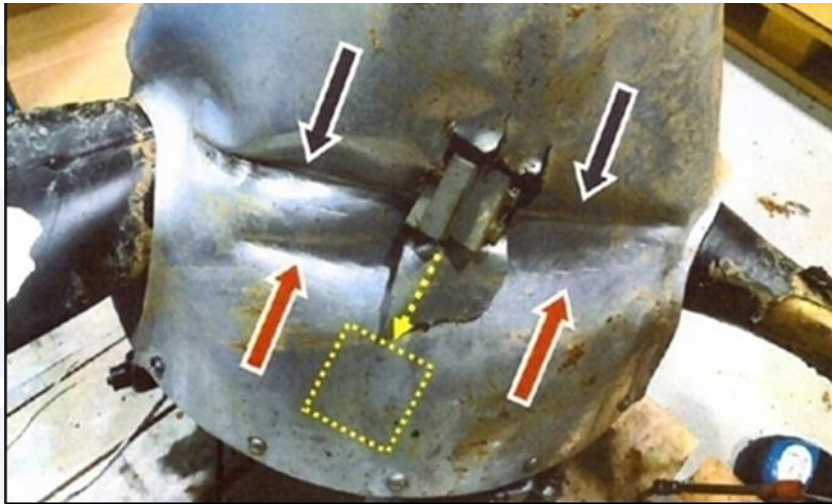
Figure 36 - Lightning arrester cable mark left on the right engine spinner.

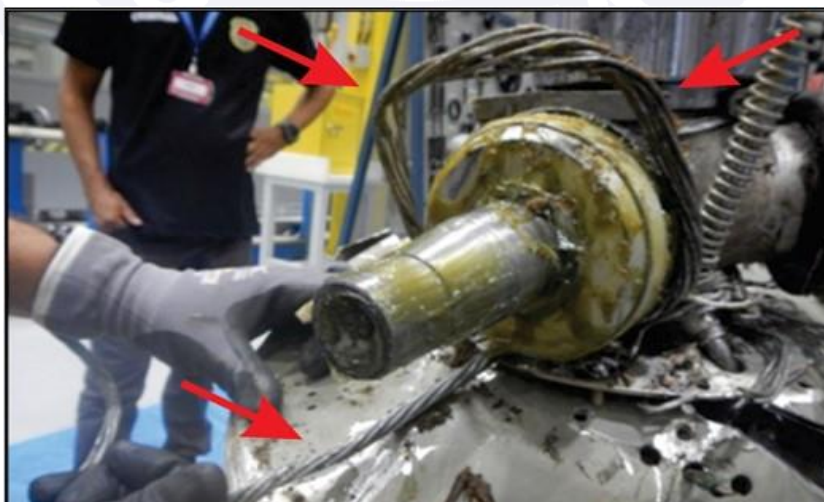
Figure 37 - Lightning arrester cable wrapped around the left engine propeller shaft, indicated by red arrows.

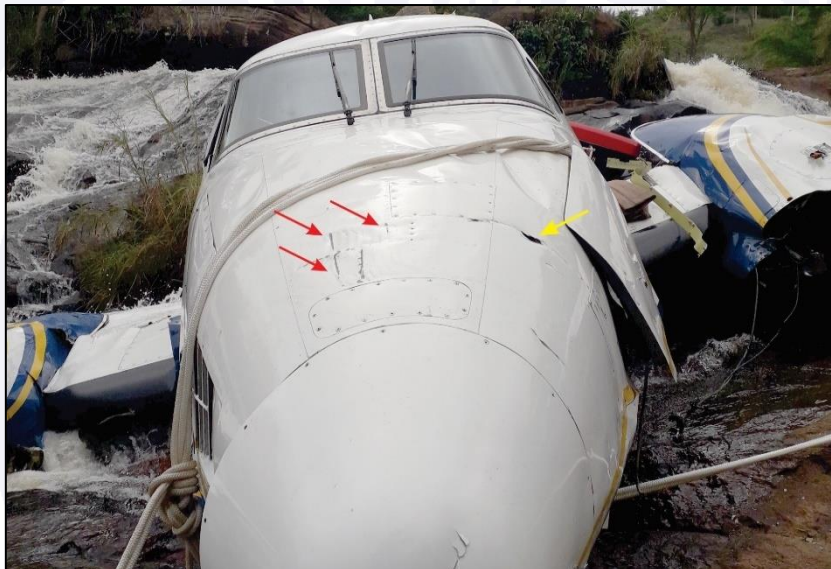
Figure 40 - Contact marks of the cable against the nose of the aircraft. The red arrows point to friction marks, and the yellow arrow shows one of the perforation points in the coating.

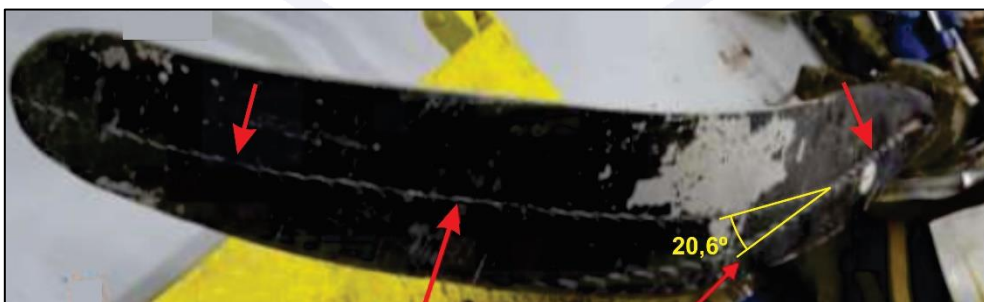
Figure 41 - Details of the impact marks of the cable against the left engine propeller blade.

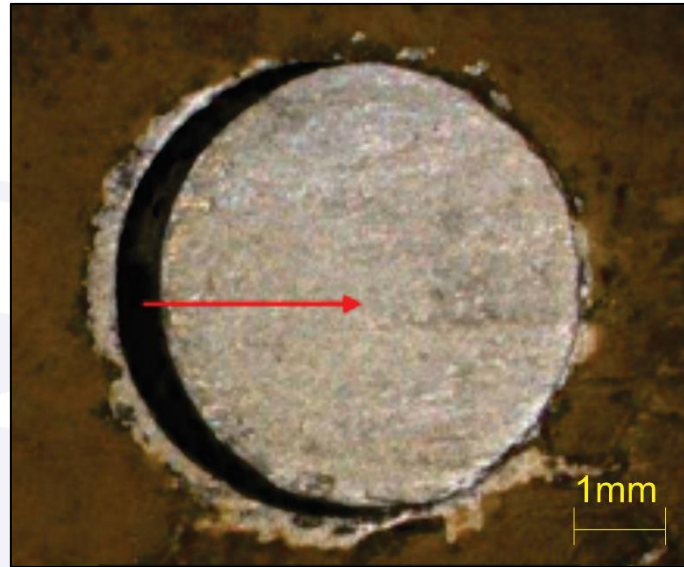
Figure 42 - Detail of the shear marks on the left engine support rivet. The arrow indicates the direction of the shear.

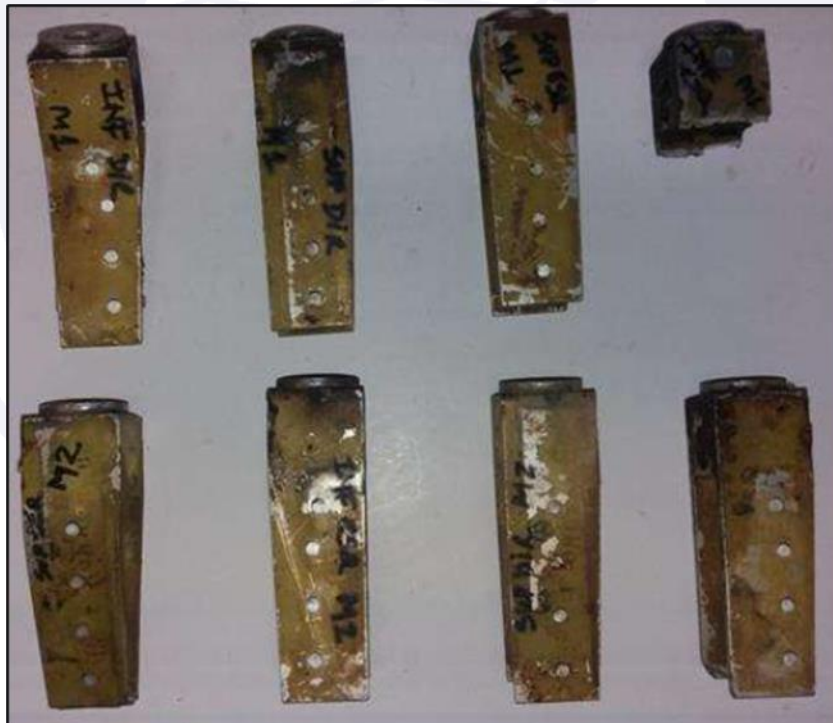
Figure 43 - (A) Engine fixing brackets of the left engine (above) and the right engine (below).
