COMANDO DA AERONÁUTICA
CENTRO DE INVESTIGAÇÃO E PREVENÇÃO DE
ACIDENTES AERONÁUTICOS

FINAL REPORT
A - 501/CENIPA/2015

OCCURRENCE:	ACCIDENT
AIRCRAFT:	N988AR
MODEL:	MD-11F
DATE:	13 OCT 2012

This the Final Report of the 13 October 2012 aeronautical accident with the MD-11F aircraft, registration N988AR. The accident was classified as “system/component failure”.

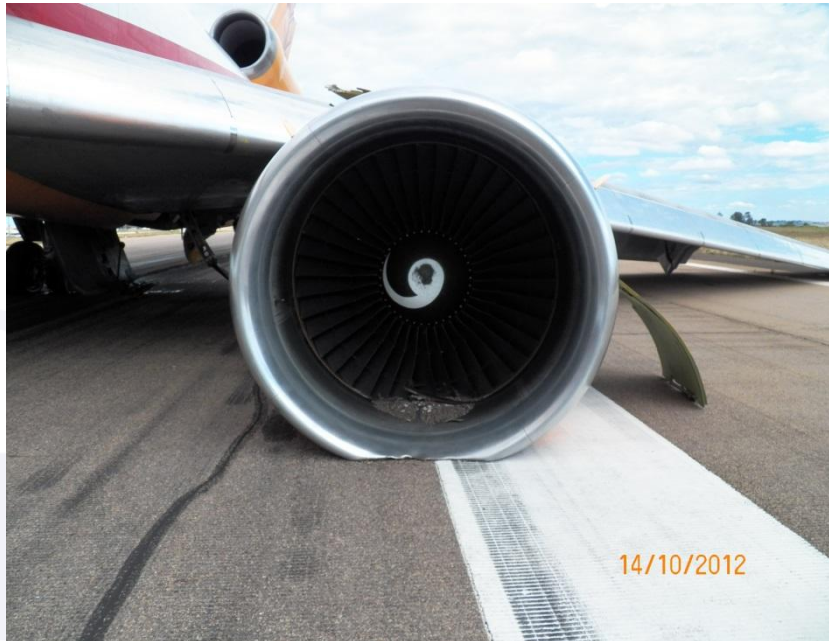
The aircraft sustained substantial damage to the left main gear assembly, left wing, and left engine.

Figure 1 – Position of the aircraft on the runway, showing the damage to the left main gear, left wing and left engine.

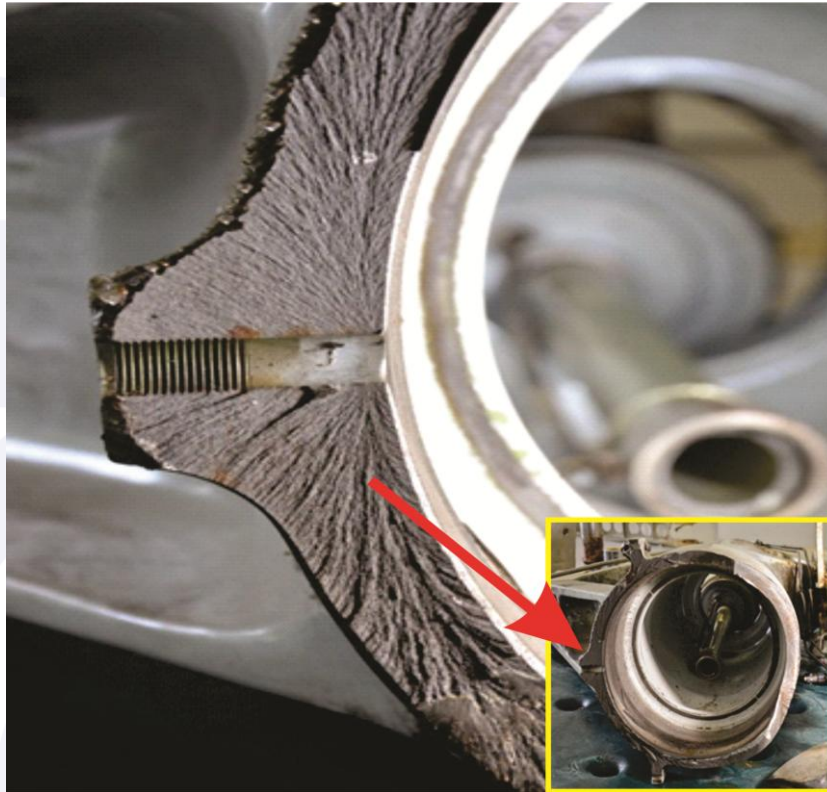
Figure 2- Fractured cylinder. Fracture surface with chevron markings.

Following the analysis, the DCTA report described that the “failure of the landing gear was due to overload in the structure of the cylinder. The fracture started in the rear section of the cylinder in a connection hole (bolt hole), which served as a tension concentration point, and ended in the front part of the cylinder which broke into two parts. The chevron markings on the fracture surface point toward the origin of the failure, and are typical of ductile overload”.

According to the DCTA technical report, the landing gear failure occurred on account of overload in the structure of the cylinder. The fracture started in the rear section of the cylinder in a connection hole (bolt hole), which served as a tension concentration point, and ended in the front part of the cylinder with its breakage into two parts.

Considering that the crew complied with the prescriptions of the aircraft manuals, and that the data retrieved from the flight recorders corroborate with the fact that the aircraft did not make a hard landing, the hypothesis of a pre-crack resulting from an earlier condition of overload, which would have functioned as a tension concentration point, was regarded as the main hypothesis related to this accident.

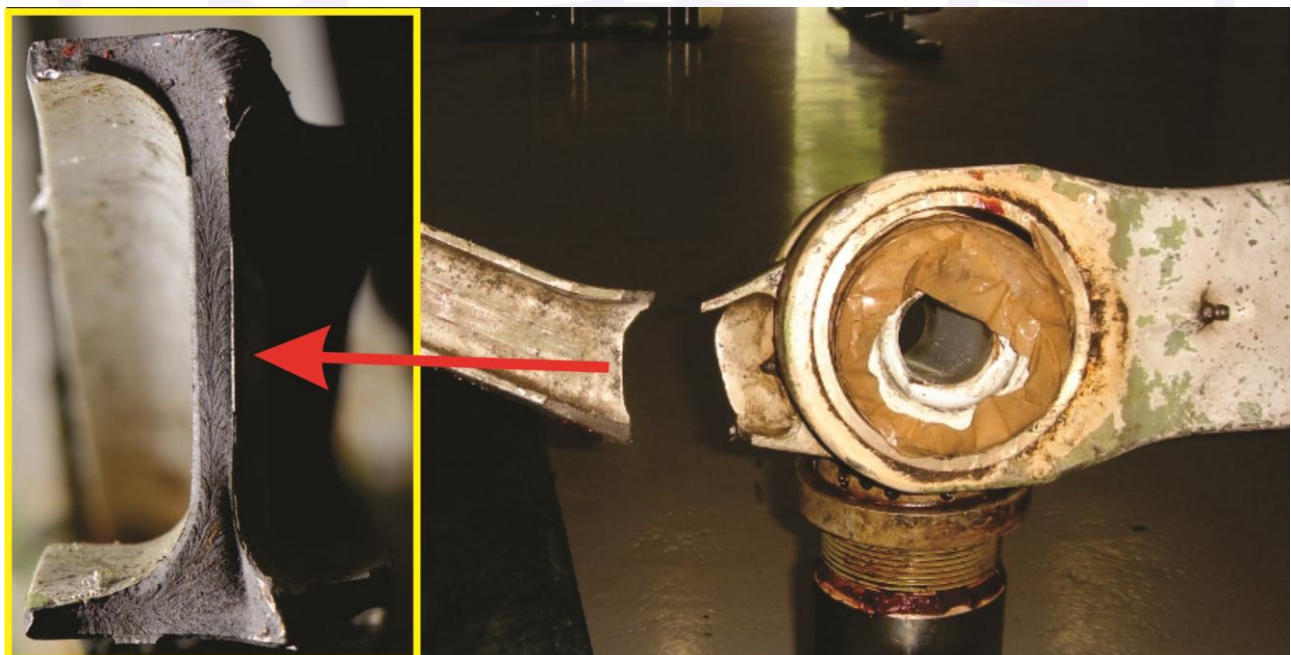
Figure 3 – Fractured articulated-arm seen from the side and from the front. The fracture occurred on account of overload.

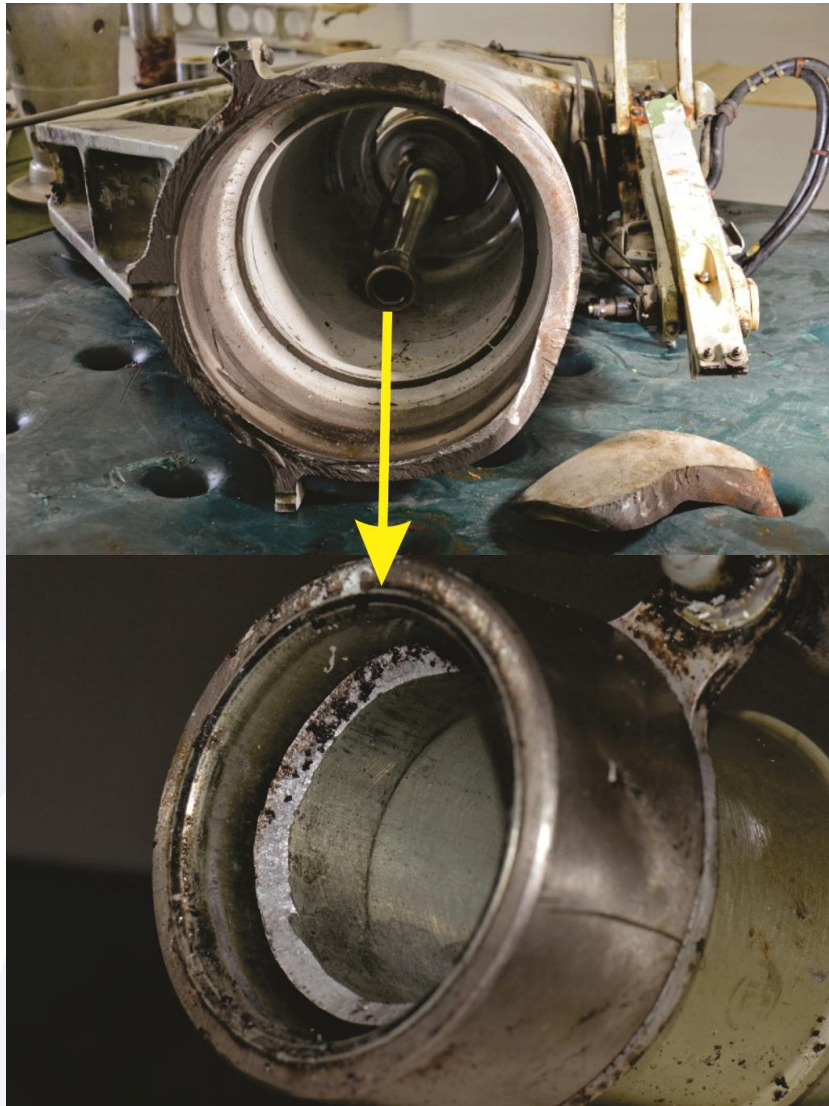
Figure 4 – General view of the cylinder interior and a fracture with a 45-degree incline in the interior of the tube (typical fracture due to overload).

The tests also showed that there were not any problems of dimensional nature, similarly to the DCTA exams, and that the material duress was within the prescribed limits. They also showed, by means of electron microscopy, that there were not any signs of corrosion or fatigue. The breakage was solely on account of overload.

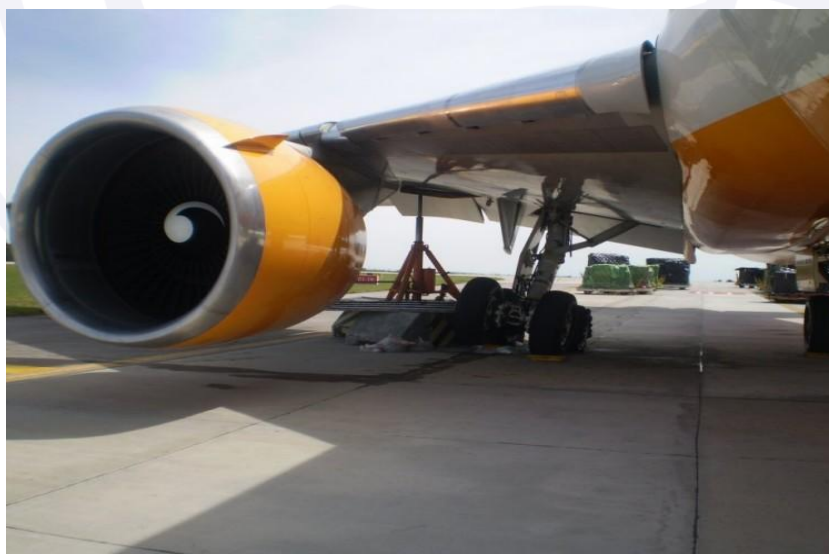
Figure 7 – Aspect of the aircraft after the accident in Montevideo (2009).

There was substantial damage to the right main gear and to the right wing. The technical report issued after the analysis of the right landing gear cylinder at the Boeing laboratory in Huntington Beach, California, stated that the failure of the component was due to overload. It is deducted that such overload resulted from the “Hard Landing”.

The right landing gear replacement took place in Montevideo and was conducted by Varig Engineering & Maintenance (VEM). The investigation commission did not identify in the records the organization responsible for the research of the damage sustained by the aircraft, the specification of the services necessary for the restoration of airworthiness, and the provision of all the services that enabled the restoration of the aircraft airworthy condition in Montevideo.
