COMANDO DA AERONÁUTICA
CENTRO DE INVESTIGAÇÃO E PREVENÇÃO DE
ACIDENTES AERONÁUTICOS

FINAL REPORT
A-519/CENIPA/2016

OCCURRENCE:	ACCIDENT
AIRCRAFT:	PT-HLE
MODEL:	HB-350B
DATE:	15JAN2010

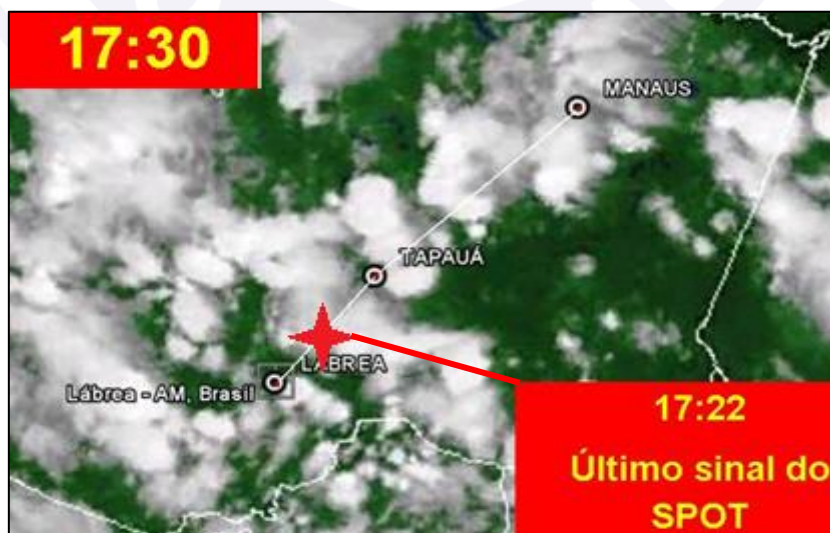
Figure 1 – Last SPOT signal received.

The company monitored the position of the aircraft by means of a satellite aircraft tracking system. The last position signal was received at 20:22 UTC, showing the aircraft in the coordinates 36°54'6"S/064°06'42"W, at a distance of approximately 16.5 NM from Canutama.

The meteorological analysis carried out during the investigation showed that the weather conditions became more and more degraded and intensified significantly by the end of the day. At the moment of the loss of the SPOT signal, the aircraft was in the middle of a heavy cloud formation, and was well closer to the destination than to the location from where it had departed. For this reason, it is possible to infer that the pilot may have decided to proceed with the flight even in unfavorable meteorological conditions.
